## Profile/Photo Observation Report

Date:	<b>04/18/2018</b>	Weather:		Coding:	<b>PACP 6.0</b>
Pipe Length (ft):	<b>316.2</b>	Owner:	<b>NA</b>	Pre Clean:	<b>No Pre-Cleaning</b>
P.O.#:		Surveyor:	<b>Byrd Fitzgerald</b>	PSR:	<b>P-305-016-015</b>
Customer:		Clean Date:	<b>01/01/1900</b>	Shape:	<b>C</b>

Street:	<b>FOXCROFT STREET</b>	Flow Control:	<b>Not Controlled</b>
City:	<b>Hobart, IN</b>	Year Renewed:	
Location:	<b>Yard</b>	Tape/Media #:	
Purpose:	<b>Routine Assessment</b>	Dia/Height:	<b>10"</b>
Use:	<b>Sanitary</b>	Material:	<b>VCP</b>
Drain Area:	<b>NA</b>	Lining:	<b>Cured in Place</b>
Category:	<b>NA</b>		
Comment:

Location Details:		Direction of Survey:	<b>Upstream</b>
US MH:	<b>M-305-016</b>	DS MH:	<b>M-305-015</b>
		Total Length Surveyed (ft):	<b>302.3</b>

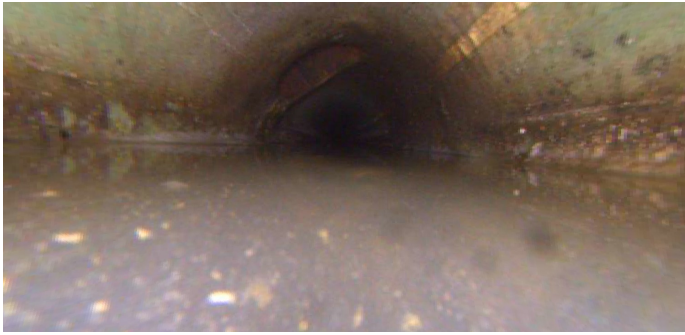
Code: **AMH**  
Description: **Manhole**

Distance (ft): **.0**  
Structural Grade: **0**  
O&M Grade: **0**  
Clock Start/From:  
Clock To:  
1st Value:  
2nd Value:  
Value Percent:  
Continuous Index:  
Within 8" of Joint: **NO**  
Remarks: **M-305-015**

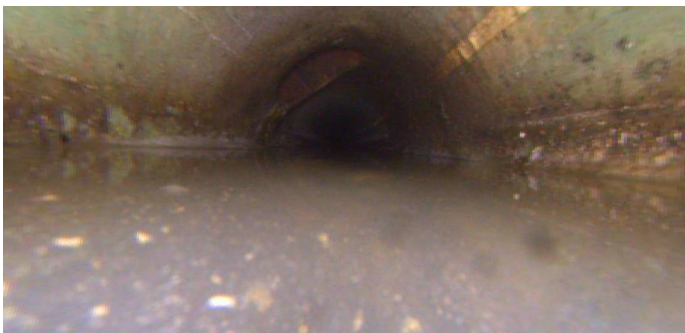
Code: **MWL**  
Description: **Water Level**

Distance (ft): **.0**  
Structural Grade: **0**  
O&M Grade: **0**  
Clock Start/From:  
Clock To:  
1st Value:  
2nd Value:  
Value Percent: **25.000**  
Continuous Index:  
Within 8" of Joint: **NO**  
Remarks:

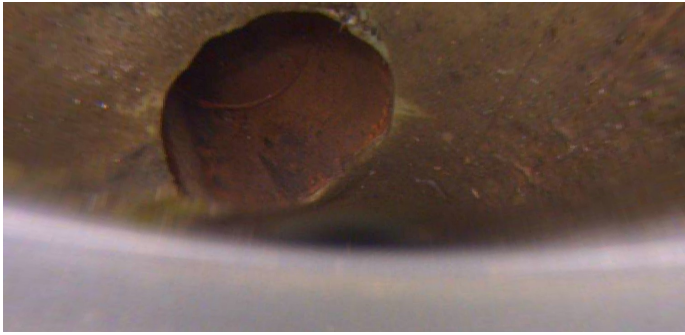
Code: **TB**  
Description: **Tap Break-in**

Distance (ft): **2.2**  
Structural Grade: **0**  
O&M Grade: **0**  
Clock Start/From: **11**  
Clock To:  
1st Value: **4.000**  
2nd Value:  
Value Percent:  
Continuous Index:  
Within 8" of Joint:  
Remarks:

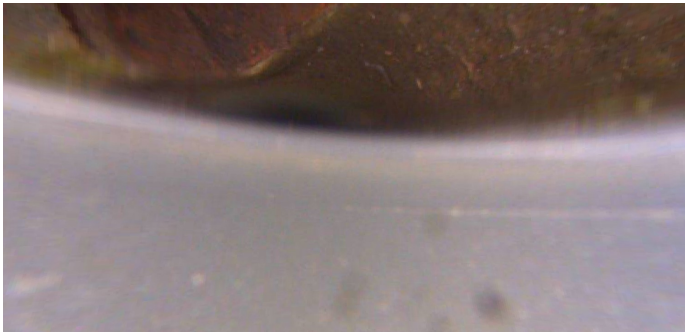
Code: **MWL**  
Description: **Water Level**

Distance (ft): **2.2**  
Structural Grade: **0**  
O&M Grade: **0**  
Clock Start/From:  
Clock To:  
1st Value:  
2nd Value:  
Value Percent: **70.000**  
Continuous Index:  
Within 8" of Joint: **NO**  
Remarks:

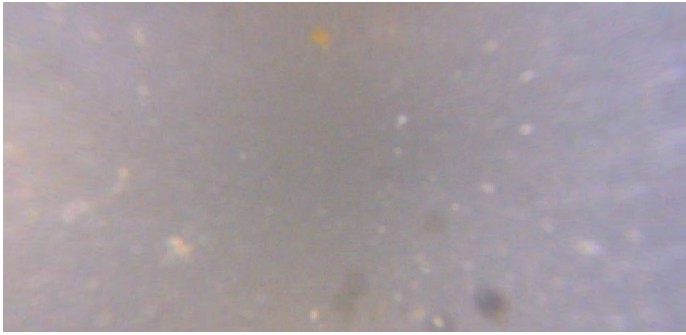
Code: **MCU**  
Description: **Camera Underwater**

Distance (ft): **3.2**  
Structural Grade: **0**  
O&M Grade: **4**  
Clock Start/From:  
Clock To:  
1st Value:  
2nd Value:  
Value Percent:  
Continuous Index:  
Within 8" of Joint: **NO**  
Remarks:

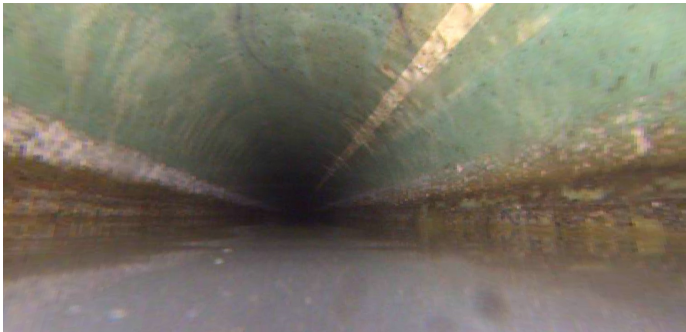
Code: **MWL**  
Description: **Water Level**

Distance (ft): **10.7**  
Structural Grade: **0**  
O&M Grade: **0**  
Clock Start/From:  
Clock To:  
1st Value:  
2nd Value:  
Value Percent: **5.000**  
Continuous Index:  
Within 8" of Joint: **NO**  
Remarks:

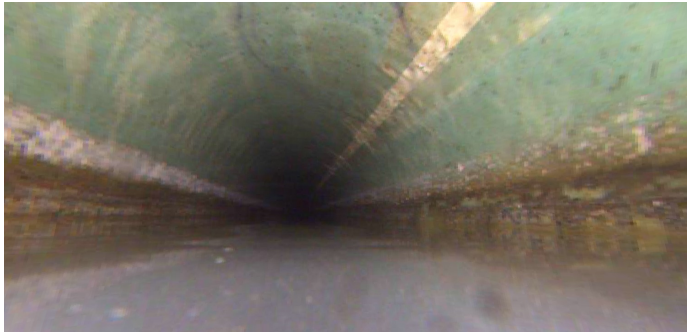
Code: **MWLS**  
Description: **Water Level Sag**

Distance (ft): **10.7**  
Structural Grade: **2**  
O&M Grade: **3**  
Clock Start/From:  
Clock To:  
1st Value:  
2nd Value:  
Value Percent: **5.000**  
Continuous Index: **S01**  
Within 8" of Joint: **NO**  
Remarks:

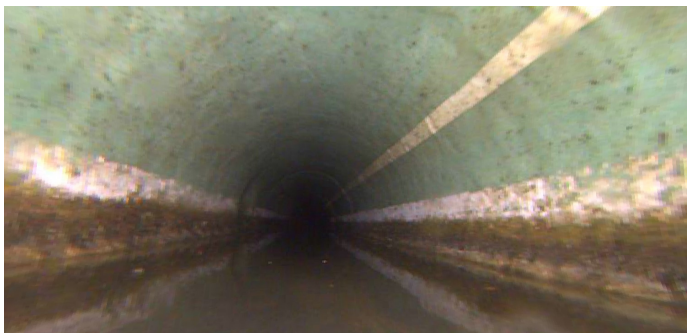
Code: **MWLS**  
Description: **Water Level Sag**

Distance (ft): **23.7**  
Structural Grade: **2**  
O&M Grade: **3**  
Clock Start/From:  
Clock To:  
1st Value:  
2nd Value:  
Value Percent: **5.000**  
Continuous Index: **F01**  
Within 8" of Joint: **NO**  
Remarks:

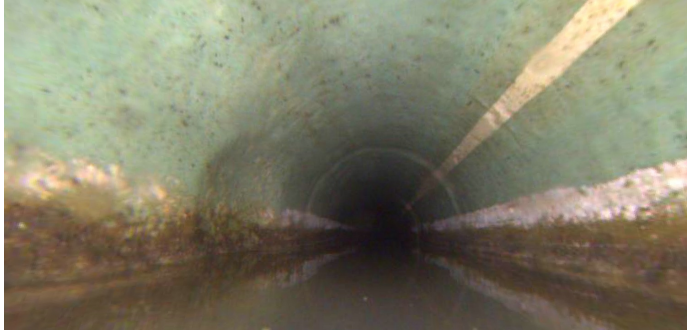
Code:	<b>LFAC</b>
Description:	<b>Lining Failure Abandoned Connection</b>
Distance (ft):	<b>24.7</b>
Structural Grade:	<b>0</b>
O&M Grade:	<b>0</b>
Clock Start/From:	<b>9</b>
Clock To:	
1st Value:	
2nd Value:	
Value Percent:	
Continuous Index:	
Within 8" of Joint:	<b>NO</b>
Remarks:

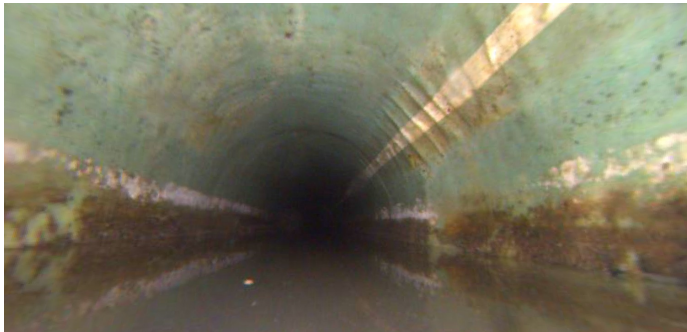
Code:	<b>LFAC</b>
Description:	<b>Lining Failure Abandoned Connection</b>
Distance (ft):	<b>27.0</b>
Structural Grade:	<b>0</b>
O&M Grade:	<b>0</b>
Clock Start/From:	<b>3</b>
Clock To:	
1st Value:	
2nd Value:	
Value Percent:	
Continuous Index:	
Within 8" of Joint:	<b>NO</b>
Remarks:

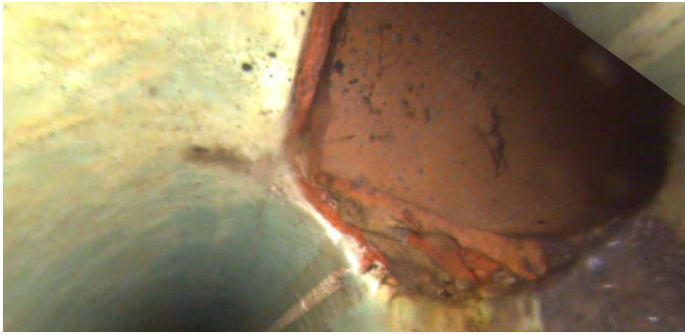
Code: **TB**  
Description: **Tap Break-in**

Distance (ft): **34.5**  
Structural Grade: **0**  
O&M Grade: **0**  
Clock Start/From: **2**  
Clock To:  
1st Value: **4.000**  
2nd Value:  
Value Percent:  
Continuous Index:  
Within 8" of Joint:  
Remarks:

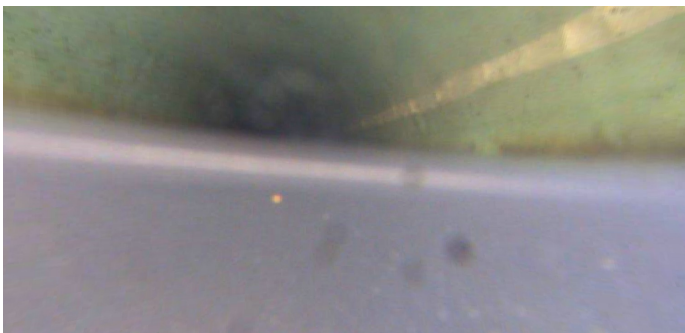
Code: **MCU**  
Description: **Camera Underwater**

Distance (ft): **63.5**  
Structural Grade: **0**  
O&M Grade: **4**  
Clock Start/From:  
Clock To:  
1st Value:  
2nd Value:  
Value Percent:  
Continuous Index:  
Within 8" of Joint: **NO**  
Remarks: **partially**

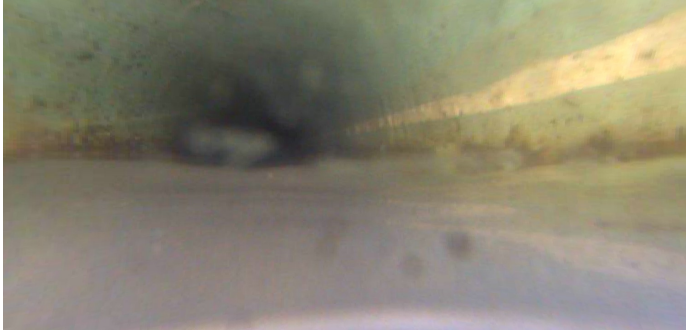
Code: **MWL**  
Description: **Water Level**

Distance (ft): **72.9**  
Structural Grade: **0**  
O&M Grade: **0**  
Clock Start/From:  
Clock To:  
1st Value:  
2nd Value:  
Value Percent: **25.000**  
Continuous Index:  
Within 8" of Joint: **NO**  
Remarks:

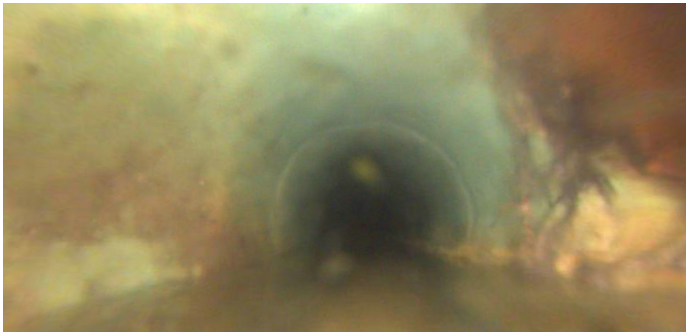
Code: **LFAC**  
Description: **Lining Failure Abandoned Connection**

Distance (ft): **103.6**  
Structural Grade: **0**  
O&M Grade: **0**  
Clock Start/From: **9**  
Clock To:  
1st Value:  
2nd Value:  
Value Percent:  
Continuous Index:  
Within 8" of Joint: **NO**  
Remarks:

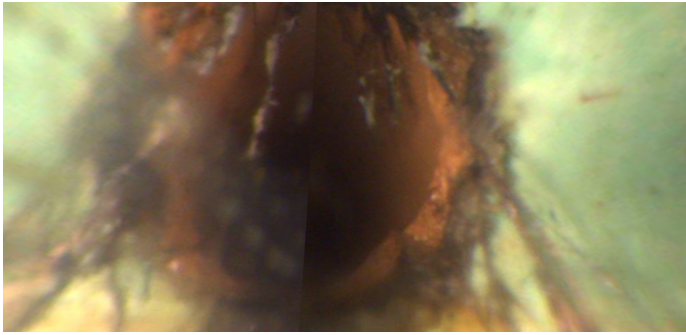
Code: **TBD**  
Description: **Tap Break-in Defective**

Distance (ft): **103.9**  
Structural Grade: **0**  
O&M Grade: **3**  
Clock Start/From: **2**  
Clock To:  
1st Value: **4.000**  
2nd Value:  
Value Percent:  
Continuous Index:  
Within 8" of Joint:  
Remarks: **roots**

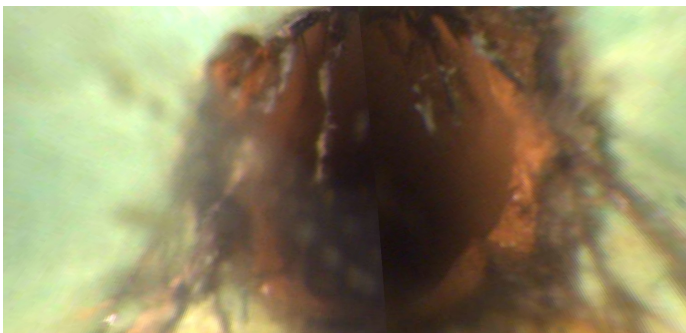
Code: **RFC**  
Description: **Roots Fine Connection**

Distance (ft): **103.9**  
Structural Grade: **0**  
O&M Grade: **1**  
Clock Start/From: **7**  
Clock To: **5**  
1st Value:  
2nd Value:  
Value Percent:  
Continuous Index:  
Within 8" of Joint: **NO**  
Remarks:

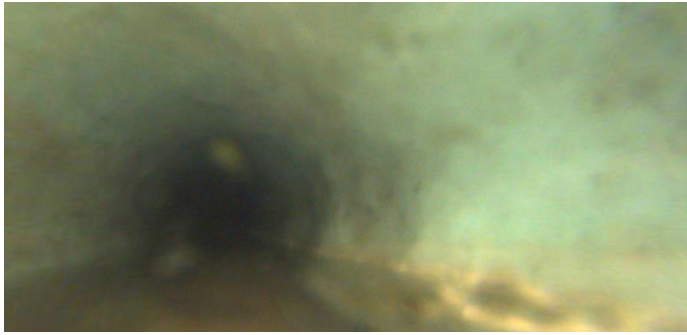
Code: **LFAC**  
Description: **Lining Failure Abandoned Connection**

Distance (ft): **105.3**  
Structural Grade: **0**  
O&M Grade: **0**  
Clock Start/From: **3**  
Clock To:  
1st Value:  
2nd Value:  
Value Percent:  
Continuous Index:  
Within 8" of Joint: **NO**  
Remarks:

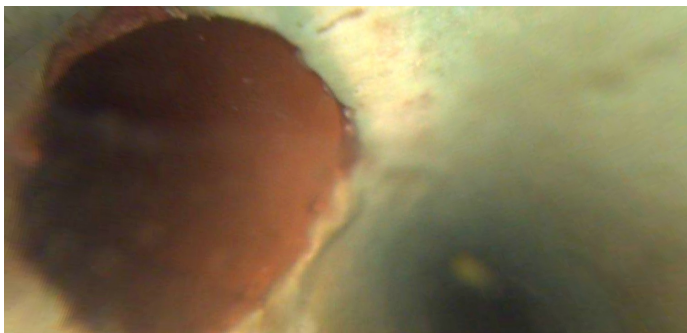
Code: **TB**  
Description: **Tap Break-in**

Distance (ft): **139.1**  
Structural Grade: **0**  
O&M Grade: **0**  
Clock Start/From: **10**  
Clock To:  
1st Value: **4.000**  
2nd Value:  
Value Percent:  
Continuous Index:  
Within 8" of Joint:  
Remarks:

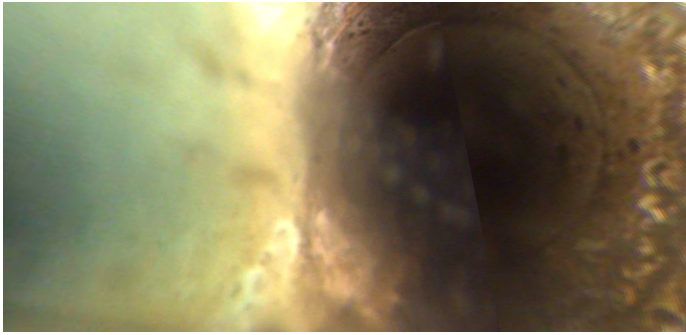
Code: **TB**  
Description: **Tap Break-in**

Distance (ft): **170.2**  
Structural Grade: **0**  
O&M Grade: **0**  
Clock Start/From: **3**  
Clock To:  
1st Value: **4.000**  
2nd Value:  
Value Percent:  
Continuous Index:  
Within 8" of Joint:  
Remarks:

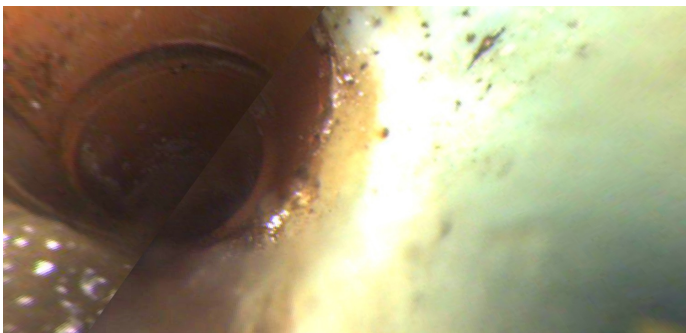
Code: **TB**  
Description: **Tap Break-in**

Distance (ft): **188.5**  
Structural Grade: **0**  
O&M Grade: **0**  
Clock Start/From: **11**  
Clock To:  
1st Value: **4.000**  
2nd Value:  
Value Percent:  
Continuous Index:  
Within 8" of Joint:  
Remarks:

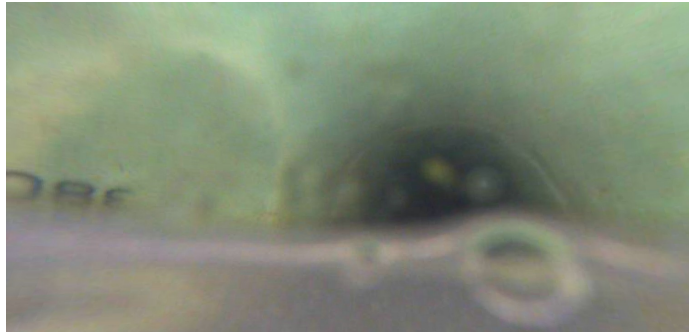
Code:	<b>LFAC</b>
Description:	<b>Lining Failure Abandoned Connection</b>
Distance (ft):	<b>191.9</b>
Structural Grade:	<b>0</b>
O&M Grade:	<b>0</b>
Clock Start/From:	<b>9</b>
Clock To:	
1st Value:	
2nd Value:	
Value Percent:	
Continuous Index:	
Within 8" of Joint:	<b>NO</b>
Remarks:

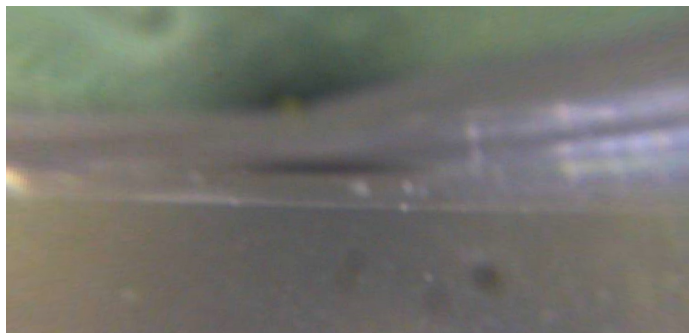
Code:	<b>MCU</b>
Description:	<b>Camera Underwater</b>
Distance (ft):	<b>193.8</b>
Structural Grade:	<b>0</b>
O&M Grade:	<b>4</b>
Clock Start/From:	
Clock To:	
1st Value:	
2nd Value:	
Value Percent:	
Continuous Index:	
Within 8" of Joint:	<b>NO</b>
Remarks:

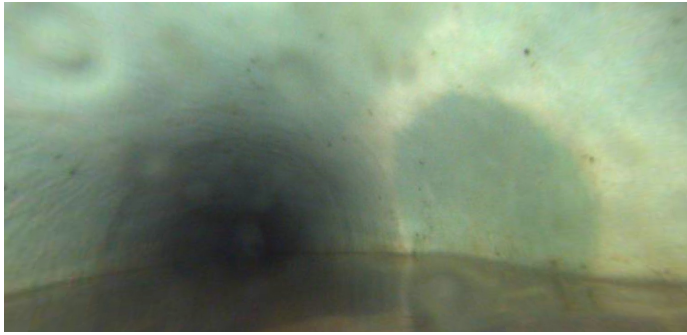
Code:	<b>LFAC</b>
Description:	<b>Lining Failure Abandoned Connection</b>
Distance (ft):	<b>194.0</b>
Structural Grade:	<b>0</b>
O&M Grade:	<b>0</b>
Clock Start/From:	<b>3</b>
Clock To:	
1st Value:	
2nd Value:	
Value Percent:	
Continuous Index:	
Within 8" of Joint:	<b>NO</b>
Remarks:

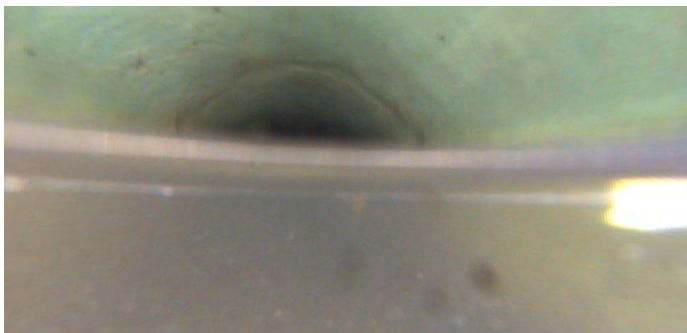
Code:	<b>MCU</b>
Description:	<b>Camera Underwater</b>
Distance (ft):	<b>199.1</b>
Structural Grade:	<b>0</b>
O&M Grade:	<b>4</b>
Clock Start/From:	
Clock To:	
1st Value:	
2nd Value:	
Value Percent:	
Continuous Index:	
Within 8" of Joint:	<b>NO</b>
Remarks:

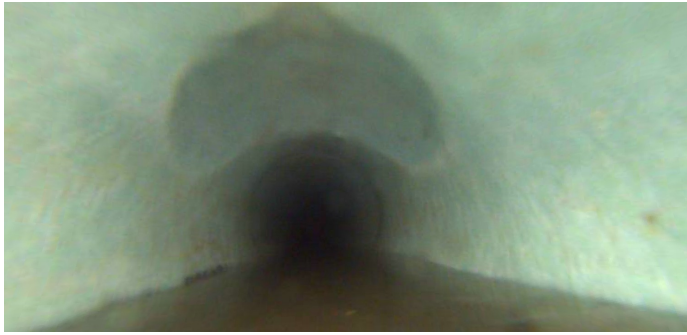
Code:	<b>LFAC</b>
Description:	<b>Lining Failure Abandoned Connection</b>
Distance (ft):	<b>289.6</b>
Structural Grade:	<b>0</b>
O&M Grade:	<b>0</b>
Clock Start/From:	<b>12</b>
Clock To:	
1st Value:	
2nd Value:	
Value Percent:	
Continuous Index:	
Within 8" of Joint:	<b>NO</b>
Remarks:

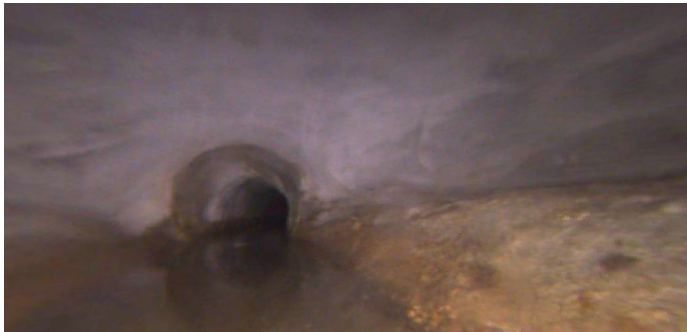
Code:	<b>AMH</b>
Description:	<b>Manhole</b>
Distance (ft):	<b>302.3</b>
Structural Grade:	<b>0</b>
O&M Grade:	<b>0</b>
Clock Start/From:	
Clock To:	
1st Value:	
2nd Value:	
Value Percent:	
Continuous Index:	
Within 8" of Joint:	<b>NO</b>
Remarks:	<b>M-305-016</b>
