## Profile/Photo Observation Report

Date:	<b>04/18/2018</b>	Weather:		Coding:	<b>PACP 6.0</b>
Pipe Length (ft):	<b>285.3</b>	Owner:	<b>NA</b>	Pre Clean:	<b>No Pre-Cleaning</b>
P.O.#:		Surveyor:	<b>Byrd Fitzgerald</b>	PSR:	<b>P-305-017-016</b>
Customer:		Clean Date:	<b>01/01/1900</b>	Shape:	<b>C</b>

Street:	<b>ALLEY BETWEEN WALNUT LN &amp; CRO</b>	Flow Control:	<b>Not Controlled</b>
City:	<b>Hobart, IN</b>	Year Renewed:	
Location:	<b>Yard</b>	Tape/Media #:	
Purpose:	<b>Routine Assessment</b>	Dia/Height:	<b>10"</b>
Use:	<b>Sanitary</b>	Material:	<b>VCP</b>
Drain Area:	<b>NA</b>	Lining:	<b>Cured in Place</b>
Category:	<b>NA</b>		
Comment:

Location Details:		Direction of Survey:	<b>Upstream</b>
US MH:	<b>M-305-017</b>	DS MH:	<b>M-305-016</b>
		Total Length Surveyed (ft):	<b>278.5</b>

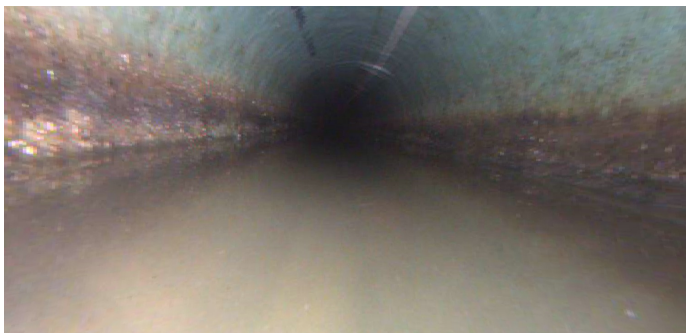
Code: **AMH**  
Description: **Manhole**

Distance (ft): **.0**  
Structural Grade: **0**  
O&M Grade: **0**  
Clock Start/From:  
Clock To:  
1st Value:  
2nd Value:  
Value Percent:  
Continuous Index:  
Within 8" of Joint: **NO**  
Remarks: **M-305-016**

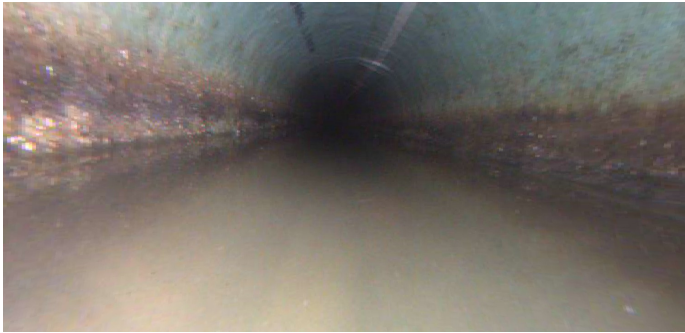
Code:	<b>MWL</b>
Description:	<b>Water Level</b>

Distance (ft):	<b>.0</b>
Structural Grade:	<b>0</b>
O&M Grade:	<b>0</b>
Clock Start/From:	
Clock To:	
1st Value:	
2nd Value:	
Value Percent:	<b>5.000</b>
Continuous Index:	
Within 8" of Joint:	<b>NO</b>
Remarks:

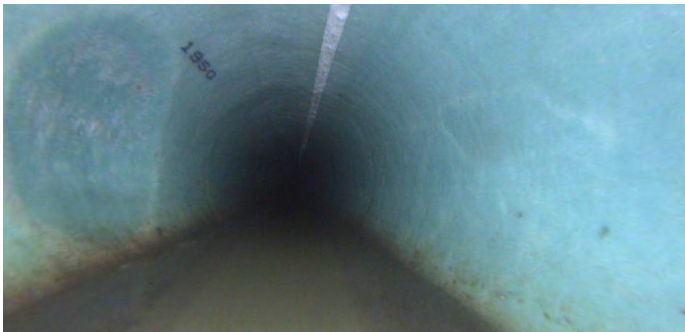
Code:	<b>LFAC</b>
Description:	<b>Lining Failure Abandoned Connection</b>

Distance (ft):	<b>38.2</b>
Structural Grade:	<b>0</b>
O&M Grade:	<b>0</b>
Clock Start/From:	<b>9</b>
Clock To:	
1st Value:	
2nd Value:	
Value Percent:	
Continuous Index:	
Within 8" of Joint:	<b>NO</b>
Remarks:

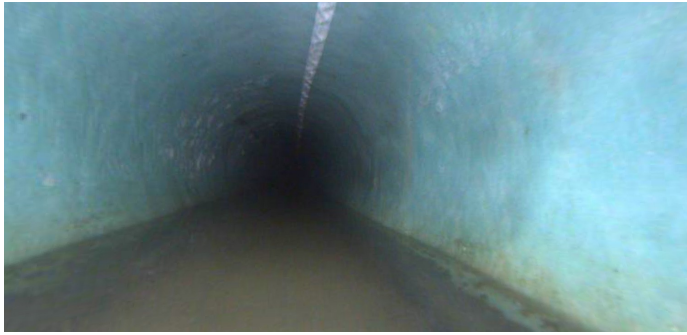
Code: **LFAC**  
Description: **Lining Failure Abandoned Connection**

Distance (ft): **40.3**  
Structural Grade: **0**  
O&M Grade: **0**  
Clock Start/From: **3**  
Clock To:  
1st Value:  
2nd Value:  
Value Percent:  
Continuous Index:  
Within 8" of Joint: **NO**  
Remarks:

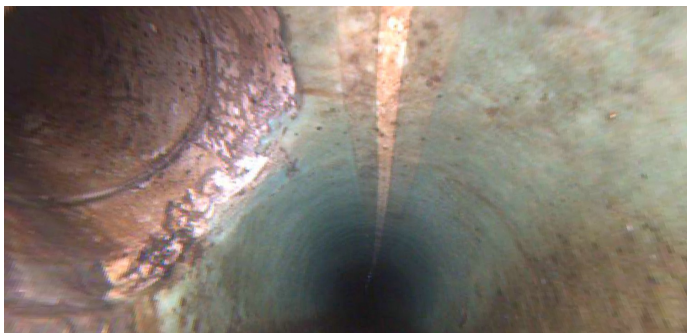
Code: **TB**  
Description: **Tap Break-in**

Distance (ft): **54.7**  
Structural Grade: **0**  
O&M Grade: **0**  
Clock Start/From: **11**  
Clock To:  
1st Value: **6.000**  
2nd Value:  
Value Percent:  
Continuous Index:  
Within 8" of Joint:  
Remarks:

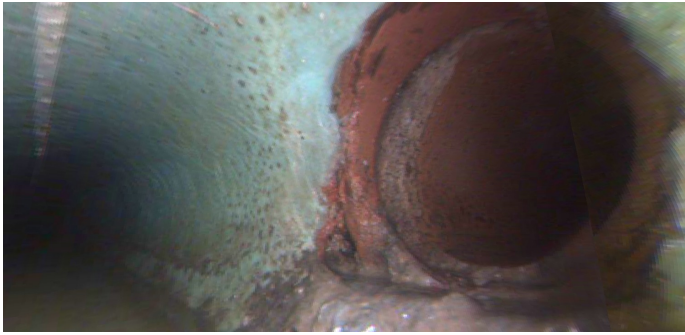
Code: **TB**  
Description: **Tap Break-in**

Distance (ft): **73.4**  
Structural Grade: **0**  
O&M Grade: **0**  
Clock Start/From: **3**  
Clock To:  
1st Value: **6.000**  
2nd Value:  
Value Percent:  
Continuous Index:  
Within 8" of Joint:  
Remarks:

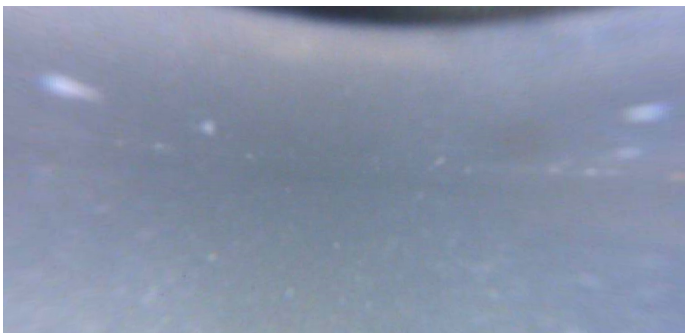
Code: **MCU**  
Description: **Camera Underwater**

Distance (ft): **107.2**  
Structural Grade: **0**  
O&M Grade: **4**  
Clock Start/From:  
Clock To:  
1st Value:  
2nd Value:  
Value Percent:  
Continuous Index:  
Within 8" of Joint: **NO**  
Remarks:

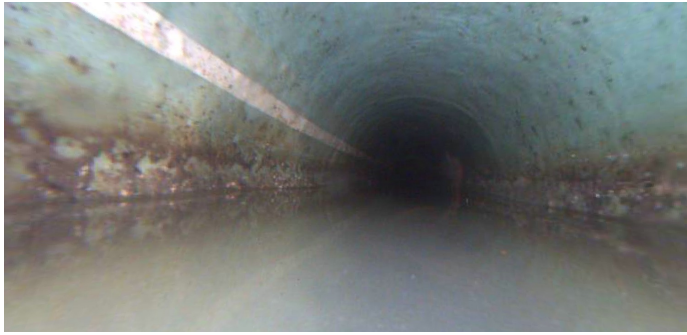
Code:	<b>LFAC</b>
Description:	<b>Lining Failure Abandoned Connection</b>
Distance (ft):	<b>116.6</b>
Structural Grade:	<b>0</b>
O&M Grade:	<b>0</b>
Clock Start/From:	<b>9</b>
Clock To:	
1st Value:	
2nd Value:	
Value Percent:	
Continuous Index:	
Within 8" of Joint:	<b>NO</b>
Remarks:

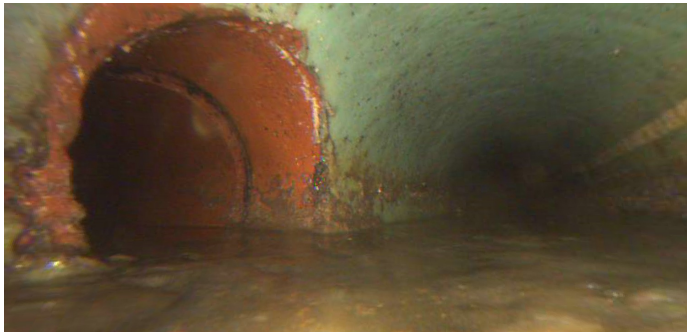
Code:	<b>TBA</b>
Description:	<b>Tap Break-in Active</b>
Distance (ft):	<b>119.6</b>
Structural Grade:	<b>0</b>
O&M Grade:	<b>0</b>
Clock Start/From:	<b>3</b>
Clock To:	
1st Value:	<b>4.000</b>
2nd Value:	
Value Percent:	
Continuous Index:	
Within 8" of Joint:	
Remarks:

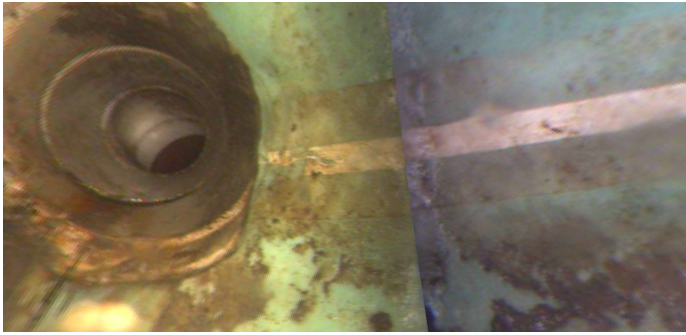
Code: **TB**  
Description: **Tap Break-in**

Distance (ft): **123.7**  
Structural Grade: **0**  
O&M Grade: **0**  
Clock Start/From: **11**  
Clock To:  
1st Value: **4.000**  
2nd Value:  
Value Percent:  
Continuous Index:  
Within 8" of Joint:  
Remarks:

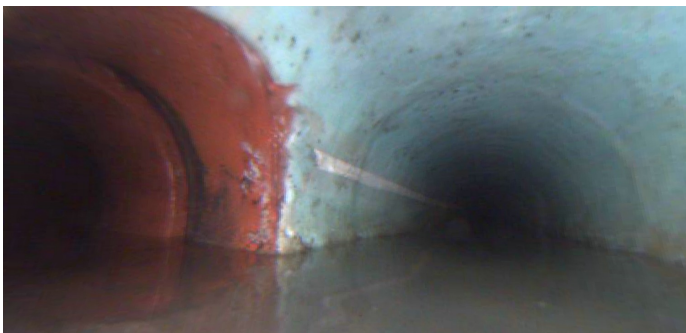
Code: **TB**  
Description: **Tap Break-in**

Distance (ft): **190.4**  
Structural Grade: **0**  
O&M Grade: **0**  
Clock Start/From: **9**  
Clock To:  
1st Value: **6.000**  
2nd Value:  
Value Percent:  
Continuous Index:  
Within 8" of Joint:  
Remarks:

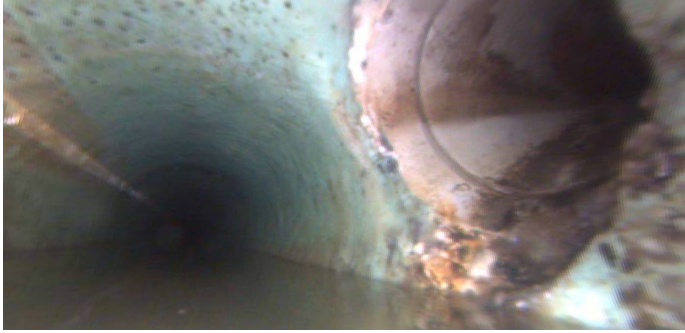
Code: **TB**  
Description: **Tap Break-in**

Distance (ft): **206.2**  
Structural Grade: **0**  
O&M Grade: **0**  
Clock Start/From: **2**  
Clock To:  
1st Value: **4.000**  
2nd Value:  
Value Percent:  
Continuous Index:  
Within 8" of Joint:  
Remarks:

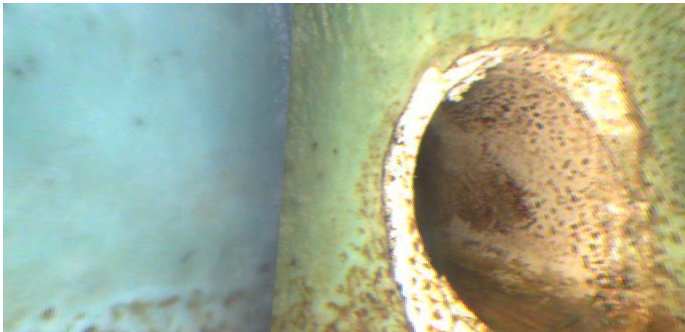
Code: **TB**  
Description: **Tap Break-in**

Distance (ft): **252.7**  
Structural Grade: **0**  
O&M Grade: **0**  
Clock Start/From: **3**  
Clock To:  
1st Value: **4.000**  
2nd Value:  
Value Percent:  
Continuous Index:  
Within 8" of Joint:  
Remarks:

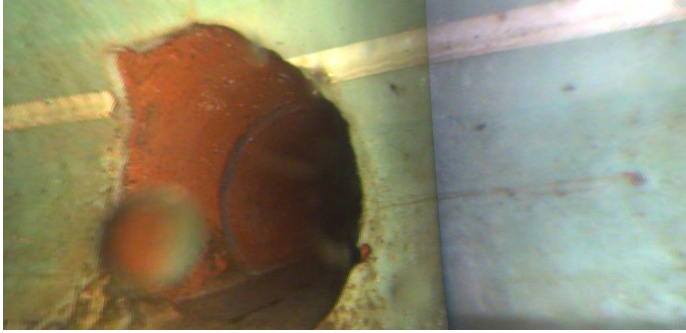
Code: **TB**  
Description: **Tap Break-in**

Distance (ft): **264.8**  
Structural Grade: **0**  
O&M Grade: **0**  
Clock Start/From: **9**  
Clock To:  
1st Value: **6.000**  
2nd Value:  
Value Percent:  
Continuous Index:  
Within 8" of Joint:  
Remarks:

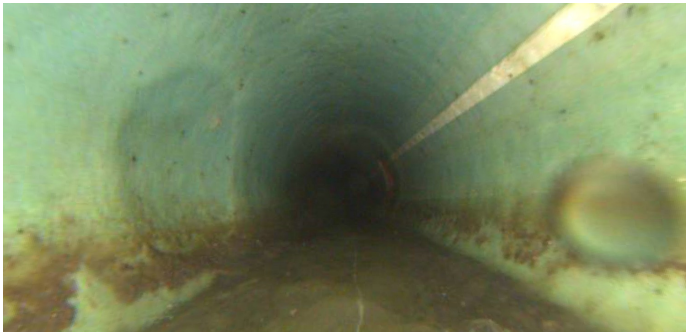
Code: **LFAC**  
Description: **Lining Failure Abandoned Connection**

Distance (ft): **267.2**  
Structural Grade: **0**  
O&M Grade: **0**  
Clock Start/From: **3**  
Clock To:  
1st Value:  
2nd Value:  
Value Percent:  
Continuous Index:  
Within 8" of Joint: **NO**  
Remarks:
