Profile/Photo Observation Report

Street:	FOXCROFT STREET	Flow Control:	Not Controlled
City:	Hobart, IN	Year Renewed:	
Location:	Yard	Tape/Media #:	
Purpose:	Routine Assessment	Dia/Height:	10"
Use:	Sanitary	Material:	VCP
Drain Area:	NA	Lining:	Cured in Place
Category:	NA		
Comment:

Location Details:		Direction of Survey:	Upstream
US MH:	M-305-017	DS MH:	M-305-016
		Total Length Surveyed (ft):	278.5

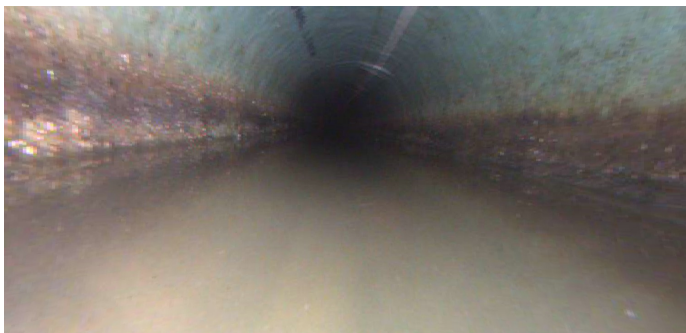
Code: **AMH**
Description: **Manhole**

Distance (ft): **.0**
Structural Grade: **0**
O&M Grade: **0**
Clock Start/From:
Clock To:
1st Value:
2nd Value:
Value Percent:
Continuous Index:
Within 8" of Joint: **NO**
Remarks: **M-305-016**

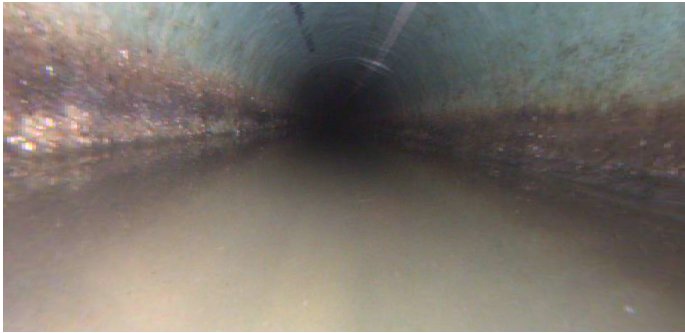
Code:	MWL
Description:	Water Level

Distance (ft):	.0
Structural Grade:	0
O&M Grade:	0
Clock Start/From:	
Clock To:	
1st Value:	
2nd Value:	
Value Percent:	5.000
Continuous Index:	
Within 8" of Joint:	NO
Remarks:

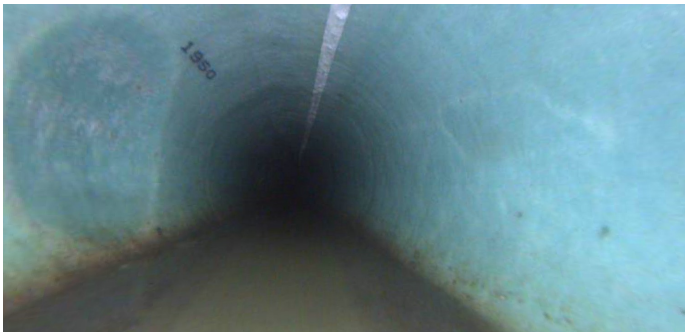
Code:	LFAC
Description:	Lining Failure Abandoned Connection

Distance (ft):	38.2
Structural Grade:	0
O&M Grade:	0
Clock Start/From:	9
Clock To:	
1st Value:	
2nd Value:	
Value Percent:	
Continuous Index:	
Within 8" of Joint:	NO
Remarks:

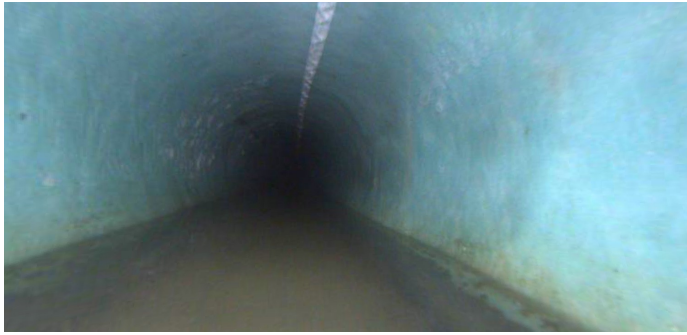
Code: **LFAC**
Description: **Lining Failure Abandoned Connection**

Distance (ft): **40.3**
Structural Grade: **0**
O&M Grade: **0**
Clock Start/From: **3**
Clock To:
1st Value:
2nd Value:
Value Percent:
Continuous Index:
Within 8" of Joint: **NO**
Remarks:

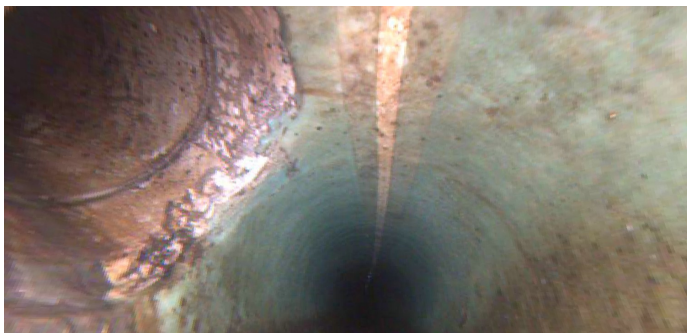
Code: **TB**
Description: **Tap Break-in**

Distance (ft): **54.7**
Structural Grade: **0**
O&M Grade: **0**
Clock Start/From: **11**
Clock To:
1st Value: **6.000**
2nd Value:
Value Percent:
Continuous Index:
Within 8" of Joint:
Remarks:

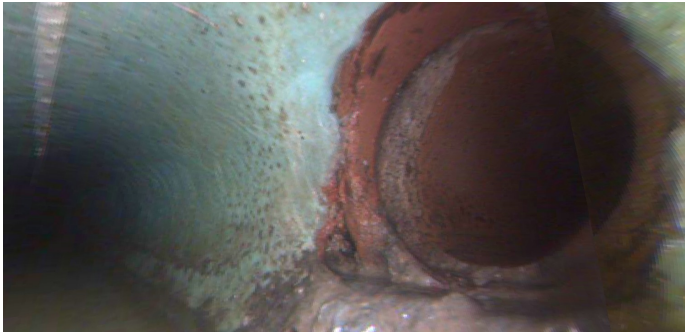
Code: **TB**
Description: **Tap Break-in**

Distance (ft): **73.4**
Structural Grade: **0**
O&M Grade: **0**
Clock Start/From: **3**
Clock To:
1st Value: **6.000**
2nd Value:
Value Percent:
Continuous Index:
Within 8" of Joint:
Remarks:

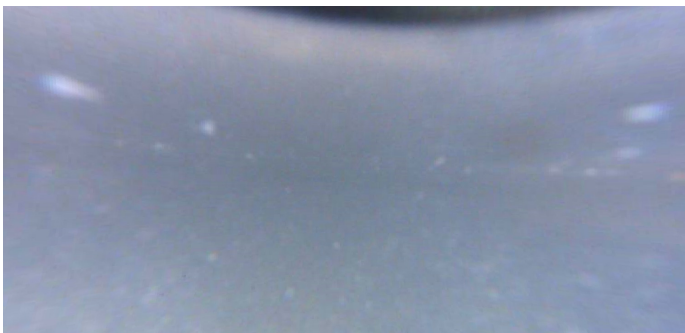
Code: **MCU**
Description: **Camera Underwater**

Distance (ft): **107.2**
Structural Grade: **0**
O&M Grade: **4**
Clock Start/From:
Clock To:
1st Value:
2nd Value:
Value Percent:
Continuous Index:
Within 8" of Joint: **NO**
Remarks:

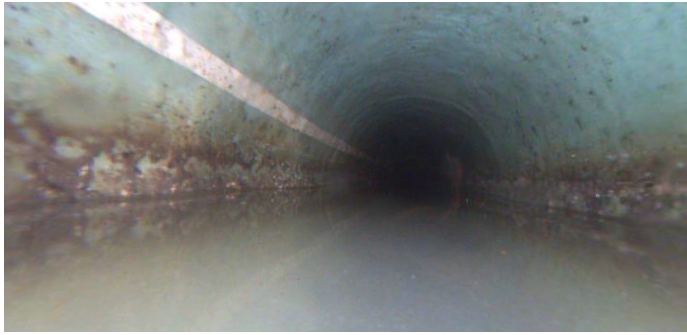
Code:	LFAC
Description:	Lining Failure Abandoned Connection
Distance (ft):	116.6
Structural Grade:	0
O&M Grade:	0
Clock Start/From:	9
Clock To:	
1st Value:	
2nd Value:	
Value Percent:	
Continuous Index:	
Within 8" of Joint:	NO
Remarks:

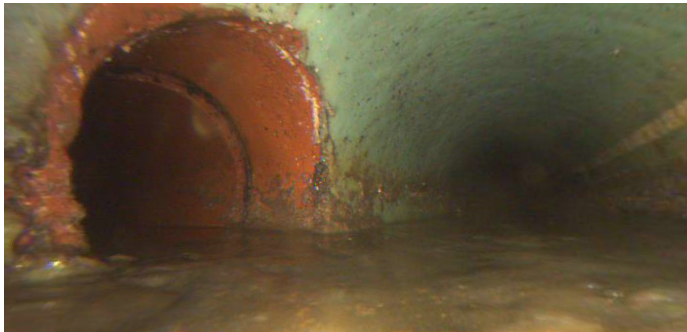
Code:	TBA
Description:	Tap Break-in Active
Distance (ft):	119.6
Structural Grade:	0
O&M Grade:	0
Clock Start/From:	3
Clock To:	
1st Value:	4.000
2nd Value:	
Value Percent:	
Continuous Index:	
Within 8" of Joint:	
Remarks:

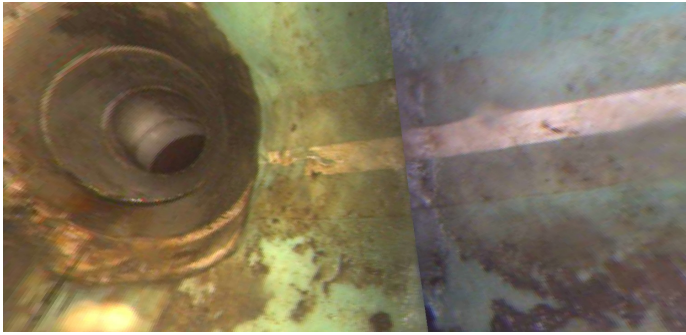
Code: **TB**
Description: **Tap Break-in**

Distance (ft): **123.7**
Structural Grade: **0**
O&M Grade: **0**
Clock Start/From: **11**
Clock To:
1st Value: **4.000**
2nd Value:
Value Percent:
Continuous Index:
Within 8" of Joint:
Remarks:

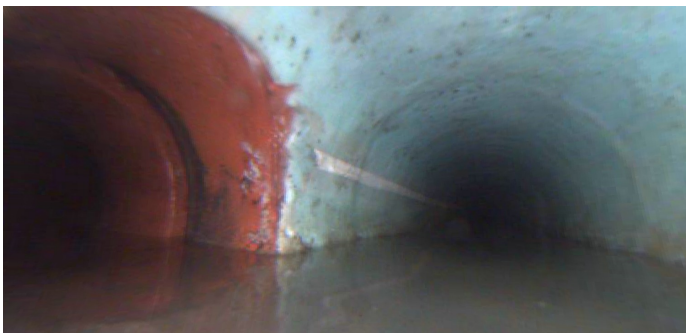
Code: **TB**
Description: **Tap Break-in**

Distance (ft): **190.4**
Structural Grade: **0**
O&M Grade: **0**
Clock Start/From: **9**
Clock To:
1st Value: **6.000**
2nd Value:
Value Percent:
Continuous Index:
Within 8" of Joint:
Remarks:

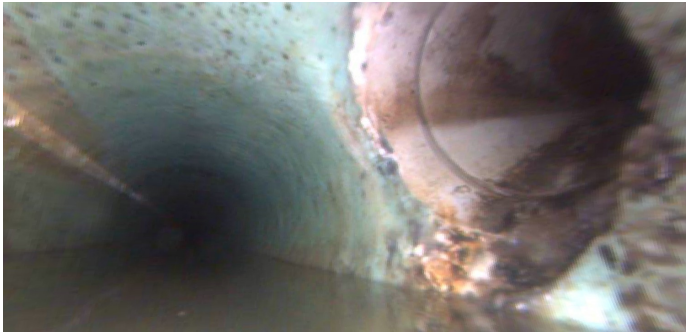
Code: **TB**
Description: **Tap Break-in**

Distance (ft): **206.2**
Structural Grade: **0**
O&M Grade: **0**
Clock Start/From: **2**
Clock To:
1st Value: **4.000**
2nd Value:
Value Percent:
Continuous Index:
Within 8" of Joint:
Remarks:

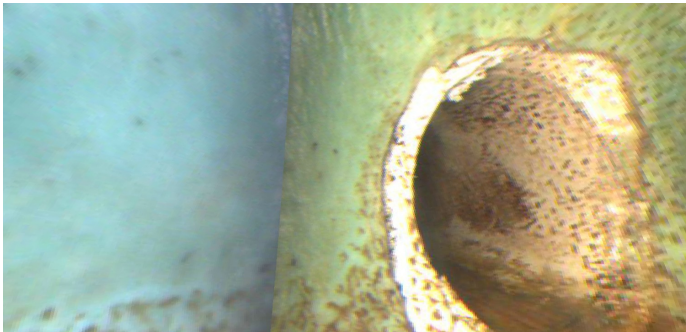
Code: **TB**
Description: **Tap Break-in**

Distance (ft): **252.7**
Structural Grade: **0**
O&M Grade: **0**
Clock Start/From: **3**
Clock To:
1st Value: **4.000**
2nd Value:
Value Percent:
Continuous Index:
Within 8" of Joint:
Remarks:

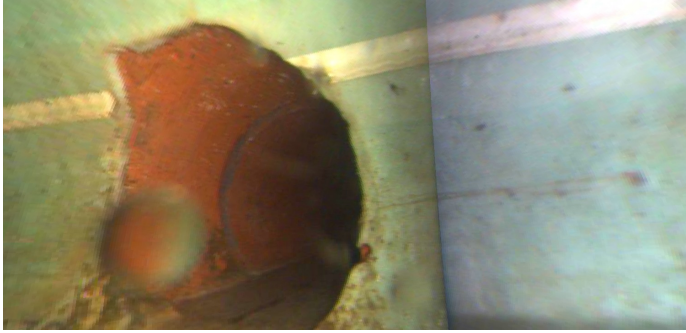
Code: **TB**
Description: **Tap Break-in**

Distance (ft): **264.8**
Structural Grade: **0**
O&M Grade: **0**
Clock Start/From: **9**
Clock To:
1st Value: **6.000**
2nd Value:
Value Percent:
Continuous Index:
Within 8" of Joint:
Remarks:

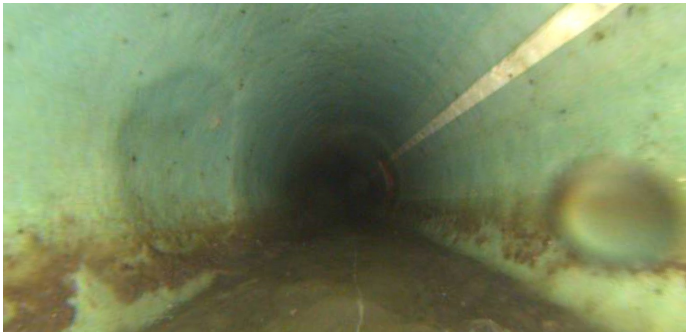
Code: **LFAC**
Description: **Lining Failure Abandoned Connection**

Distance (ft): **267.2**
Structural Grade: **0**
O&M Grade: **0**
Clock Start/From: **3**
Clock To:
1st Value:
2nd Value:
Value Percent:
Continuous Index:
Within 8" of Joint: **NO**
Remarks:
