Profile/Photo Observation Report

Date:	04/18/2018	Weather:		Coding:	PACP 6.0
Pipe Length (ft):	303.9	Owner:	NA	Pre Clean:	No Pre-Cleaning
P.O.#:		Surveyor:	Byrd Fitzgerald	PSR:	P-305-019-018
Customer:		Clean Date:	01/01/1900	Shape:	C

Street:	ALLEY BETWEEN WALNUT LN & CRO	Flow Control:	Not Controlled
City:	Hobart, IN	Year Renewed:	
Location:	Yard	Tape/Media #:	
Purpose:	Routine Assessment	Dia/Height:	10"
Use:	Sanitary	Material:	XXX
Drain Area:	NA	Lining:	Cured in Place
Category:	NA		
Comment:

Location Details:		Direction of Survey:	Upstream
US MH:	M-305-019	DS MH:	M-305-018
		Total Length Surveyed (ft):	286.2

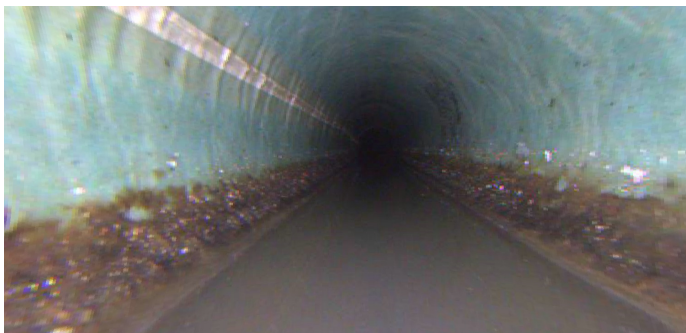
Code: **AMH**
Description: **Manhole**

Distance (ft): **.0**
Structural Grade: **0**
O&M Grade: **0**
Clock Start/From:
Clock To:
1st Value:
2nd Value:
Value Percent:
Continuous Index:
Within 8" of Joint: **NO**
Remarks: **M-305-018**

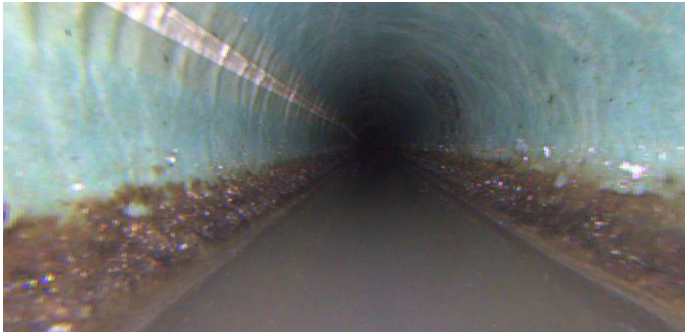
Code:	MWL
Description:	Water Level

Distance (ft):	.0
Structural Grade:	0
O&M Grade:	0
Clock Start/From:	
Clock To:	
1st Value:	
2nd Value:	
Value Percent:	5.000
Continuous Index:	
Within 8" of Joint:	NO
Remarks:

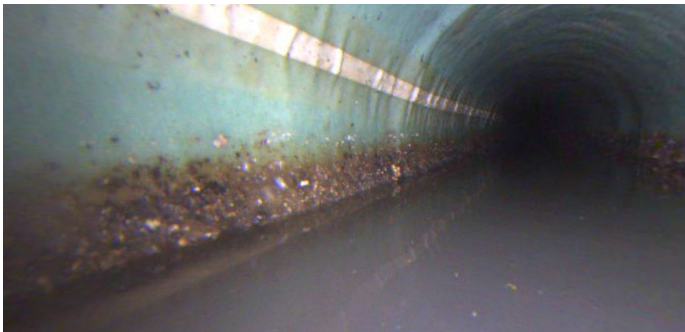
Code:	LFAC
Description:	Lining Failure Abandoned Connection

Distance (ft):	5.2
Structural Grade:	0
O&M Grade:	0
Clock Start/From:	9
Clock To:	
1st Value:	
2nd Value:	
Value Percent:	
Continuous Index:	
Within 8" of Joint:	NO
Remarks:

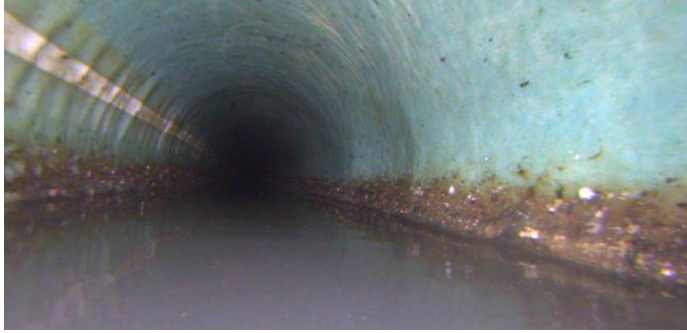
Code:	LFAC
Description:	Lining Failure Abandoned Connection
Distance (ft):	6.5
Structural Grade:	0
O&M Grade:	0
Clock Start/From:	3
Clock To:	
1st Value:	
2nd Value:	
Value Percent:	
Continuous Index:	
Within 8" of Joint:	NO
Remarks:

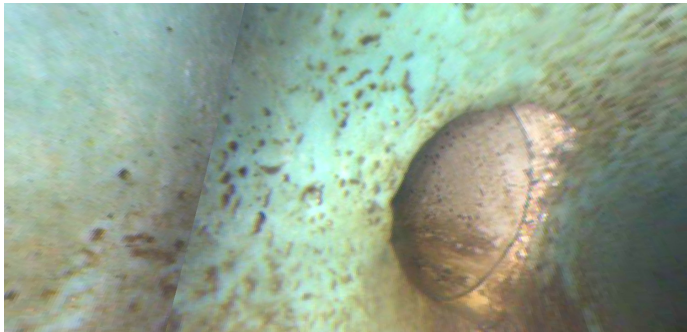
Code:	TB
Description:	Tap Break-in
Distance (ft):	51.5
Structural Grade:	0
O&M Grade:	0
Clock Start/From:	2
Clock To:	
1st Value:	4.000
2nd Value:	
Value Percent:	
Continuous Index:	
Within 8" of Joint:	
Remarks:

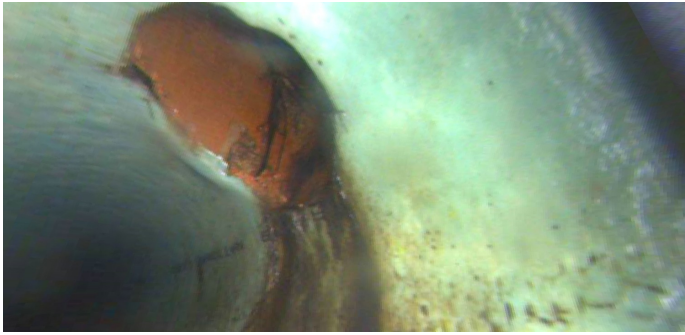
Code: **TB**
Description: **Tap Break-in**

Distance (ft): **76.8**
Structural Grade: **0**
O&M Grade: **0**
Clock Start/From: **11**
Clock To:
1st Value: **4.000**
2nd Value:
Value Percent:
Continuous Index:
Within 8" of Joint:
Remarks:

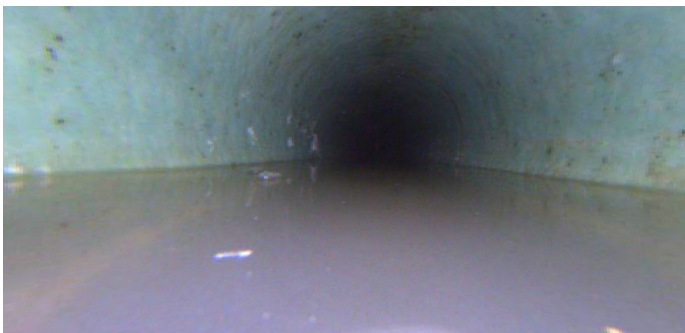
Code: **MWL**
Description: **Water Level**

Distance (ft): **132.7**
Structural Grade: **0**
O&M Grade: **0**
Clock Start/From:
Clock To:
1st Value:
2nd Value:
Value Percent: **25.000**
Continuous Index:
Within 8" of Joint: **NO**
Remarks:

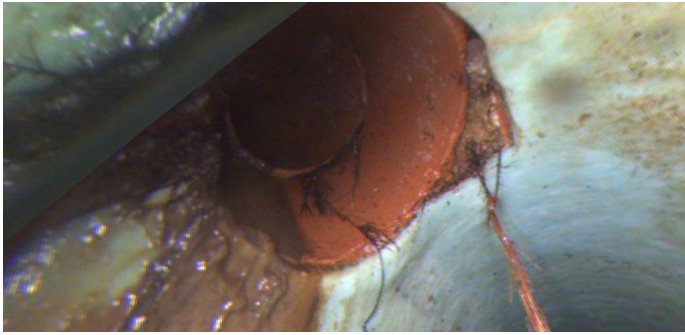
Code: **TBD**
Description: **Tap Break-in Defective**

Distance (ft): **138.1**
Structural Grade: **0**
O&M Grade: **3**
Clock Start/From: **11**
Clock To:
1st Value: **4.000**
2nd Value:
Value Percent:
Continuous Index:
Within 8" of Joint:
Remarks: **RFL**

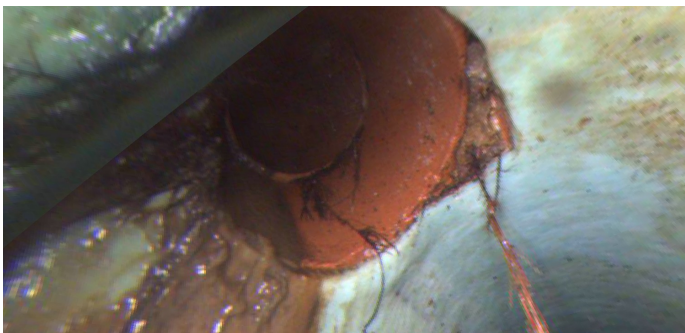
Code: **RFL**
Description: **Roots Fine Lateral**

Distance (ft): **138.1**
Structural Grade: **0**
O&M Grade: **1**
Clock Start/From: **10**
Clock To: **12**
1st Value:
2nd Value:
Value Percent:
Continuous Index:
Within 8" of Joint: **NO**
Remarks:

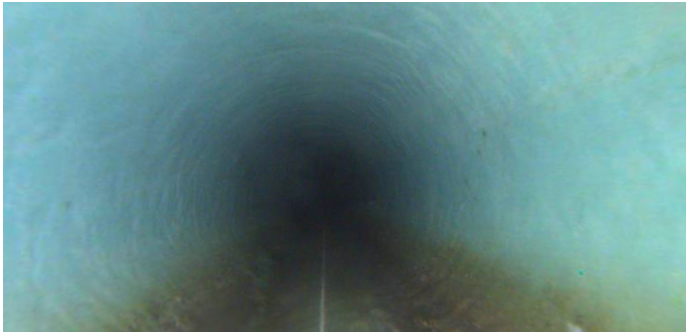
Code: **MGO**
Description: **General Observation**

Distance (ft): **144.8**
Structural Grade: **0**
O&M Grade: **0**
Clock Start/From:
Clock To:
1st Value:
2nd Value:
Value Percent:
Continuous Index:
Within 8" of Joint: **NO**
Remarks: **rear camera**

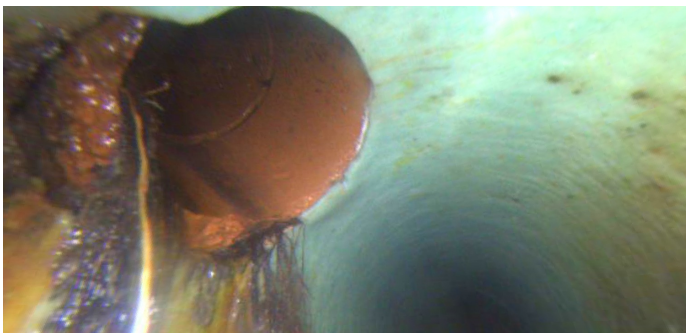
Code: **TBD**
Description: **Tap Break-in Defective**

Distance (ft): **154.8**
Structural Grade: **0**
O&M Grade: **3**
Clock Start/From: **11**
Clock To:
1st Value: **4.000**
2nd Value:
Value Percent:
Continuous Index:
Within 8" of Joint:
Remarks: **rfl**

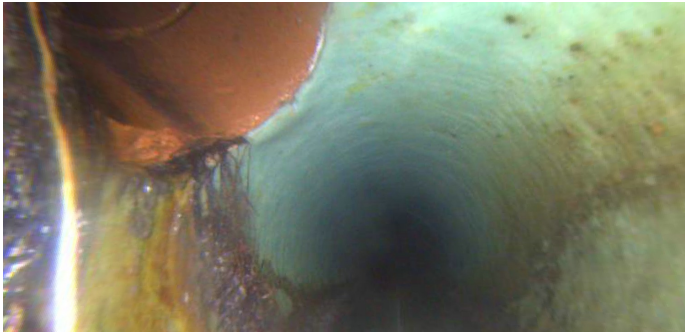
Code: **RFL**
Description: **Roots Fine Lateral**

Distance (ft): **154.8**
Structural Grade: **0**
O&M Grade: **1**
Clock Start/From: **9**
Clock To: **10**
1st Value:
2nd Value:
Value Percent:
Continuous Index:
Within 8" of Joint: **NO**
Remarks:

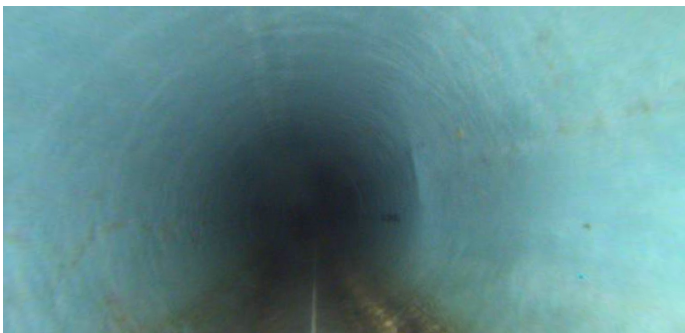
Code: **LFAC**
Description: **Lining Failure Abandoned Connection**

Distance (ft): **159.3**
Structural Grade: **0**
O&M Grade: **0**
Clock Start/From: **9**
Clock To:
1st Value:
2nd Value:
Value Percent:
Continuous Index:
Within 8" of Joint: **NO**
Remarks:

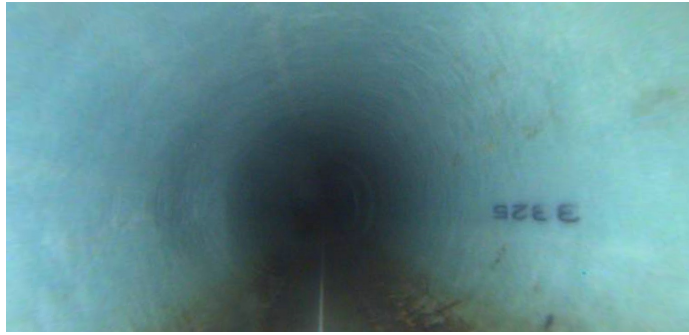
Code:	LFAC
Description:	Lining Failure Abandoned Connection
Distance (ft):	161.6
Structural Grade:	0
O&M Grade:	0
Clock Start/From:	3
Clock To:	
1st Value:	
2nd Value:	
Value Percent:	
Continuous Index:	
Within 8" of Joint:	NO
Remarks:

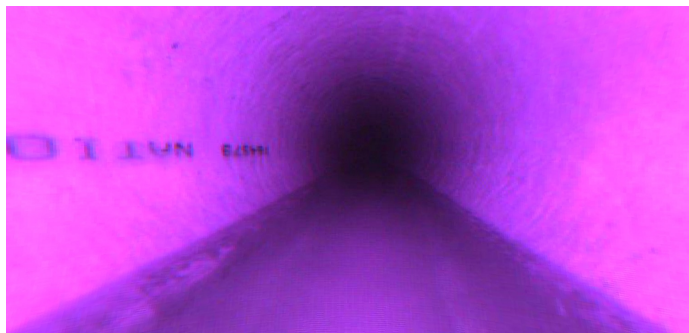
Code:	MWL
Description:	Water Level
Distance (ft):	162.1
Structural Grade:	0
O&M Grade:	0
Clock Start/From:	
Clock To:	
1st Value:	
2nd Value:	
Value Percent:	5.000
Continuous Index:	
Within 8" of Joint:	NO
Remarks:

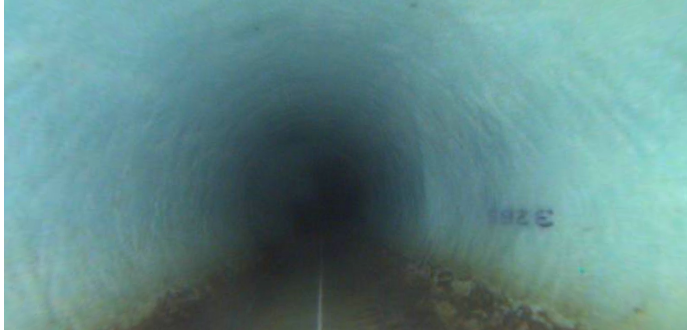
Code: **LFAC**
Description: **Lining Failure Abandoned Connection**

Distance (ft): **223.5**
Structural Grade: **0**
O&M Grade: **0**
Clock Start/From: **9**
Clock To:
1st Value:
2nd Value:
Value Percent:
Continuous Index:
Within 8" of Joint: **NO**
Remarks:

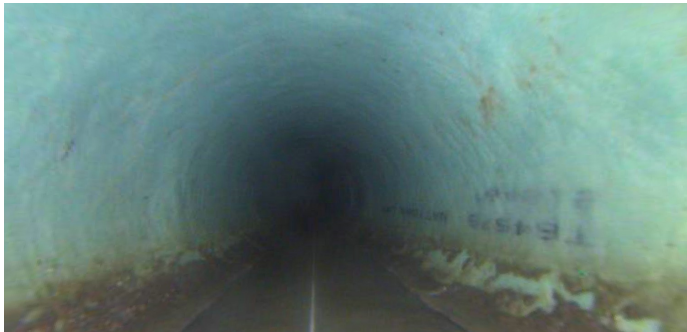
Code: **LFAC**
Description: **Lining Failure Abandoned Connection**

Distance (ft): **225.5**
Structural Grade: **0**
O&M Grade: **0**
Clock Start/From: **9**
Clock To:
1st Value:
2nd Value:
Value Percent:
Continuous Index:
Within 8" of Joint: **NO**
Remarks:

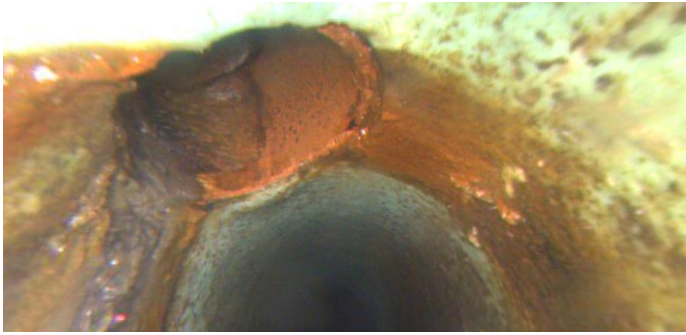
Code: **TBA**
Description: **Tap Break-in Active**

Distance (ft): **228.2**
Structural Grade: **0**
O&M Grade: **0**
Clock Start/From: **1**
Clock To:
1st Value: **4.000**
2nd Value:
Value Percent:
Continuous Index:
Within 8" of Joint:
Remarks:

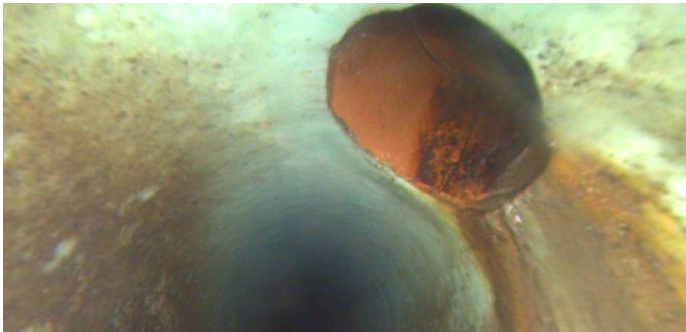
Code: **TF**
Description: **Tap Factory**

Distance (ft): **234.3**
Structural Grade: **0**
O&M Grade: **0**
Clock Start/From: **11**
Clock To:
1st Value: **4.000**
2nd Value:
Value Percent:
Continuous Index:
Within 8" of Joint:
Remarks:

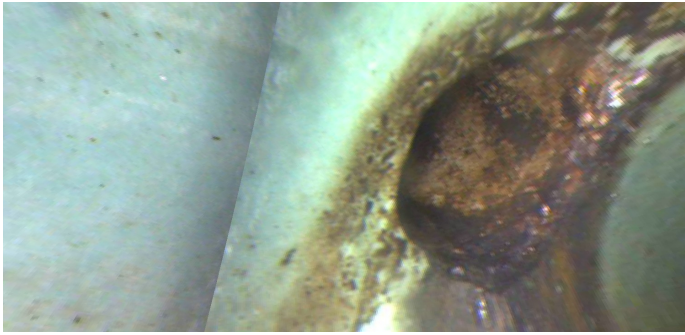
Code: **TB**
Description: **Tap Break-in**

Distance (ft): **268.2**
Structural Grade: **0**
O&M Grade: **0**
Clock Start/From: **2**
Clock To:
1st Value: **4.000**
2nd Value:
Value Percent:
Continuous Index:
Within 8" of Joint:
Remarks:

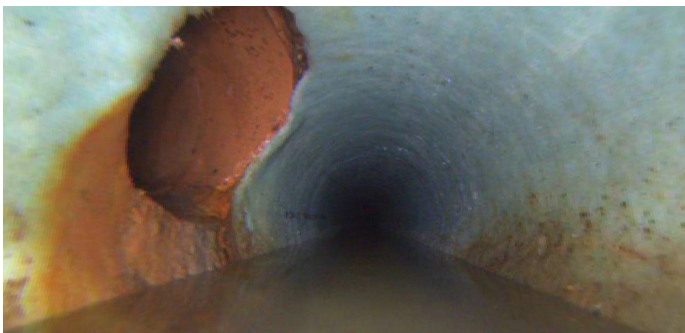
Code: **TB**
Description: **Tap Break-in**

Distance (ft): **273.8**
Structural Grade: **0**
O&M Grade: **0**
Clock Start/From: **10**
Clock To:
1st Value: **6.000**
2nd Value:
Value Percent:
Continuous Index:
Within 8" of Joint:
Remarks:

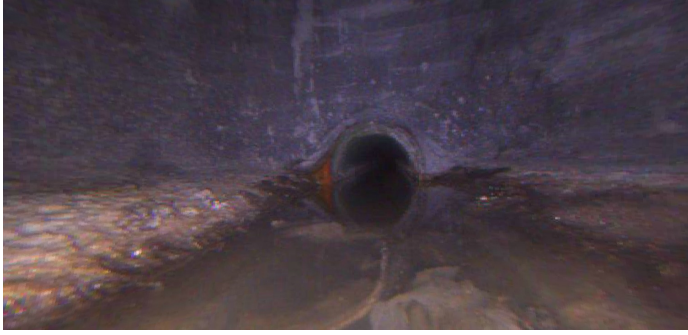
Code:	AMH
Description:	Manhole
Distance (ft):	286.2
Structural Grade:	0
O&M Grade:	0
Clock Start/From:	
Clock To:	
1st Value:	
2nd Value:	
Value Percent:	
Continuous Index:	
Within 8" of Joint:	NO
Remarks:	M-305-019
