Profile/Photo Observation Report

Street:	FOXCROFT STREET	Flow Control:	Not Controlled
City:	Hobart, IN	Year Renewed:	
Location:	Yard	Tape/Media #:	
Purpose:	Routine Assessment	Dia/Height:	10"
Use:	Sanitary	Material:	XXX
Drain Area:	NA	Lining:	Cured in Place
Category:	NA		
Comment:

Location Details:		Direction of Survey:	Upstream
US MH:	M-305-019	DS MH:	M-305-018
		Total Length Surveyed (ft):	286.2

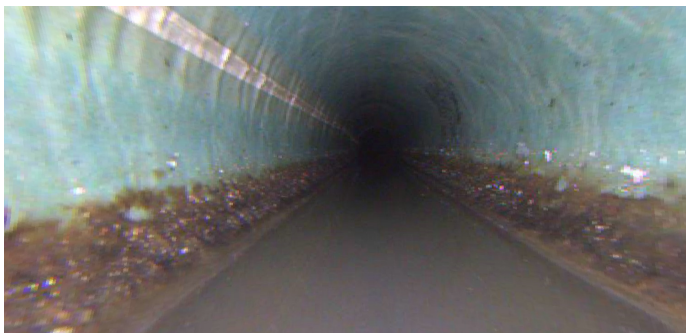
Code: **AMH**
Description: **Manhole**

Distance (ft): **.0**
Structural Grade: **0**
O&M Grade: **0**
Clock Start/From:
Clock To:
1st Value:
2nd Value:
Value Percent:
Continuous Index:
Within 8" of Joint: **NO**
Remarks: **M-305-018**

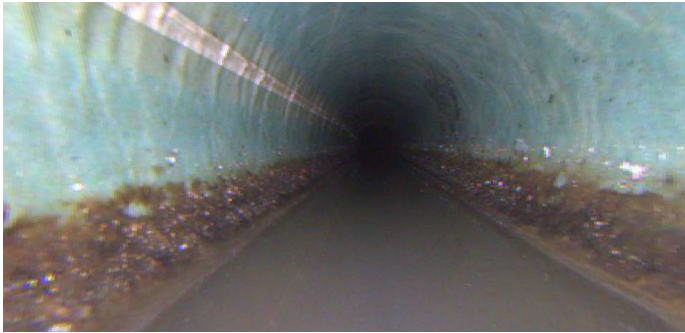
Code:	MWL
Description:	Water Level

Distance (ft):	.0
Structural Grade:	0
O&M Grade:	0
Clock Start/From:	
Clock To:	
1st Value:	
2nd Value:	
Value Percent:	5.000
Continuous Index:	
Within 8" of Joint:	NO
Remarks:

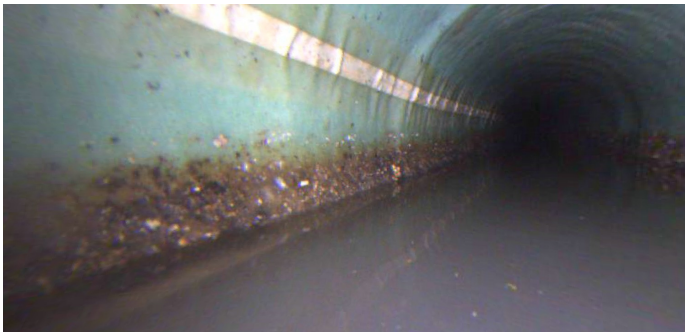
Code:	LFAC
Description:	Lining Failure Abandoned Connection

Distance (ft):	5.2
Structural Grade:	0
O&M Grade:	0
Clock Start/From:	9
Clock To:	
1st Value:	
2nd Value:	
Value Percent:	
Continuous Index:	
Within 8" of Joint:	NO
Remarks:

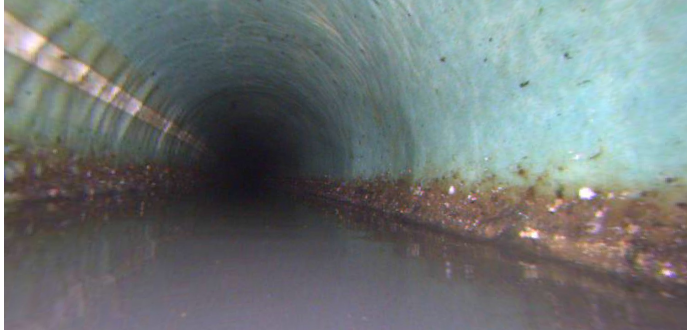
Code:	LFAC
Description:	Lining Failure Abandoned Connection
Distance (ft):	6.5
Structural Grade:	0
O&M Grade:	0
Clock Start/From:	3
Clock To:	
1st Value:	
2nd Value:	
Value Percent:	
Continuous Index:	
Within 8" of Joint:	NO
Remarks:

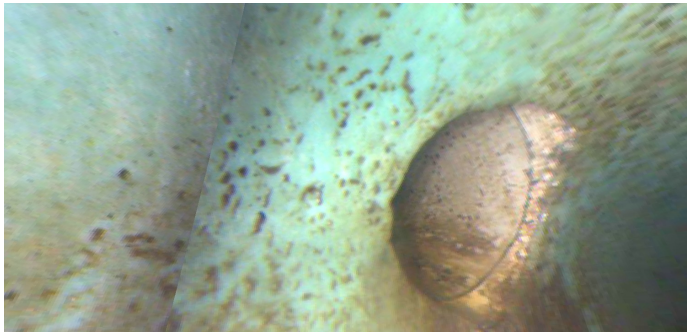
Code:	TB
Description:	Tap Break-in
Distance (ft):	51.5
Structural Grade:	0
O&M Grade:	0
Clock Start/From:	2
Clock To:	
1st Value:	4.000
2nd Value:	
Value Percent:	
Continuous Index:	
Within 8" of Joint:	
Remarks:

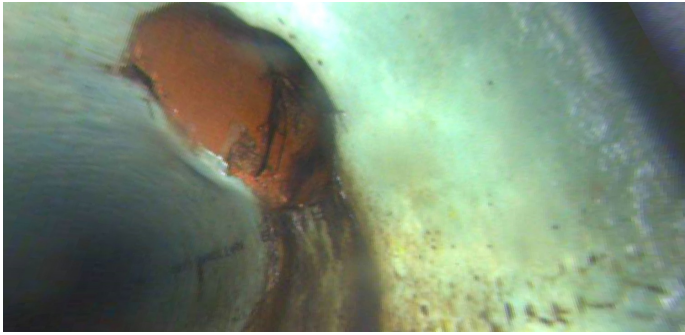
Code: **TB**
Description: **Tap Break-in**

Distance (ft): **76.8**
Structural Grade: **0**
O&M Grade: **0**
Clock Start/From: **11**
Clock To:
1st Value: **4.000**
2nd Value:
Value Percent:
Continuous Index:
Within 8" of Joint:
Remarks:

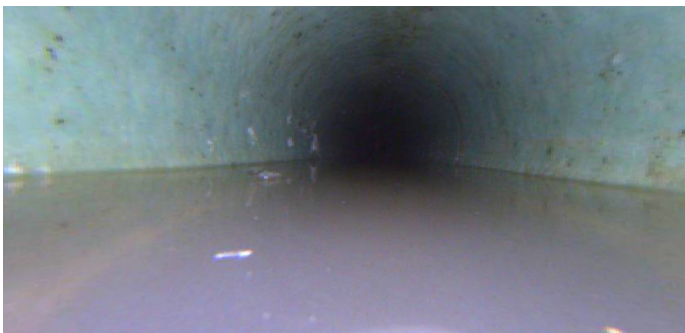
Code: **MWL**
Description: **Water Level**

Distance (ft): **132.7**
Structural Grade: **0**
O&M Grade: **0**
Clock Start/From:
Clock To:
1st Value:
2nd Value:
Value Percent: **25.000**
Continuous Index:
Within 8" of Joint: **NO**
Remarks:

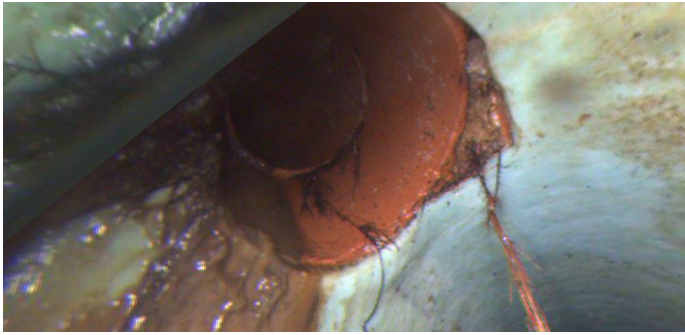
Code: **TBD**
Description: **Tap Break-in Defective**

Distance (ft): **138.1**
Structural Grade: **0**
O&M Grade: **3**
Clock Start/From: **11**
Clock To:
1st Value: **4.000**
2nd Value:
Value Percent:
Continuous Index:
Within 8" of Joint:
Remarks: **RFL**

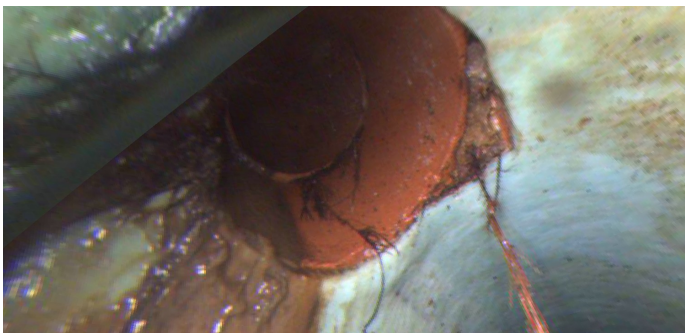
Code: **RFL**
Description: **Roots Fine Lateral**

Distance (ft): **138.1**
Structural Grade: **0**
O&M Grade: **1**
Clock Start/From: **10**
Clock To: **12**
1st Value:
2nd Value:
Value Percent:
Continuous Index:
Within 8" of Joint: **NO**
Remarks:

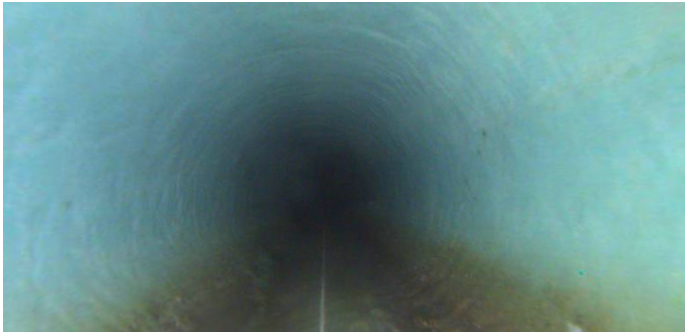
Code: **MGO**
Description: **General Observation**

Distance (ft): **144.8**
Structural Grade: **0**
O&M Grade: **0**
Clock Start/From:
Clock To:
1st Value:
2nd Value:
Value Percent:
Continuous Index:
Within 8" of Joint: **NO**
Remarks: **rear camera**

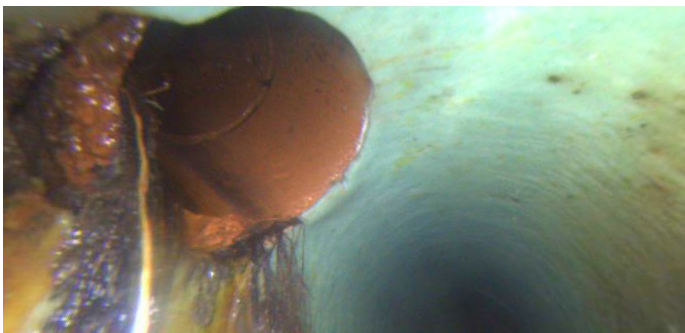
Code: **TBD**
Description: **Tap Break-in Defective**

Distance (ft): **154.8**
Structural Grade: **0**
O&M Grade: **3**
Clock Start/From: **11**
Clock To:
1st Value: **4.000**
2nd Value:
Value Percent:
Continuous Index:
Within 8" of Joint:
Remarks: **rfl**

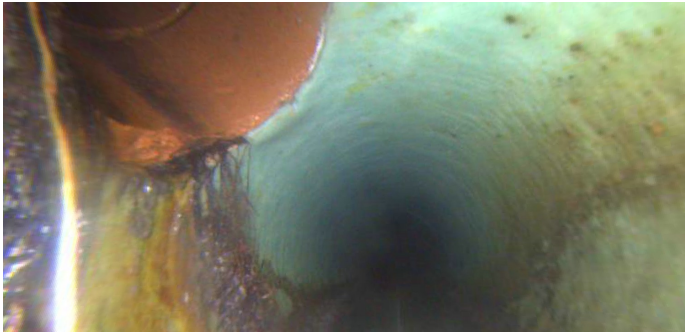
Code: **RFL**
Description: **Roots Fine Lateral**

Distance (ft): **154.8**
Structural Grade: **0**
O&M Grade: **1**
Clock Start/From: **9**
Clock To: **10**
1st Value:
2nd Value:
Value Percent:
Continuous Index:
Within 8" of Joint: **NO**
Remarks:

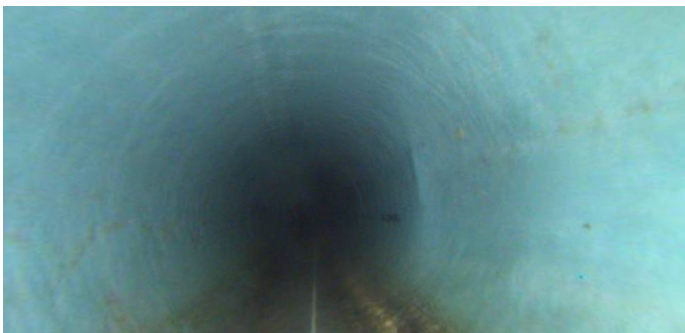
Code: **LFAC**
Description: **Lining Failure Abandoned Connection**

Distance (ft): **159.3**
Structural Grade: **0**
O&M Grade: **0**
Clock Start/From: **9**
Clock To:
1st Value:
2nd Value:
Value Percent:
Continuous Index:
Within 8" of Joint: **NO**
Remarks:

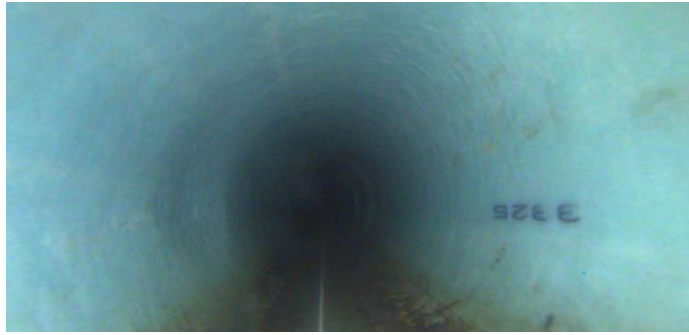
Code:	LFAC
Description:	Lining Failure Abandoned Connection
Distance (ft):	161.6
Structural Grade:	0
O&M Grade:	0
Clock Start/From:	3
Clock To:	
1st Value:	
2nd Value:	
Value Percent:	
Continuous Index:	
Within 8" of Joint:	NO
Remarks:

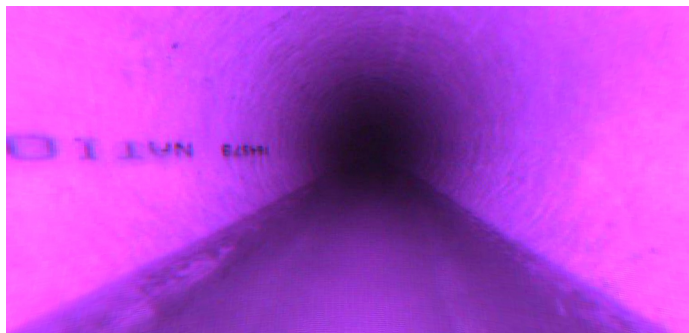
Code:	MWL
Description:	Water Level
Distance (ft):	162.1
Structural Grade:	0
O&M Grade:	0
Clock Start/From:	
Clock To:	
1st Value:	
2nd Value:	
Value Percent:	5.000
Continuous Index:	
Within 8" of Joint:	NO
Remarks:

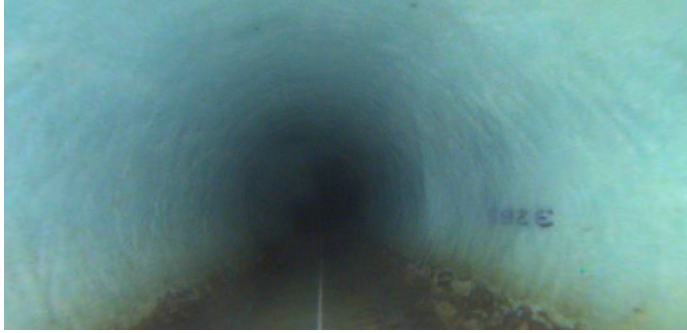
Code: **LFAC**
Description: **Lining Failure Abandoned Connection**

Distance (ft): **223.5**
Structural Grade: **0**
O&M Grade: **0**
Clock Start/From: **9**
Clock To:
1st Value:
2nd Value:
Value Percent:
Continuous Index:
Within 8" of Joint: **NO**
Remarks:

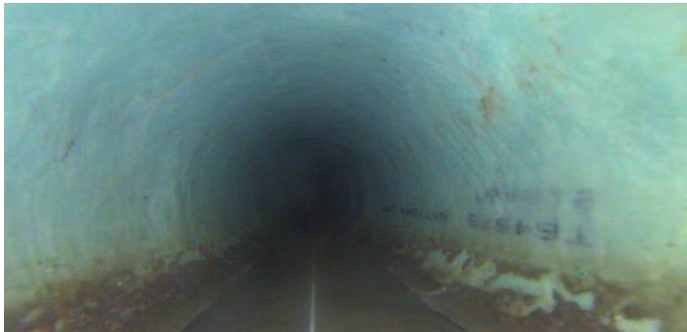
Code: **LFAC**
Description: **Lining Failure Abandoned Connection**

Distance (ft): **225.5**
Structural Grade: **0**
O&M Grade: **0**
Clock Start/From: **9**
Clock To:
1st Value:
2nd Value:
Value Percent:
Continuous Index:
Within 8" of Joint: **NO**
Remarks:

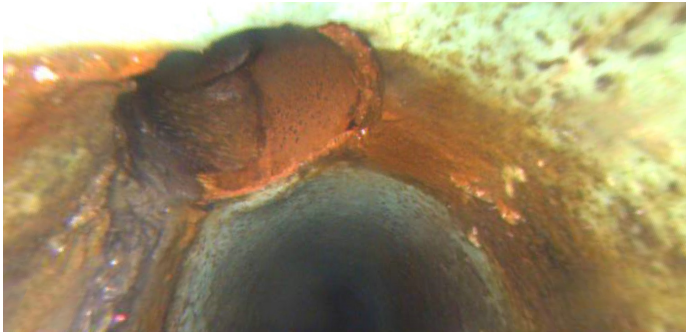
Code: **TBA**
Description: **Tap Break-in Active**

Distance (ft): **228.2**
Structural Grade: **0**
O&M Grade: **0**
Clock Start/From: **1**
Clock To:
1st Value: **4.000**
2nd Value:
Value Percent:
Continuous Index:
Within 8" of Joint:
Remarks:

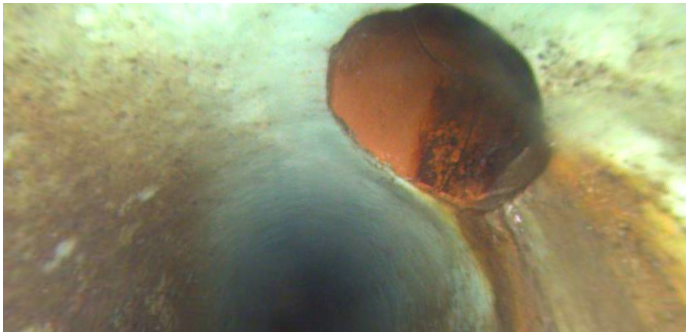
Code: **TF**
Description: **Tap Factory**

Distance (ft): **234.3**
Structural Grade: **0**
O&M Grade: **0**
Clock Start/From: **11**
Clock To:
1st Value: **4.000**
2nd Value:
Value Percent:
Continuous Index:
Within 8" of Joint:
Remarks:

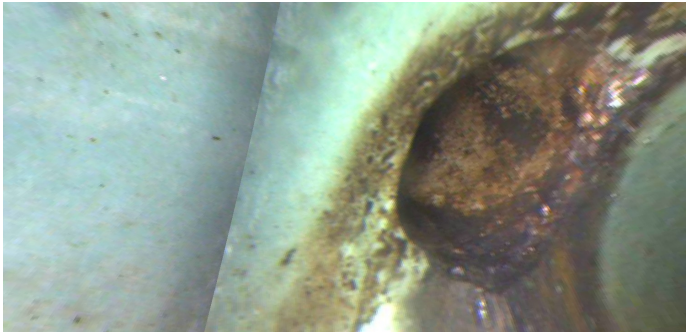
Code: **TB**
Description: **Tap Break-in**

Distance (ft): **268.2**
Structural Grade: **0**
O&M Grade: **0**
Clock Start/From: **2**
Clock To:
1st Value: **4.000**
2nd Value:
Value Percent:
Continuous Index:
Within 8" of Joint:
Remarks:

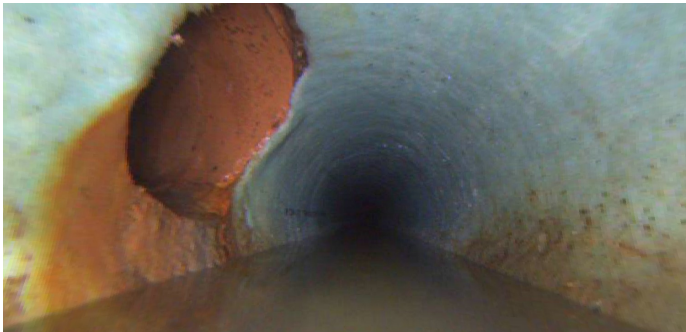
Code: **TB**
Description: **Tap Break-in**

Distance (ft): **273.8**
Structural Grade: **0**
O&M Grade: **0**
Clock Start/From: **10**
Clock To:
1st Value: **6.000**
2nd Value:
Value Percent:
Continuous Index:
Within 8" of Joint:
Remarks:

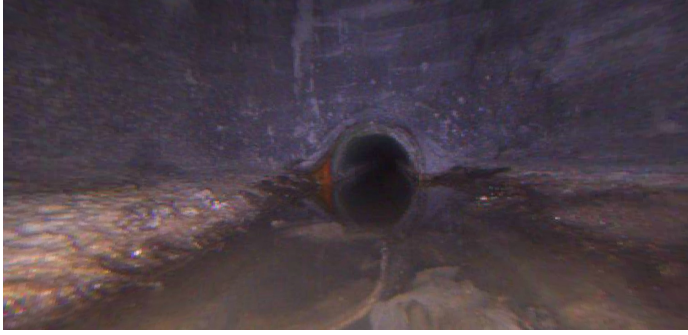
Code:	AMH
Description:	Manhole
Distance (ft):	286.2
Structural Grade:	0
O&M Grade:	0
Clock Start/From:	
Clock To:	
1st Value:	
2nd Value:	
Value Percent:	
Continuous Index:	
Within 8" of Joint:	NO
Remarks:	M-305-019
