## Profile/Photo Observation Report

Street:	<b>ALLEY BETWEEN N LIVERPOOL RD &amp;</b>	Flow Control:	<b>Not Controlled</b>
City:	<b>Hobart, IN</b>	Year Renewed:	
Location:	<b>Yard</b>	Tape/Media #:	
Purpose:	<b>Routine Assessment</b>	Dia/Height:	<b>10"</b>
Use:	<b>Sanitary</b>	Material:	<b>XXX</b>
Drain Area:	<b>NA</b>	Lining:	<b>Cured in Place</b>
Category:	<b>NA</b>		
Comment:	<b>Flow direction wrong</b>

Location Details:		Direction of Survey:	<b>Downstream</b>
US MH:	<b>M-305-020</b>	DS MH:	<b>M-305-011</b>
		Total Length Surveyed (ft):	<b>155.8</b>

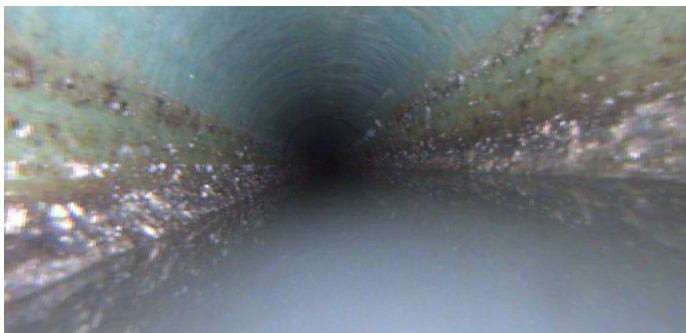
Code: **AMH**  
Description: **Manhole**

Distance (ft): **.0**  
Structural Grade: **0**  
O&M Grade: **0**  
Clock Start/From:  
Clock To:  
1st Value:  
2nd Value:  
Value Percent:  
Continuous Index:  
Within 8" of Joint: **NO**  
Remarks: **M-305-020**

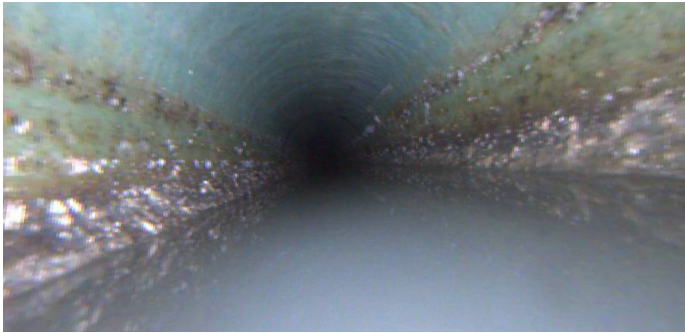
Code:	<b>MWL</b>
Description:	<b>Water Level</b>

Distance (ft):	<b>.0</b>
Structural Grade:	<b>0</b>
O&M Grade:	<b>0</b>
Clock Start/From:	
Clock To:	
1st Value:	
2nd Value:	
Value Percent:	<b>20.000</b>
Continuous Index:	
Within 8" of Joint:	<b>NO</b>
Remarks:

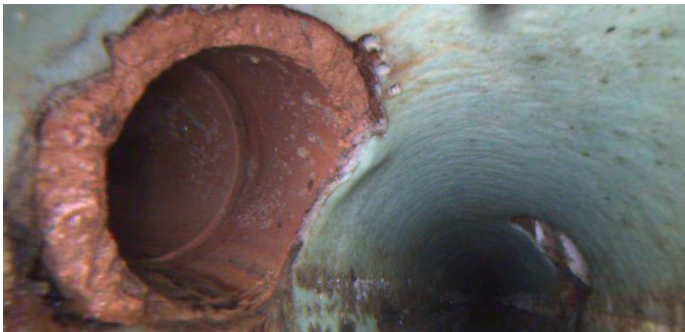
Code:	<b>TB</b>
Description:	<b>Tap Break-in</b>

Distance (ft):	<b>43.8</b>
Structural Grade:	<b>0</b>
O&M Grade:	<b>0</b>
Clock Start/From:	<b>10</b>
Clock To:	
1st Value:	<b>4.000</b>
2nd Value:	
Value Percent:	
Continuous Index:	
Within 8" of Joint:	<b>NO</b>
Remarks:

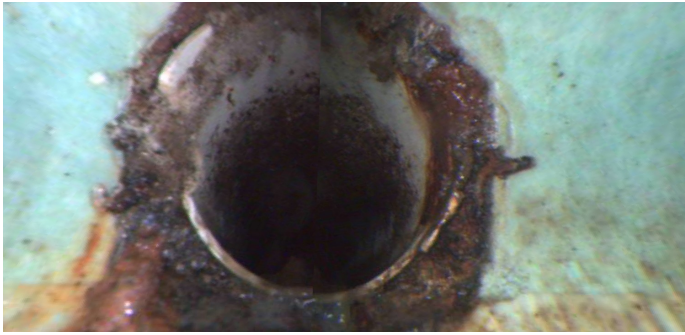
Code: **TB**  
Description: **Tap Break-in**

Distance (ft): **45.6**  
Structural Grade: **0**  
O&M Grade: **0**  
Clock Start/From: **3**  
Clock To:  
1st Value: **4.000**  
2nd Value:  
Value Percent:  
Continuous Index:  
Within 8" of Joint:  
Remarks:

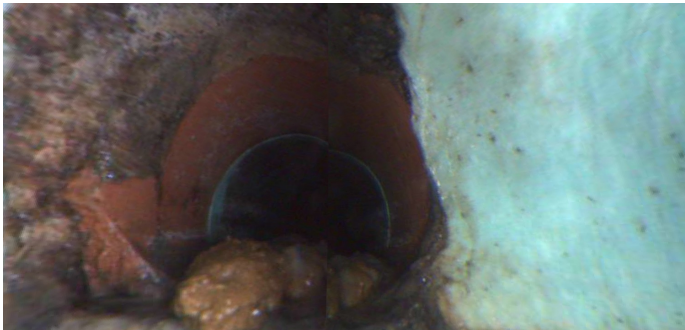
Code: **TB**  
Description: **Tap Break-in**

Distance (ft): **104.2**  
Structural Grade: **0**  
O&M Grade: **0**  
Clock Start/From: **3**  
Clock To:  
1st Value: **4.000**  
2nd Value:  
Value Percent:  
Continuous Index:  
Within 8" of Joint:  
Remarks:

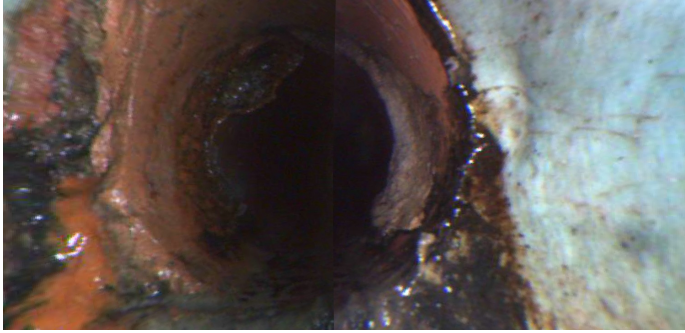
Code: **TBA**  
Description: **Tap Break-in Active**

Distance (ft): **112.5**  
Structural Grade: **0**  
O&M Grade: **0**  
Clock Start/From: **9**  
Clock To:  
1st Value: **4.000**  
2nd Value:  
Value Percent:  
Continuous Index:  
Within 8" of Joint:  
Remarks:

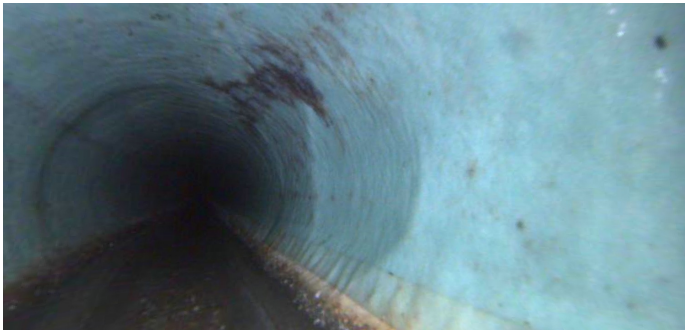
Code: **LFAC**  
Description: **Lining Failure Abandoned Connection**

Distance (ft): **113.9**  
Structural Grade: **0**  
O&M Grade: **0**  
Clock Start/From: **3**  
Clock To:  
1st Value:  
2nd Value:  
Value Percent:  
Continuous Index:  
Within 8" of Joint: **NO**  
Remarks:

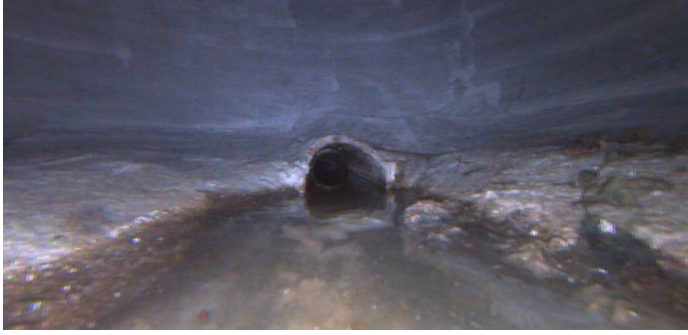
Code:	AMH
Description:	Manhole
Distance (ft):	155.8
Structural Grade:	0
O&M Grade:	0
Clock Start/From:	
Clock To:	
1st Value:	
2nd Value:	
Value Percent:	
Continuous Index:	
Within 8" of Joint:	NO
Remarks:	M-305-011
