## Profile/Photo Observation Report

Street:	<b>FOXCROFT STREET</b>	Flow Control:	<b>Not Controlled</b>
City:	<b>Hobart, IN</b>	Year Renewed:	
Location:	<b>Yard</b>	Tape/Media #:	
Purpose:	<b>Routine Assessment</b>	Dia/Height:	<b>10"</b>
Use:	<b>Sanitary</b>	Material:	<b>XXX</b>
Drain Area:	<b>NA</b>	Lining:	<b>Cured in Place</b>
Category:	<b>NA</b>		
Comment:	<b>Flow direction wrong</b>

Location Details:		Direction of Survey:	<b>Downstream</b>
US MH:	<b>M-305-020</b>	DS MH:	<b>M-305-011</b>
		Total Length Surveyed (ft):	<b>155.8</b>

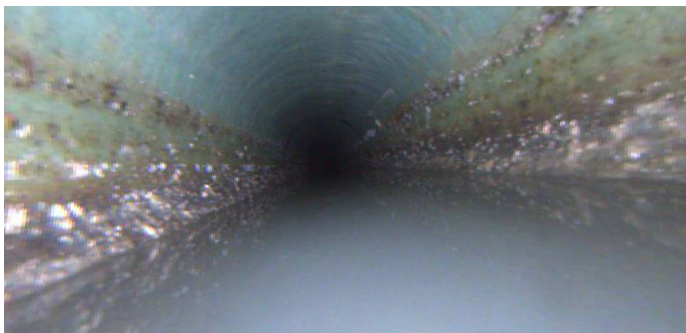
Code: **AMH**  
Description: **Manhole**

Distance (ft): **.0**  
Structural Grade: **0**  
O&M Grade: **0**  
Clock Start/From:  
Clock To:  
1st Value:  
2nd Value:  
Value Percent:  
Continuous Index:  
Within 8" of Joint: **NO**  
Remarks: **M-305-020**

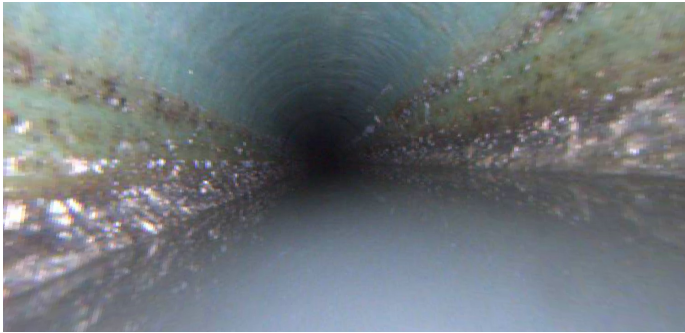
Code:	<b>MWL</b>
Description:	<b>Water Level</b>

Distance (ft):	<b>.0</b>
Structural Grade:	<b>0</b>
O&M Grade:	<b>0</b>
Clock Start/From:	
Clock To:	
1st Value:	
2nd Value:	
Value Percent:	<b>20.000</b>
Continuous Index:	
Within 8" of Joint:	<b>NO</b>
Remarks:

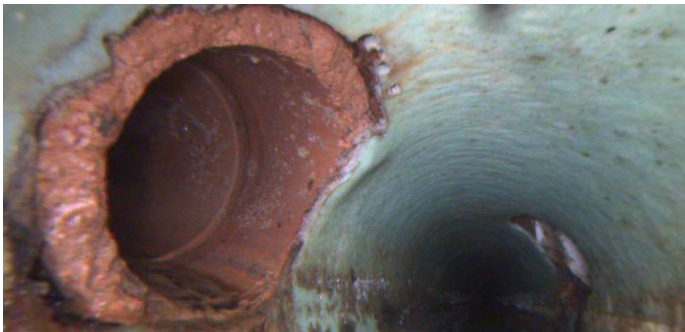
Code:	<b>TB</b>
Description:	<b>Tap Break-in</b>

Distance (ft):	<b>43.8</b>
Structural Grade:	<b>0</b>
O&M Grade:	<b>0</b>
Clock Start/From:	<b>10</b>
Clock To:	
1st Value:	<b>4.000</b>
2nd Value:	
Value Percent:	
Continuous Index:	
Within 8" of Joint:	<b>NO</b>
Remarks:

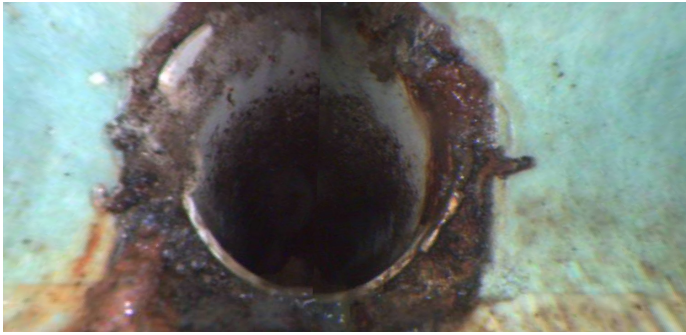
Code: **TB**  
Description: **Tap Break-in**

Distance (ft): **45.6**  
Structural Grade: **0**  
O&M Grade: **0**  
Clock Start/From: **3**  
Clock To:  
1st Value: **4.000**  
2nd Value:  
Value Percent:  
Continuous Index:  
Within 8" of Joint:  
Remarks:

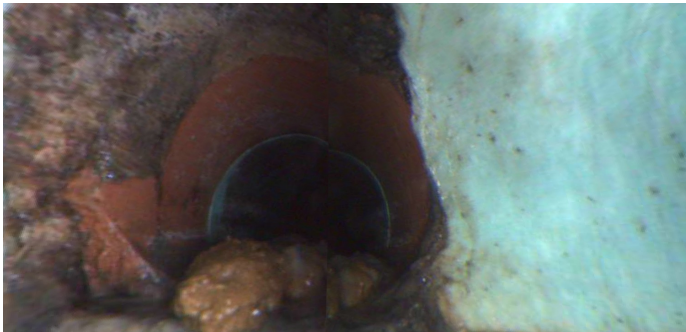
Code: **TB**  
Description: **Tap Break-in**

Distance (ft): **104.2**  
Structural Grade: **0**  
O&M Grade: **0**  
Clock Start/From: **3**  
Clock To:  
1st Value: **4.000**  
2nd Value:  
Value Percent:  
Continuous Index:  
Within 8" of Joint:  
Remarks:

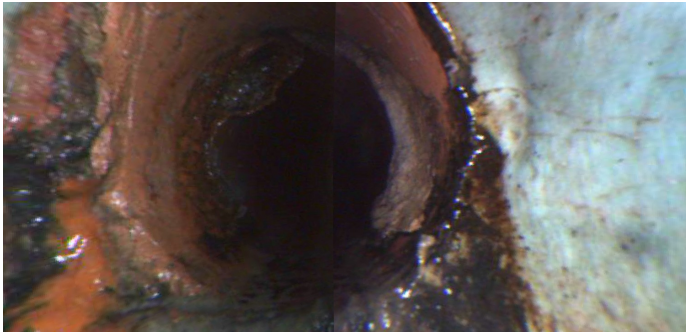
Code: **TBA**  
Description: **Tap Break-in Active**

Distance (ft): **112.5**  
Structural Grade: **0**  
O&M Grade: **0**  
Clock Start/From: **9**  
Clock To:  
1st Value: **4.000**  
2nd Value:  
Value Percent:  
Continuous Index:  
Within 8" of Joint:  
Remarks:

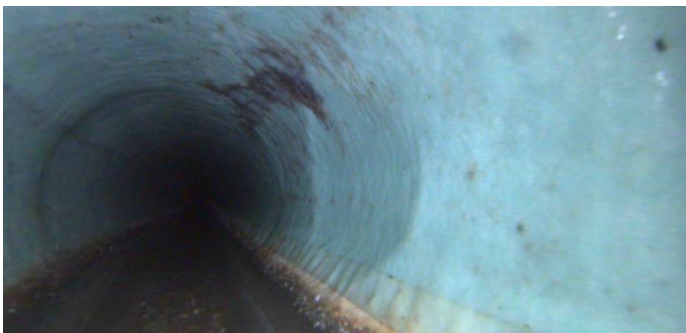
Code: **LFAC**  
Description: **Lining Failure Abandoned Connection**

Distance (ft): **113.9**  
Structural Grade: **0**  
O&M Grade: **0**  
Clock Start/From: **3**  
Clock To:  
1st Value:  
2nd Value:  
Value Percent:  
Continuous Index:  
Within 8" of Joint: **NO**  
Remarks:

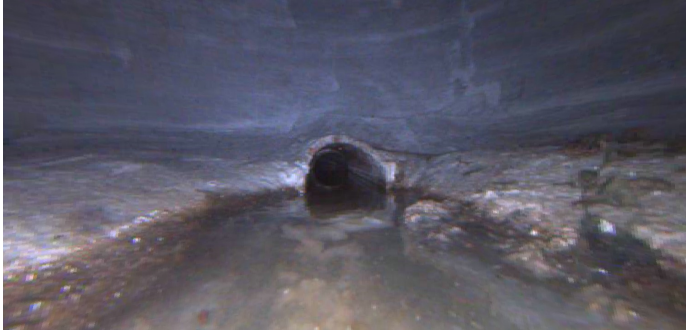
Code:	<b>AMH</b>
Description:	<b>Manhole</b>
Distance (ft):	<b>155.8</b>
Structural Grade:	<b>0</b>
O&M Grade:	<b>0</b>
Clock Start/From:	
Clock To:	
1st Value:	
2nd Value:	
Value Percent:	
Continuous Index:	
Within 8" of Joint:	<b>NO</b>
Remarks:	<b>M-305-011</b>
