Profile/Photo Observation Report

Street:	BRIARWOOD LN	Flow Control:	Not Controlled
City:	Hobart, IN	Year Renewed:	
Location:	Yard	Tape/Media #:	
Purpose:	Routine Assessment	Dia/Height:	10"
Use:	Sanitary	Material:	XXX
Drain Area:	NA	Lining:	Cured in Place
Category:	NA		
Comment:

Location Details:		Direction of Survey:	Downstream
US MH:	M-305-020	DS MH:	M-305-019
		Total Length Surveyed (ft):	233.9

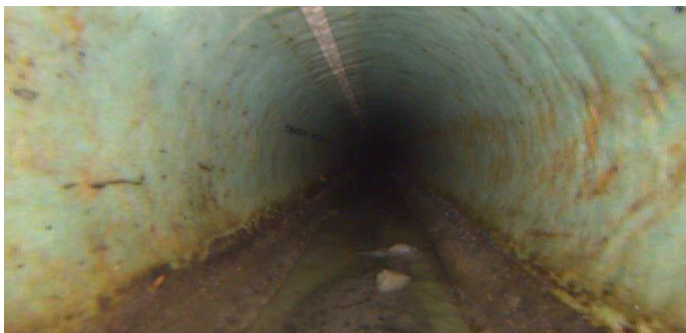
Code: **AMH**
Description: **Manhole**

Distance (ft): **.0**
Structural Grade: **0**
O&M Grade: **0**
Clock Start/From:
Clock To:
1st Value:
2nd Value:
Value Percent:
Continuous Index:
Within 8" of Joint: **NO**
Remarks: **M-305-020**

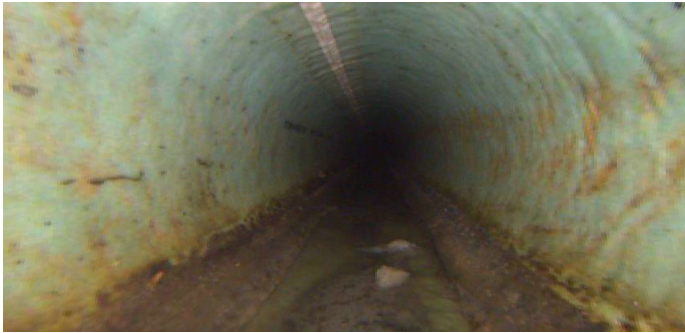
Code:	MWL
Description:	Water Level

Distance (ft):	.0
Structural Grade:	0
O&M Grade:	0
Clock Start/From:	
Clock To:	
1st Value:	
2nd Value:	
Value Percent:	5.000
Continuous Index:	
Within 8" of Joint:	NO
Remarks:

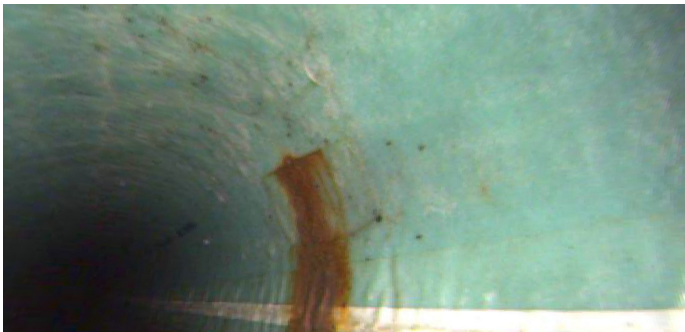
Code:	LFZ
Description:	Lining Failure Other

Distance (ft):	147.6
Structural Grade:	0
O&M Grade:	0
Clock Start/From:	2
Clock To:	
1st Value:	
2nd Value:	
Value Percent:	
Continuous Index:	
Within 8" of Joint:	NO
Remarks:	deep scratch

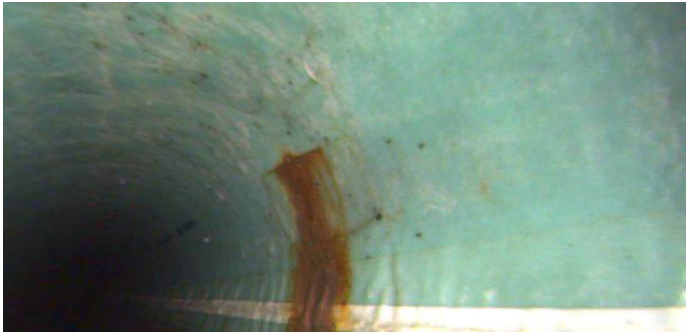
Code: **IS**
Description: **Infil Stain**

Distance (ft): **147.6**
Structural Grade: **0**
O&M Grade: **0**
Clock Start/From: **2**
Clock To: **5**
1st Value:
2nd Value:
Value Percent:
Continuous Index:
Within 8" of Joint:
Remarks:

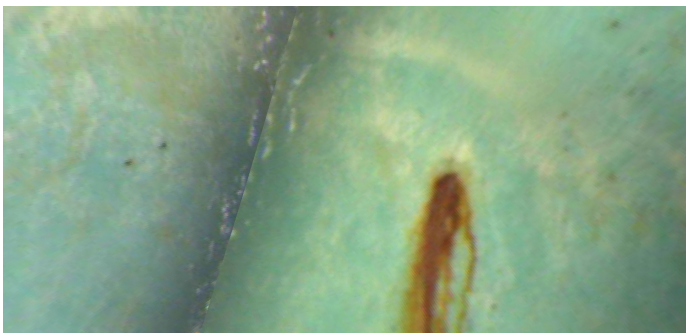
Code: **H**
Description: **Hole**

Distance (ft): **179.2**
Structural Grade: **3**
O&M Grade: **0**
Clock Start/From: **2**
Clock To:
1st Value:
2nd Value:
Value Percent:
Continuous Index:
Within 8" of Joint:
Remarks: **pin hole**

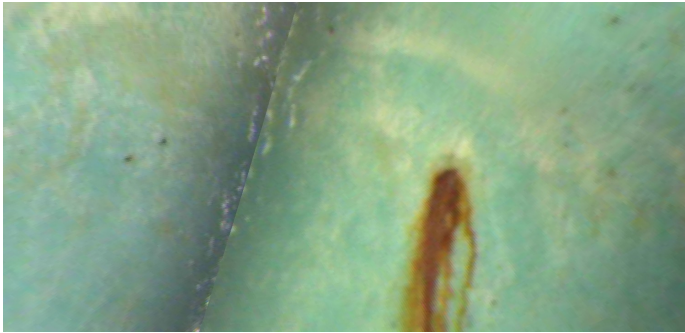
Code: **IS**
Description: **Infil Stain**

Distance (ft): **179.2**
Structural Grade: **0**
O&M Grade: **0**
Clock Start/From: **2**
Clock To: **5**
1st Value:
2nd Value:
Value Percent:
Continuous Index:
Within 8" of Joint:
Remarks:

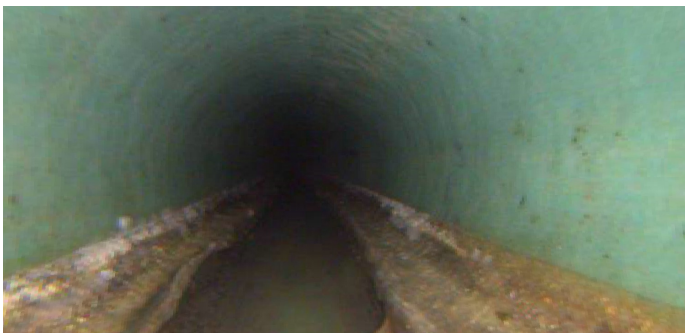
Code: **DAGS**
Description: **Deposits Attached Grease**

Distance (ft): **192.6**
Structural Grade: **0**
O&M Grade: **2**
Clock Start/From: **7**
Clock To: **5**
1st Value:
2nd Value:
Value Percent: **5.000**
Continuous Index: **S01**
Within 8" of Joint: **NO**
Remarks: **7 and 5 oclock**

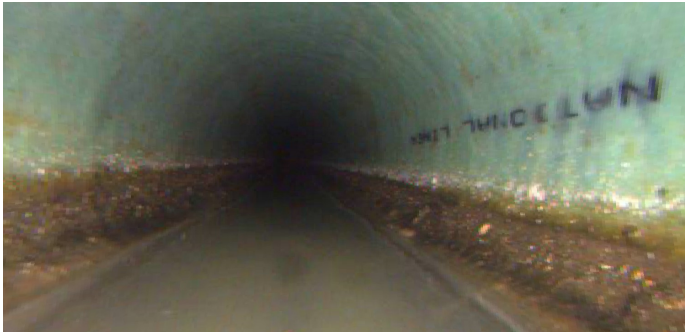
Code: **DAGS**
Description: **Deposits Attached Grease**

Distance (ft): **220.4**
Structural Grade: **0**
O&M Grade: **2**
Clock Start/From: **7**
Clock To: **5**
1st Value:
2nd Value:
Value Percent: **5.000**
Continuous Index: **F01**
Within 8" of Joint: **NO**
Remarks: **7 and 5 oclock**

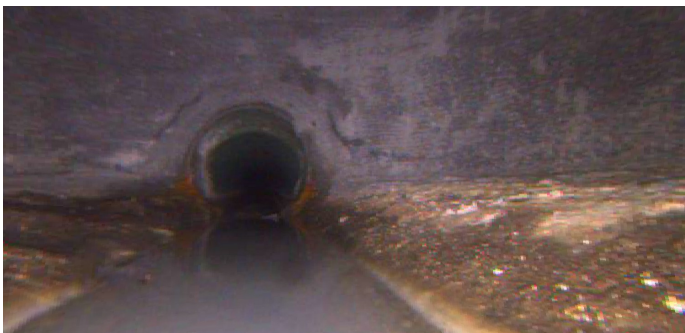
Code: **AMH**
Description: **Manhole**

Distance (ft): **233.9**
Structural Grade: **0**
O&M Grade: **0**
Clock Start/From:
Clock To:
1st Value:
2nd Value:
Value Percent:
Continuous Index:
Within 8" of Joint: **NO**
Remarks: **M-305-019**
