Profile/Photo Observation Report

Date:	04/18/2018	Weather:		Coding:	PACP 6.0
Pipe Length (ft):	241.2	Owner:	NA	Pre Clean:	No Pre-Cleaning
P.O.#:		Surveyor:	Byrd Fitzgerald	PSR:	P-305-020-019
Customer:		Clean Date:	01/01/1900	Shape:	C

Street:	FOXCROFT STREET	Flow Control:	Not Controlled
City:	Hobart, IN	Year Renewed:	
Location:	Yard	Tape/Media #:	
Purpose:	Routine Assessment	Dia/Height:	10"
Use:	Sanitary	Material:	XXX
Drain Area:	NA	Lining:	Cured in Place
Category:	NA		
Comment:

Location Details:		Direction of Survey:	Downstream
US MH:	M-305-020	DS MH:	M-305-019
		Total Length Surveyed (ft):	233.9

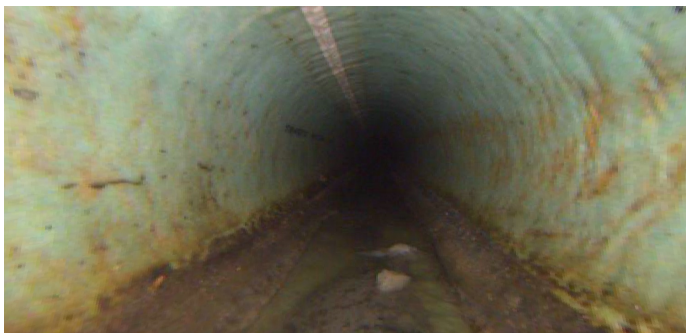
Code: **AMH**
Description: **Manhole**

Distance (ft): **.0**
Structural Grade: **0**
O&M Grade: **0**
Clock Start/From:
Clock To:
1st Value:
2nd Value:
Value Percent:
Continuous Index:
Within 8" of Joint: **NO**
Remarks: **M-305-020**

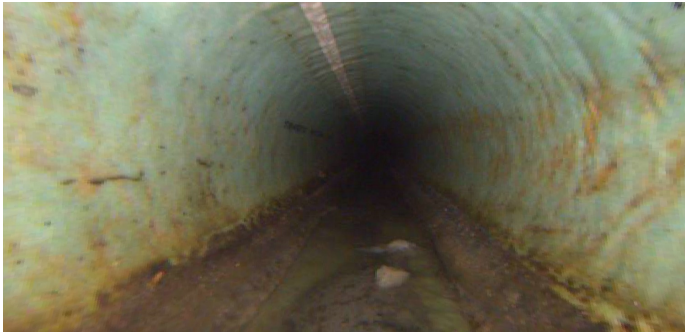
Code:	MWL
Description:	Water Level

Distance (ft):	.0
Structural Grade:	0
O&M Grade:	0
Clock Start/From:	
Clock To:	
1st Value:	
2nd Value:	
Value Percent:	5.000
Continuous Index:	
Within 8" of Joint:	NO
Remarks:

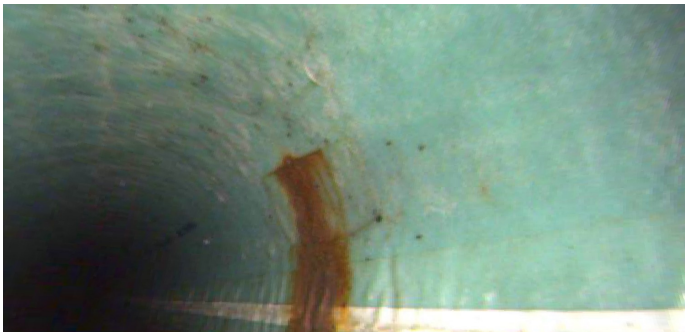
Code:	LFZ
Description:	Lining Failure Other

Distance (ft):	147.6
Structural Grade:	0
O&M Grade:	0
Clock Start/From:	2
Clock To:	
1st Value:	
2nd Value:	
Value Percent:	
Continuous Index:	
Within 8" of Joint:	NO
Remarks:	deep scratch

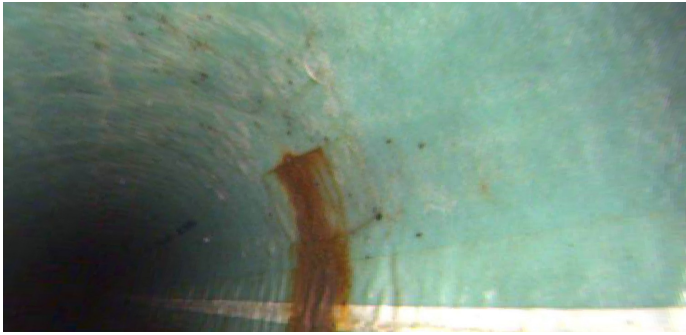
Code: **IS**
Description: **Infil Stain**

Distance (ft): **147.6**
Structural Grade: **0**
O&M Grade: **0**
Clock Start/From: **2**
Clock To: **5**
1st Value:
2nd Value:
Value Percent:
Continuous Index:
Within 8" of Joint:
Remarks:

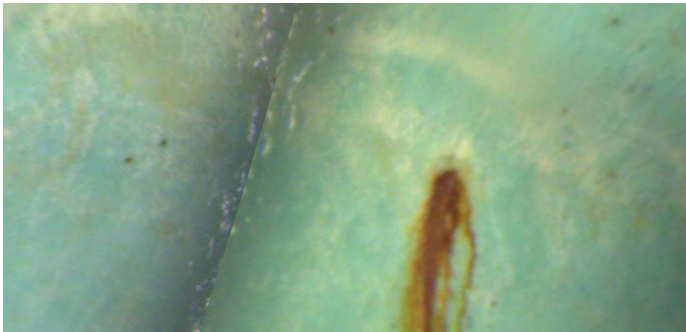
Code: **H**
Description: **Hole**

Distance (ft): **179.2**
Structural Grade: **3**
O&M Grade: **0**
Clock Start/From: **2**
Clock To:
1st Value:
2nd Value:
Value Percent:
Continuous Index:
Within 8" of Joint:
Remarks: **pin hole**

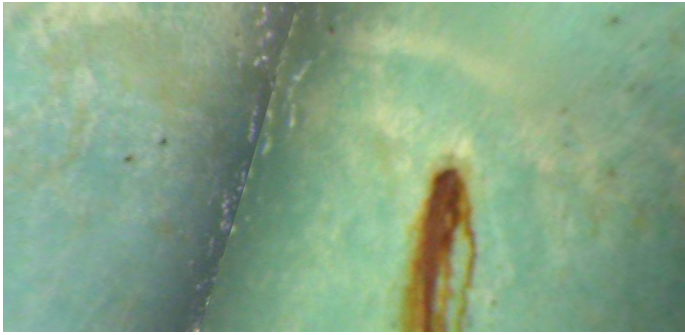
Code: **IS**
Description: **Infil Stain**

Distance (ft): **179.2**
Structural Grade: **0**
O&M Grade: **0**
Clock Start/From: **2**
Clock To: **5**
1st Value:
2nd Value:
Value Percent:
Continuous Index:
Within 8" of Joint:
Remarks:

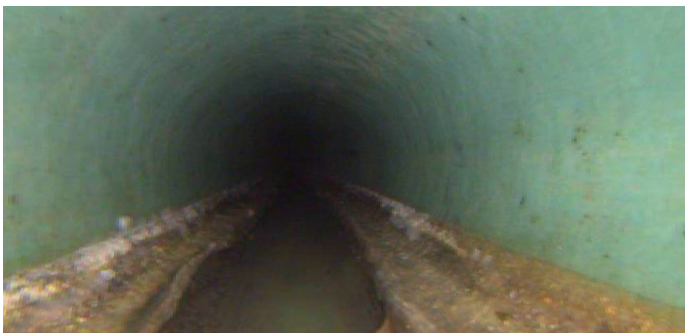
Code: **DAGS**
Description: **Deposits Attached Grease**

Distance (ft): **192.6**
Structural Grade: **0**
O&M Grade: **2**
Clock Start/From: **7**
Clock To: **5**
1st Value:
2nd Value:
Value Percent: **5.000**
Continuous Index: **S01**
Within 8" of Joint: **NO**
Remarks: **7 and 5 oclock**

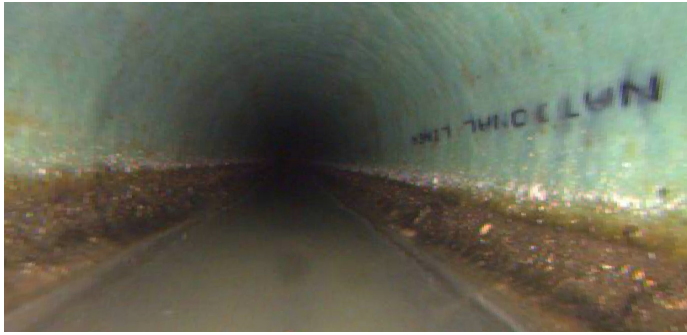
Code:	DAGS
Description:	Deposits Attached Grease
Distance (ft):	220.4
Structural Grade:	0
O&M Grade:	2
Clock Start/From:	7
Clock To:	5
1st Value:	
2nd Value:	
Value Percent:	5.000
Continuous Index:	F01
Within 8" of Joint:	NO
Remarks:	7 and 5 oclock

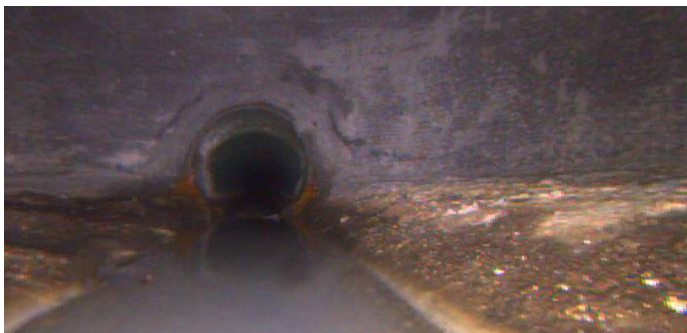
Code:	AMH
Description:	Manhole
Distance (ft):	233.9
Structural Grade:	0
O&M Grade:	0
Clock Start/From:	
Clock To:	
1st Value:	
2nd Value:	
Value Percent:	
Continuous Index:	
Within 8" of Joint:	NO
Remarks:	M-305-019
