Profile/Photo Observation Report

Date:	04/19/2018	Weather:		Coding:	PACP 6.0
Pipe Length (ft):	281.3	Owner:	NA	Pre Clean:	No Pre-Cleaning
P.O.#:		Surveyor:	Justin Gonzales	PSR:	P-305-022-001
Customer:		Clean Date:	01/01/1900	Shape:	C

Street:	ALLEY BETWEEN CRESTWOOD DR &	Flow Control:	Not Controlled
City:	Hobart, IN	Year Renewed:	
Location:	Yard	Tape/Media #:	
Purpose:	Routine Assessment	Dia/Height:	10"
Use:	Sanitary	Material:	PVC
Drain Area:	NA	Lining:	Cured in Place
Category:	NA		
Comment:	R_M at 292 ft At O_C		
Location Details:		Direction of Survey:	Upstream
US MH:	M-305-022	DS MH:	M-305-001
		Total Length Surveyed (ft):	293.4

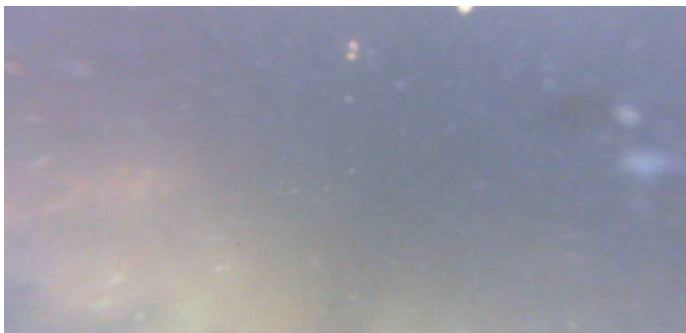
Code: **AMH**
Description: **Manhole**

Distance (ft): **.0**
Structural Grade: **0**
O&M Grade: **0**
Clock Start/From:
Clock To:
1st Value:
2nd Value:
Value Percent:
Continuous Index:
Within 8" of Joint: **NO**
Remarks: **M-305-001**

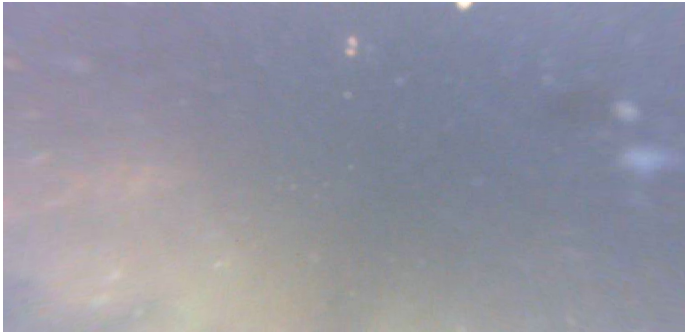
Code:	MWL
Description:	Water Level

Distance (ft):	.0
Structural Grade:	0
O&M Grade:	0
Clock Start/From:	
Clock To:	
1st Value:	
2nd Value:	
Value Percent:	100.000
Continuous Index:	
Within 8" of Joint:	NO
Remarks:

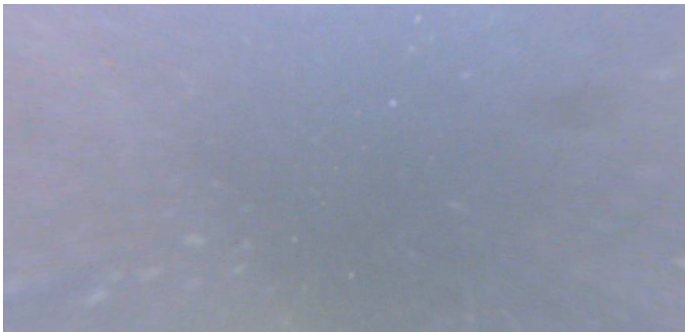
Code:	MGO
Description:	General Observation

Distance (ft):	3.1
Structural Grade:	0
O&M Grade:	0
Clock Start/From:	
Clock To:	
1st Value:	
2nd Value:	
Value Percent:	
Continuous Index:	
Within 8" of Joint:	NO
Remarks:	FLOW TO HIGH

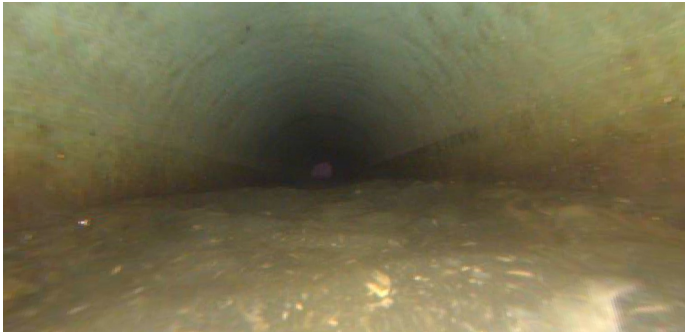
Code: **MWL**
Description: **Water Level**

Distance (ft): **8.7**
Structural Grade: **0**
O&M Grade: **0**
Clock Start/From:
Clock To:
1st Value:
2nd Value:
Value Percent: **15.000**
Continuous Index:
Within 8" of Joint: **NO**
Remarks:

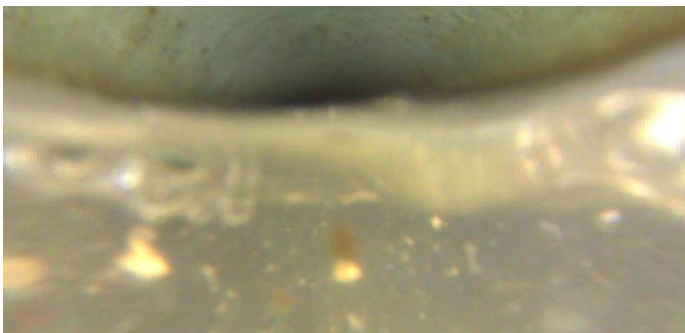
Code: **MWLS**
Description: **Water Level Sag**

Distance (ft): **12.6**
Structural Grade: **3**
O&M Grade: **3**
Clock Start/From:
Clock To:
1st Value:
2nd Value:
Value Percent: **50.000**
Continuous Index:
Within 8" of Joint: **NO**
Remarks:

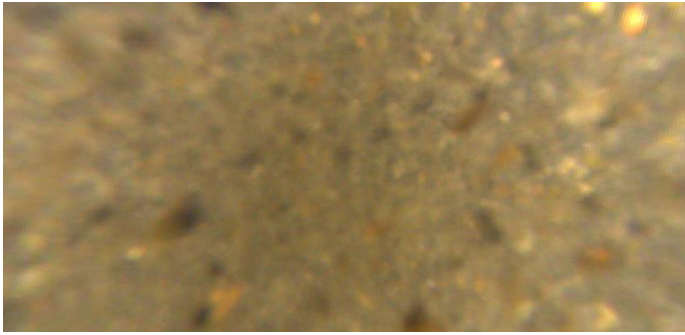
Code: **MCU**
Description: **Camera Underwater**

Distance (ft): **25.8**
Structural Grade: **0**
O&M Grade: **4**
Clock Start/From:
Clock To:
1st Value:
2nd Value:
Value Percent:
Continuous Index: **S01**
Within 8" of Joint: **NO**
Remarks:

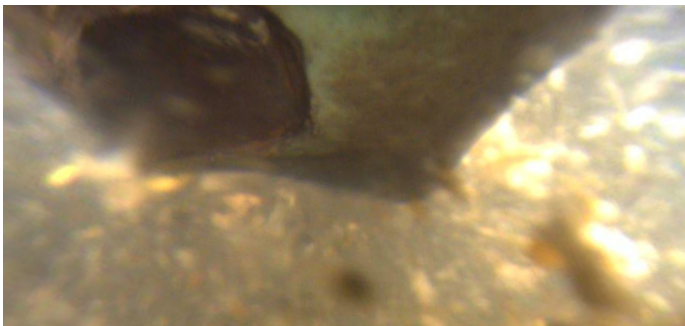
Code: **TB**
Description: **Tap Break-in**

Distance (ft): **50.1**
Structural Grade: **0**
O&M Grade: **0**
Clock Start/From: **1**
Clock To:
1st Value: **4.000**
2nd Value:
Value Percent:
Continuous Index:
Within 8" of Joint:
Remarks:

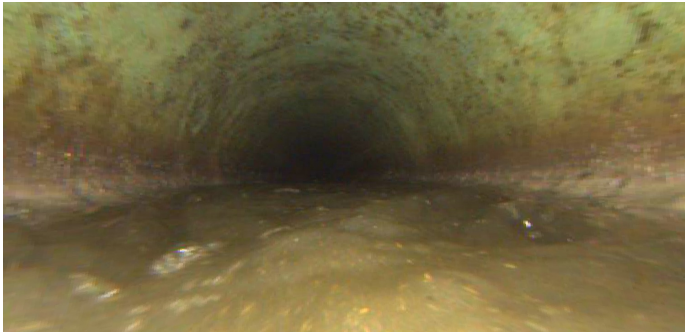
Code: **MCU**
Description: **Camera Underwater**

Distance (ft): **72.6**
Structural Grade: **0**
O&M Grade: **4**
Clock Start/From:
Clock To:
1st Value:
2nd Value:
Value Percent:
Continuous Index: **F01**
Within 8" of Joint: **NO**
Remarks: **FLOW SUBSIDED**

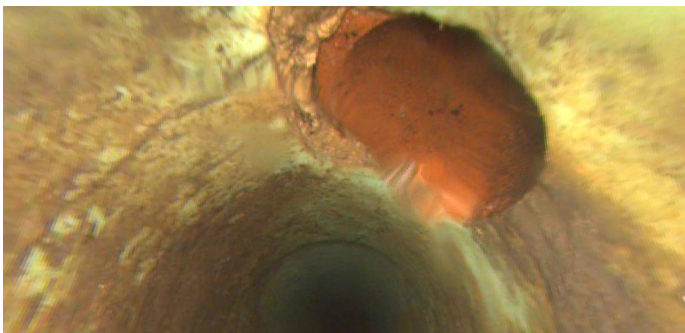
Code: **TF**
Description: **Tap Factory**

Distance (ft): **96.7**
Structural Grade: **0**
O&M Grade: **0**
Clock Start/From: **11**
Clock To:
1st Value: **4.000**
2nd Value:
Value Percent:
Continuous Index:
Within 8" of Joint:
Remarks:

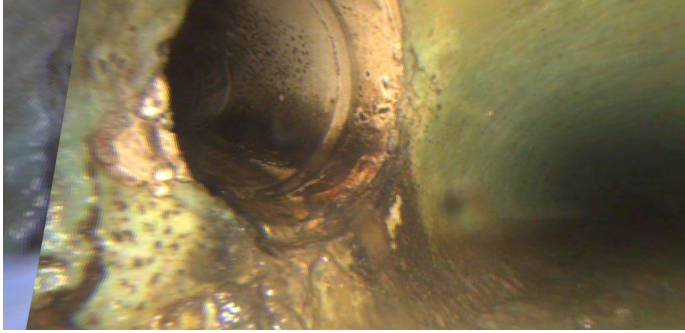
Code: **TF**
Description: **Tap Factory**

Distance (ft): **110.0**
Structural Grade: **0**
O&M Grade: **0**
Clock Start/From: **3**
Clock To:
1st Value: **4.000**
2nd Value:
Value Percent:
Continuous Index:
Within 8" of Joint:
Remarks:

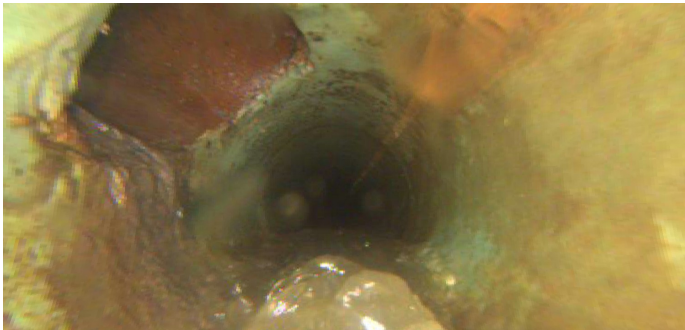
Code: **TF**
Description: **Tap Factory**

Distance (ft): **197.8**
Structural Grade: **0**
O&M Grade: **0**
Clock Start/From: **2**
Clock To:
1st Value: **4.000**
2nd Value:
Value Percent:
Continuous Index:
Within 8" of Joint:
Remarks:

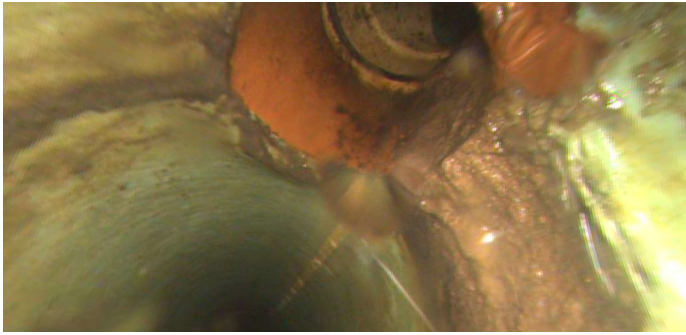
Code: **TF**
Description: **Tap Factory**

Distance (ft): **202.6**
Structural Grade: **0**
O&M Grade: **0**
Clock Start/From: **11**
Clock To:
1st Value: **4.000**
2nd Value:
Value Percent:
Continuous Index:
Within 8" of Joint:
Remarks:

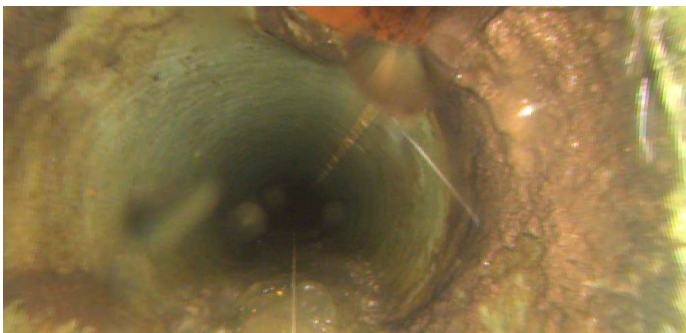
Code: **DAE**
Description: **Deposits Attached Encrustation**

Distance (ft): **202.6**
Structural Grade: **0**
O&M Grade: **2**
Clock Start/From: **7**
Clock To: **10**
1st Value:
2nd Value:
Value Percent: **5.000**
Continuous Index:
Within 8" of Joint: **NO**
Remarks:

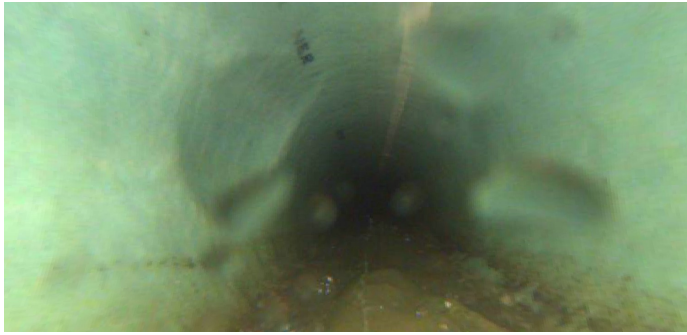
Code:	LFAC
Description:	Lining Failure Abandoned Connection
Distance (ft):	220.1
Structural Grade:	0
O&M Grade:	0
Clock Start/From:	2
Clock To:	
1st Value:	
2nd Value:	
Value Percent:	
Continuous Index:	
Within 8" of Joint:	NO
Remarks:

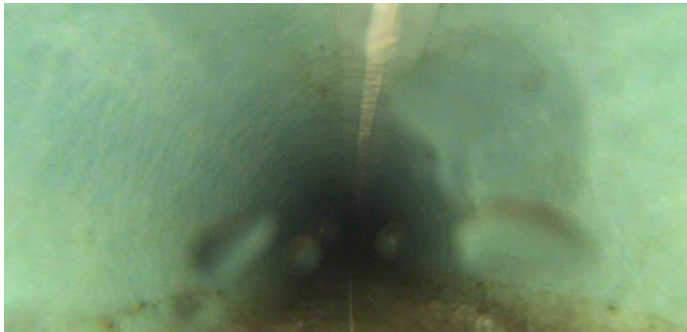
Code:	LFAC
Description:	Lining Failure Abandoned Connection
Distance (ft):	223.0
Structural Grade:	0
O&M Grade:	0
Clock Start/From:	10
Clock To:	
1st Value:	
2nd Value:	
Value Percent:	
Continuous Index:	
Within 8" of Joint:	NO
Remarks:

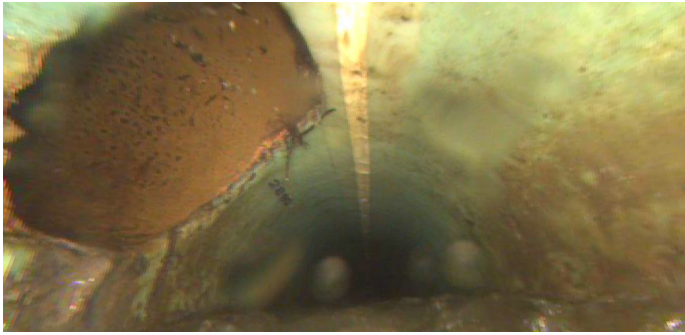
Code: **TF**
Description: **Tap Factory**

Distance (ft): **281.5**
Structural Grade: **0**
O&M Grade: **0**
Clock Start/From: **2**
Clock To:
1st Value: **6.000**
2nd Value:
Value Percent:
Continuous Index:
Within 8" of Joint:
Remarks:

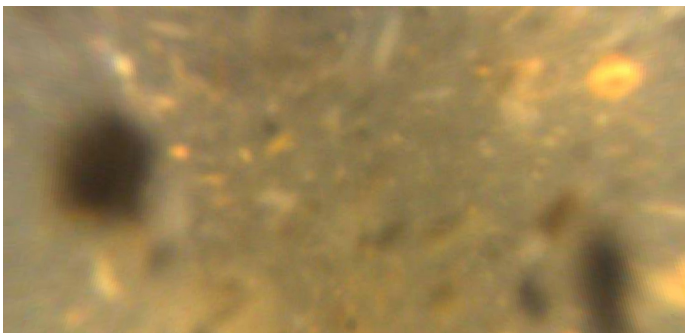
Code: **MCU**
Description: **Camera Underwater**

Distance (ft): **282.2**
Structural Grade: **0**
O&M Grade: **4**
Clock Start/From:
Clock To:
1st Value:
2nd Value:
Value Percent:
Continuous Index: **S04**
Within 8" of Joint: **NO**
Remarks:

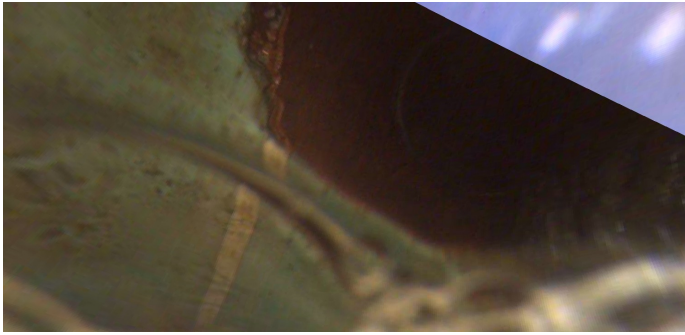
Code: **TF**
Description: **Tap Factory**

Distance (ft): **284.5**
Structural Grade: **0**
O&M Grade: **0**
Clock Start/From: **10**
Clock To:
1st Value: **6.000**
2nd Value:
Value Percent:
Continuous Index:
Within 8" of Joint:
Remarks:

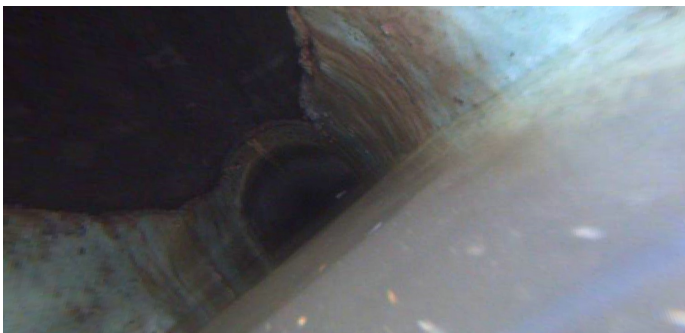
Code: **AMH**
Description: **Manhole**

Distance (ft): **293.4**
Structural Grade: **0**
O&M Grade: **0**
Clock Start/From:
Clock To:
1st Value:
2nd Value:
Value Percent:
Continuous Index:
Within 8" of Joint: **NO**
Remarks: **M-305-022**

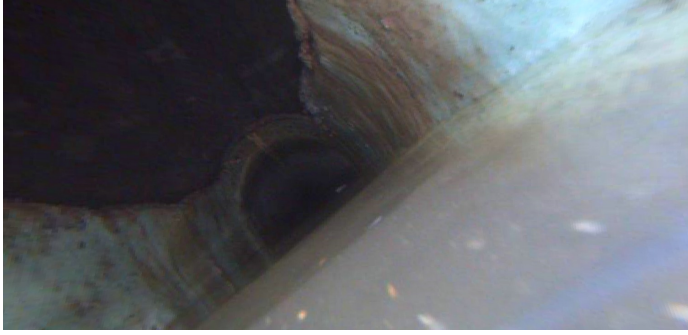
Code:	MCU
Description:	Camera Underwater
Distance (ft):	293.4
Structural Grade:	0
O&M Grade:	4
Clock Start/From:	
Clock To:	
1st Value:	
2nd Value:	
Value Percent:	
Continuous Index:	F04
Within 8" of Joint:	NO
Remarks:
