## Profile/Photo Observation Report

| Street: | <b>FOXCROFT STREET</b> | Flow Control: | <b>Not Controlled</b> |
| City: | <b>Hobart, IN</b> | Year Renewed: | |
| US MH: | <b>M-305-022</b> | DS MH: | <b>M-305-001</b> |

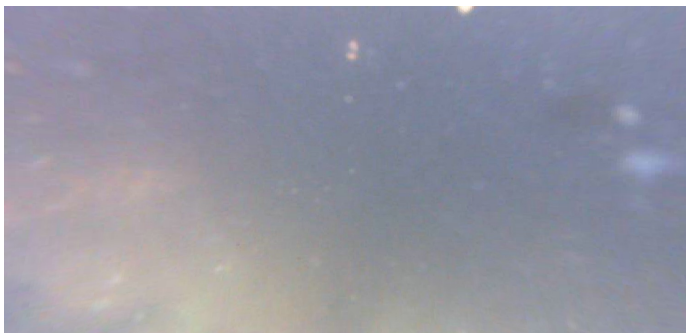
Code: **AMH**  
Description: **Manhole**

Distance (ft): **.0**  
Structural Grade: **0**  
O&M Grade: **0**  
Clock Start/From:  
Clock To:  
1st Value:  
2nd Value:  
Value Percent:  
Continuous Index:  
Within 8" of Joint: **NO**  
Remarks: **M-305-001**

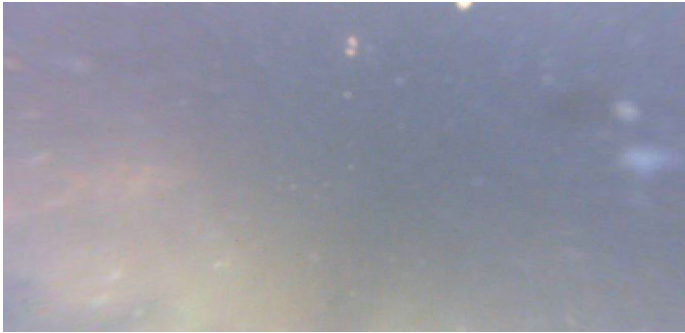
| Description: | <b>Water Level</b> |

| Value Percent: | <b>100.000</b> |

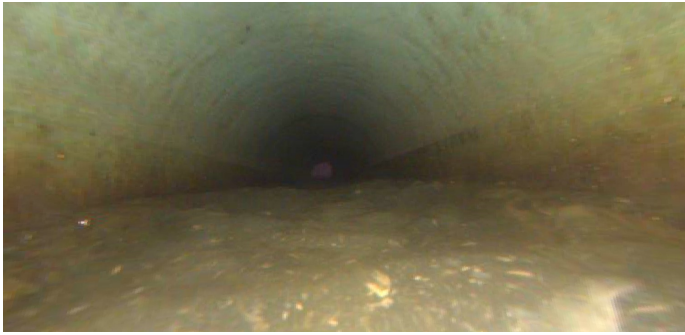
Code: **MWL**  
Description: **Water Level**

Distance (ft): **8.7**  
Structural Grade: **0**  
O&M Grade: **0**  
Clock Start/From:  
Clock To:  
1st Value:  
2nd Value:  
Value Percent: **15.000**  
Continuous Index:  
Within 8" of Joint: **NO**  
Remarks:

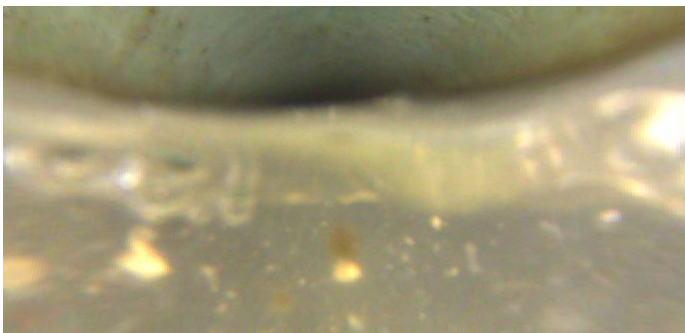
Code: **MWLS**  
Description: **Water Level Sag**

Distance (ft): **12.6**  
Structural Grade: **3**  
O&M Grade: **3**  
Clock Start/From:  
Clock To:  
1st Value:  
2nd Value:  
Value Percent: **50.000**  
Continuous Index:  
Within 8" of Joint: **NO**  
Remarks:

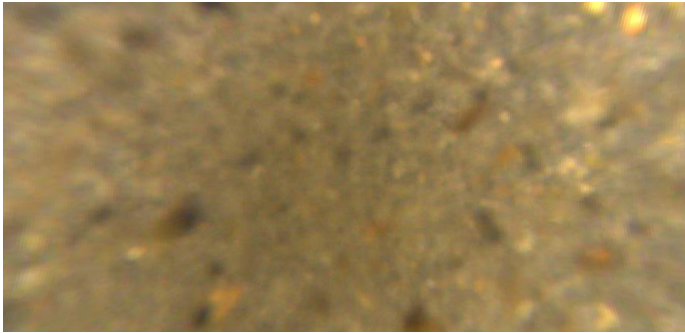
Code: **MCU**  
Description: **Camera Underwater**

Distance (ft): **25.8**  
Structural Grade: **0**  
O&M Grade: **4**  
Clock Start/From:  
Clock To:  
1st Value:  
2nd Value:  
Value Percent:  
Continuous Index: **S01**  
Within 8" of Joint: **NO**  
Remarks:

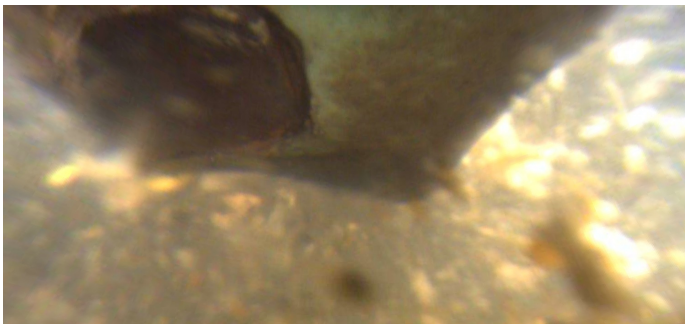
Code: **TB**  
Description: **Tap Break-in**

Distance (ft): **50.1**  
Structural Grade: **0**  
O&M Grade: **0**  
Clock Start/From: **1**  
Clock To:  
1st Value: **4.000**  
2nd Value:  
Value Percent:  
Continuous Index:  
Within 8" of Joint:  
Remarks:

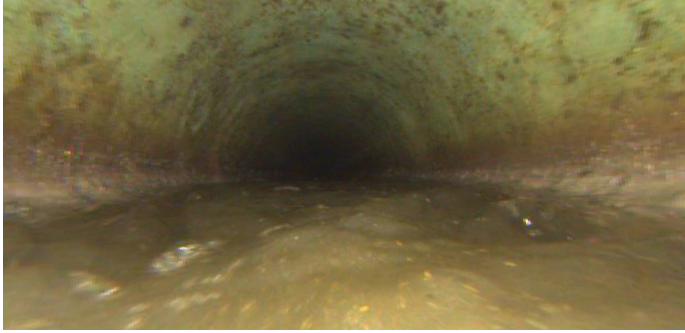
Code: **MCU**  
Description: **Camera Underwater**

Distance (ft): **72.6**  
Structural Grade: **0**  
O&M Grade: **4**  
Clock Start/From:  
Clock To:  
1st Value:  
2nd Value:  
Value Percent:  
Continuous Index: **F01**  
Within 8" of Joint: **NO**  
Remarks: **FLOW SUBSIDED**

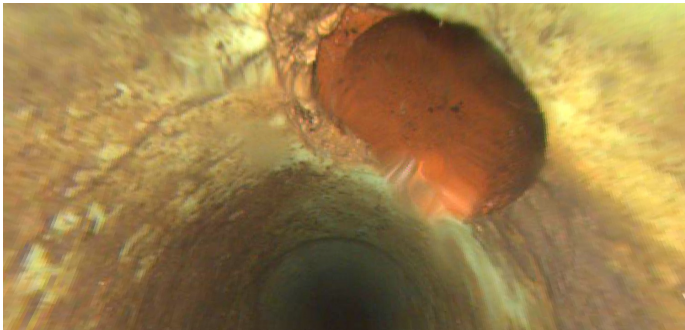
Code: **TF**  
Description: **Tap Factory**

Distance (ft): **96.7**  
Structural Grade: **0**  
O&M Grade: **0**  
Clock Start/From: **11**  
Clock To:  
1st Value: **4.000**  
2nd Value:  
Value Percent:  
Continuous Index:  
Within 8" of Joint:  
Remarks:

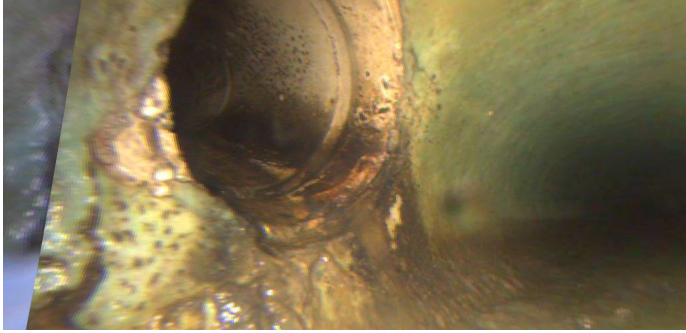
Code: **TF**  
Description: **Tap Factory**

Distance (ft): **110.0**  
Structural Grade: **0**  
O&M Grade: **0**  
Clock Start/From: **3**  
Clock To:  
1st Value: **4.000**  
2nd Value:  
Value Percent:  
Continuous Index:  
Within 8" of Joint:  
Remarks:

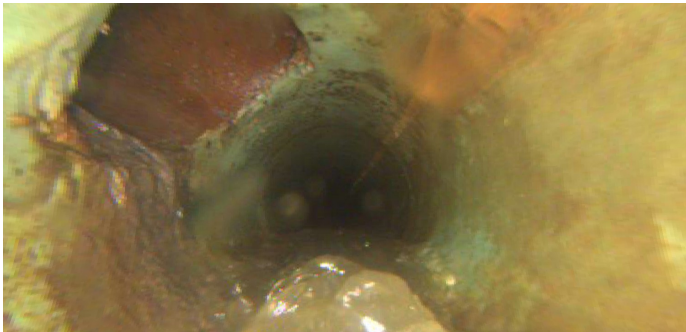
Code: **TF**  
Description: **Tap Factory**

Distance (ft): **197.8**  
Structural Grade: **0**  
O&M Grade: **0**  
Clock Start/From: **2**  
Clock To:  
1st Value: **4.000**  
2nd Value:  
Value Percent:  
Continuous Index:  
Within 8" of Joint:  
Remarks:

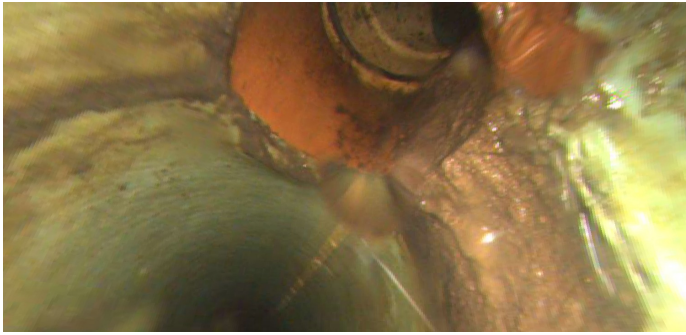
Code: **TF**  
Description: **Tap Factory**

Distance (ft): **202.6**  
Structural Grade: **0**  
O&M Grade: **0**  
Clock Start/From: **11**  
Clock To:  
1st Value: **4.000**  
2nd Value:  
Value Percent:  
Continuous Index:  
Within 8" of Joint:  
Remarks:

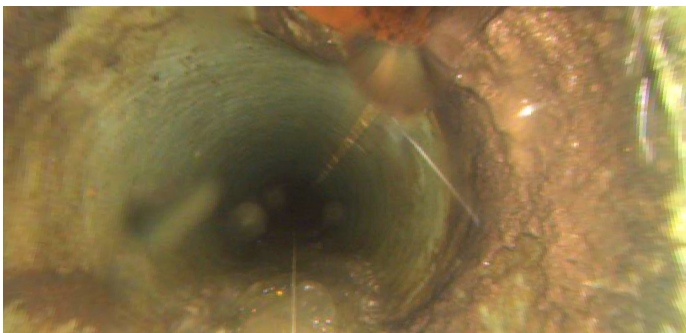
Code: **DAE**  
Description: **Deposits Attached Encrustation**

Distance (ft): **202.6**  
Structural Grade: **0**  
O&M Grade: **2**  
Clock Start/From: **7**  
Clock To: **10**  
1st Value:  
2nd Value:  
Value Percent: **5.000**  
Continuous Index:  
Within 8" of Joint: **NO**  
Remarks:

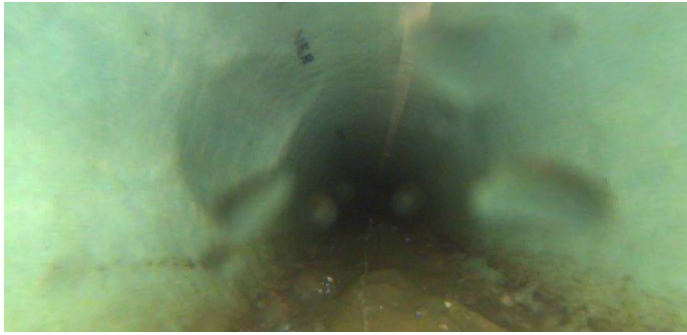
| Description: | <b>Lining Failure Abandoned Connection</b> |
| Distance (ft): | <b>220.1</b> |
| Clock Start/From: | <b>2</b> |

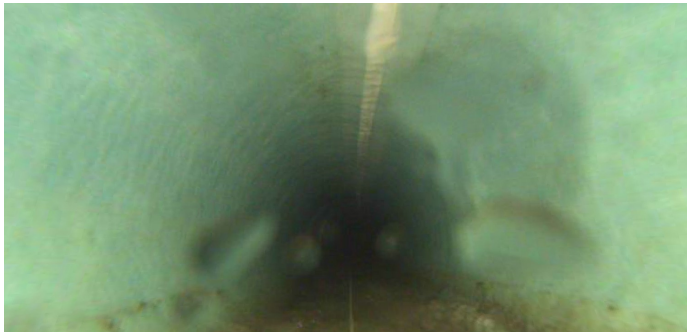
| Description: | <b>Lining Failure Abandoned Connection</b> |
| Distance (ft): | <b>223.0</b> |
| Clock Start/From: | <b>10</b> |

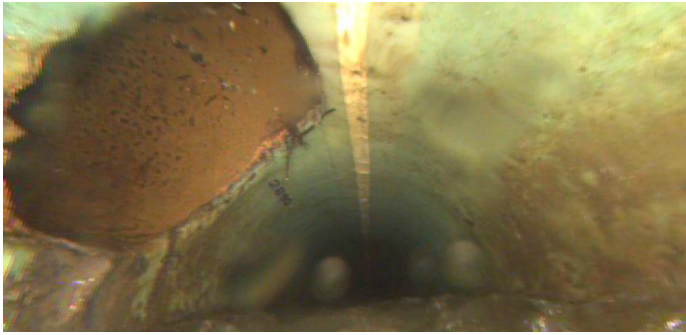
Code: **TF**  
Description: **Tap Factory**

Distance (ft): **281.5**  
Structural Grade: **0**  
O&M Grade: **0**  
Clock Start/From: **2**  
Clock To:  
1st Value: **6.000**  
2nd Value:  
Value Percent:  
Continuous Index:  
Within 8" of Joint:  
Remarks:

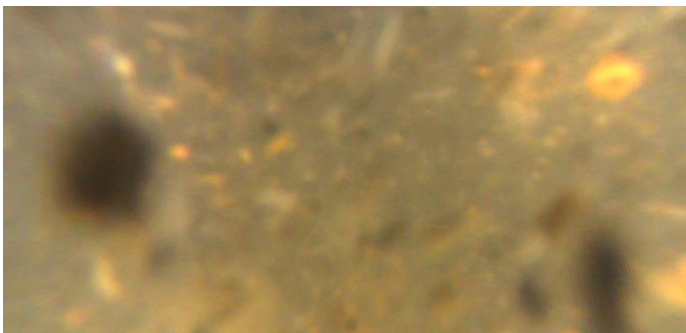
Code: **MCU**  
Description: **Camera Underwater**

Distance (ft): **282.2**  
Structural Grade: **0**  
O&M Grade: **4**  
Clock Start/From:  
Clock To:  
1st Value:  
2nd Value:  
Value Percent:  
Continuous Index: **S04**  
Within 8" of Joint: **NO**  
Remarks:

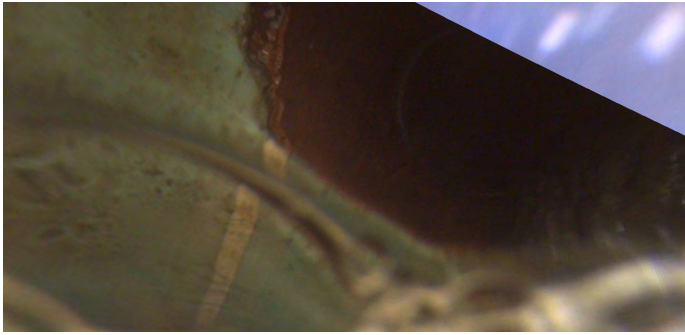
Code: **TF**  
Description: **Tap Factory**

Distance (ft): **284.5**  
Structural Grade: **0**  
O&M Grade: **0**  
Clock Start/From: **10**  
Clock To:  
1st Value: **6.000**  
2nd Value:  
Value Percent:  
Continuous Index:  
Within 8" of Joint:  
Remarks:

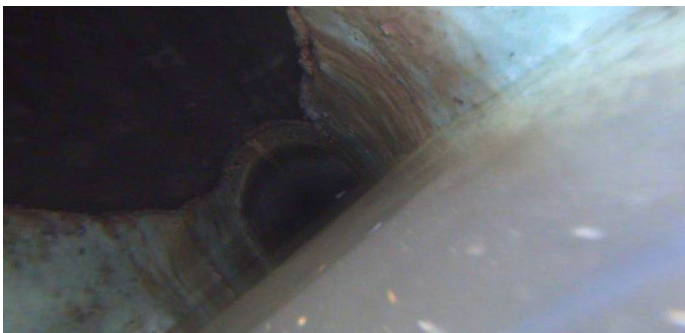
Code: **AMH**  
Description: **Manhole**

Distance (ft): **293.4**  
Structural Grade: **0**  
O&M Grade: **0**  
Clock Start/From:  
Clock To:  
1st Value:  
2nd Value:  
Value Percent:  
Continuous Index:  
Within 8" of Joint: **NO**  
Remarks: **M-305-022**

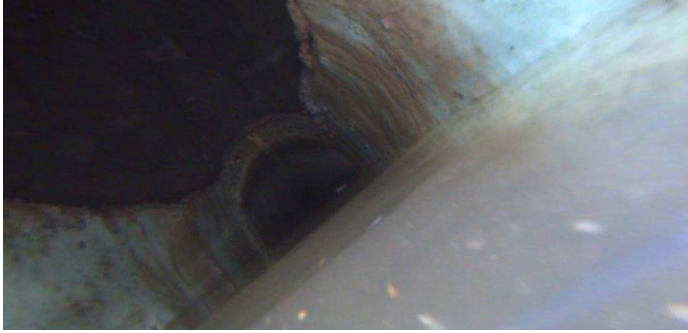
| Description: | Camera Underwater |
| Distance (ft): | 293.4 |
| O&M Grade: | 4 |
| Continuous Index: | F04 |
