## Profile/Photo Observation Report

Date:	<b>04/19/2018</b>	Weather:		Coding:	<b>PACP 6.0</b>
Pipe Length (ft):	<b>97.6</b>	Owner:	<b>NA</b>	Pre Clean:	<b>No Pre-Cleaning</b>
P.O.#:		Surveyor:	<b>Byrd Fitzgerald</b>	PSR:	<b>P-305-024-023</b>
Customer:		Clean Date:	<b>01/01/1900</b>	Shape:	<b>C</b>

Location Details:		Direction of Survey:	<b>Upstream</b>
US MH:	<b>M-305-024</b>	DS MH:	<b>M-305-023</b>
		Total Length Surveyed (ft):	<b>58.4</b>

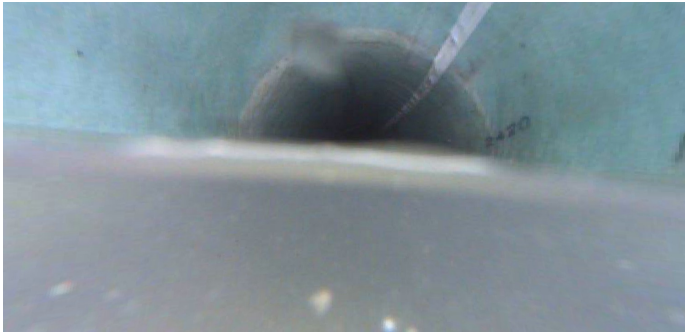
Code:	<b>MWL</b>
Description:	<b>Water Level</b>

Distance (ft):	<b>.0</b>
Structural Grade:	<b>0</b>
O&M Grade:	<b>0</b>
Clock Start/From:	
Clock To:	
1st Value:	
2nd Value:	
Value Percent:	<b>25.000</b>
Continuous Index:	
Within 8" of Joint:	<b>NO</b>
Remarks:

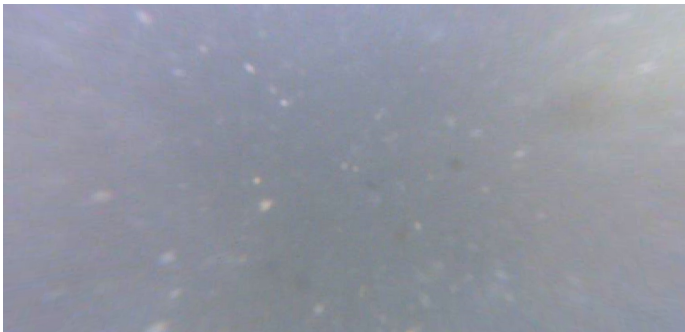
Code:	<b>MCU</b>
Description:	<b>Camera Underwater</b>

Distance (ft):	<b>3.3</b>
Structural Grade:	<b>0</b>
O&M Grade:	<b>4</b>
Clock Start/From:	
Clock To:	
1st Value:	
2nd Value:	
Value Percent:	
Continuous Index:	<b>S01</b>
Within 8" of Joint:	<b>NO</b>
Remarks:

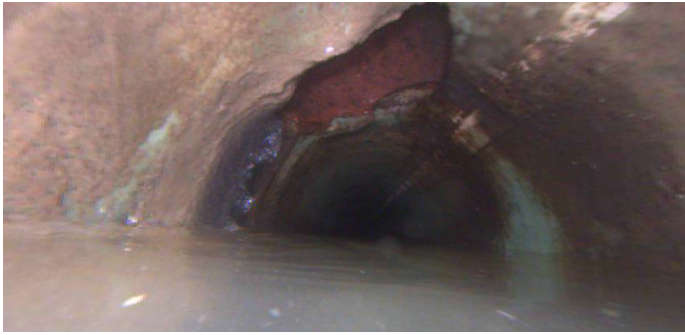
Code: **TB**  
Description: **Tap Break-in**

Distance (ft): **4.1**  
Structural Grade: **0**  
O&M Grade: **0**  
Clock Start/From: **11**  
Clock To:  
1st Value: **4.000**  
2nd Value:  
Value Percent:  
Continuous Index:  
Within 8" of Joint:  
Remarks:

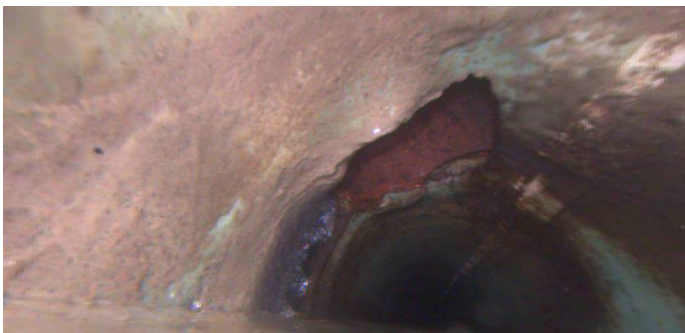
Code: **DAGS**  
Description: **Deposits Attached Grease**

Distance (ft): **4.1**  
Structural Grade: **0**  
O&M Grade: **2**  
Clock Start/From: **9**  
Clock To: **3**  
1st Value:  
2nd Value:  
Value Percent: **5.000**  
Continuous Index:  
Within 8" of Joint: **NO**  
Remarks:

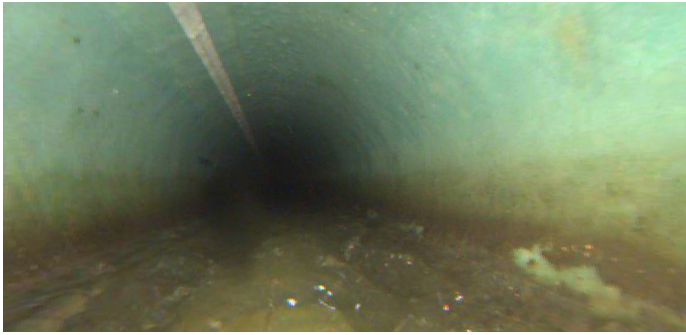
Code: **MGO**  
Description: **General Observation**

Distance (ft): **15.6**  
Structural Grade: **0**  
O&M Grade: **0**  
Clock Start/From:  
Clock To:  
1st Value:  
2nd Value:  
Value Percent:  
Continuous Index:  
Within 8" of Joint: **NO**  
Remarks: **rear camera/mcu**

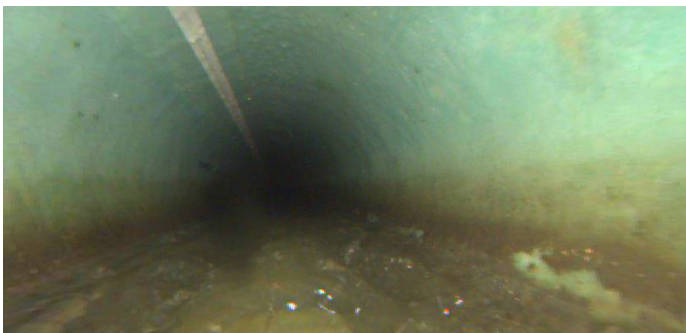
Code: **MCU**  
Description: **Camera Underwater**

Distance (ft): **15.6**  
Structural Grade: **0**  
O&M Grade: **4**  
Clock Start/From:  
Clock To:  
1st Value:  
2nd Value:  
Value Percent:  
Continuous Index: **F01**  
Within 8" of Joint: **NO**  
Remarks:
