## Profile/Photo Observation Report

Street:	<b>FOXCROFT STREET</b>	Flow Control:	<b>Not Controlled</b>
City:	<b>Hobart, IN</b>	Year Renewed:	
Location:	<b>Yard</b>	Tape/Media #:	
Purpose:	<b>Routine Assessment</b>	Dia/Height:	<b>10"</b>
Use:	<b>Sanitary</b>	Material:	<b>XXX</b>
Drain Area:	<b>NA</b>	Lining:	<b>Cured in Place</b>
Category:	<b>NA</b>		
Comment:

Location Details:		Direction of Survey:	<b>Downstream</b>
US MH:	<b>M-305-025</b>	DS MH:	<b>M-305-024</b>
		Total Length Surveyed (ft):	<b>264.9</b>

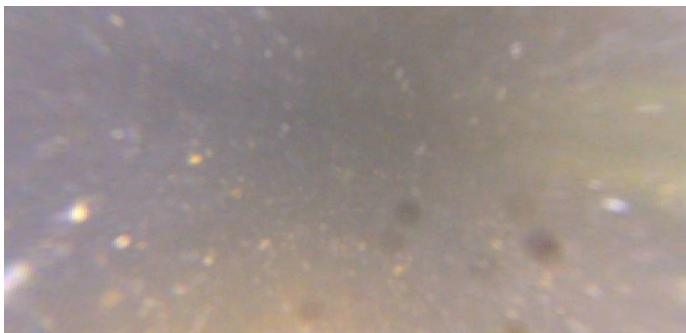
Code: **AMH**  
Description: **Manhole**

Distance (ft): **.0**  
Structural Grade: **0**  
O&M Grade: **0**  
Clock Start/From:  
Clock To:  
1st Value:  
2nd Value:  
Value Percent:  
Continuous Index:  
Within 8" of Joint: **NO**  
Remarks: **M-305-025**

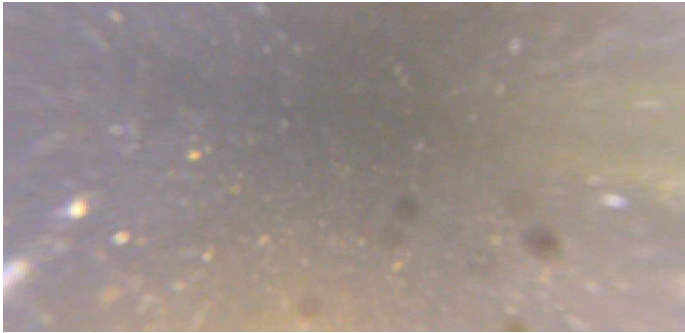
Code:	<b>MWL</b>
Description:	<b>Water Level</b>

Distance (ft):	<b>.0</b>
Structural Grade:	<b>0</b>
O&M Grade:	<b>0</b>
Clock Start/From:	
Clock To:	
1st Value:	
2nd Value:	
Value Percent:	<b>100.000</b>
Continuous Index:	
Within 8" of Joint:	<b>NO</b>
Remarks:	<b>mcu</b>

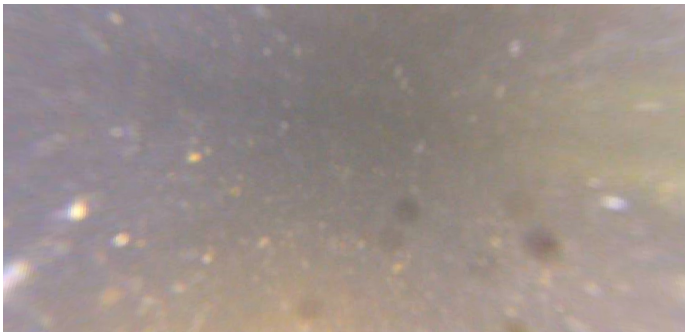
Code:	<b>MCU</b>
Description:	<b>Camera Underwater</b>

Distance (ft):	<b>.0</b>
Structural Grade:	<b>0</b>
O&M Grade:	<b>4</b>
Clock Start/From:	
Clock To:	
1st Value:	
2nd Value:	
Value Percent:	
Continuous Index:	<b>S01</b>
Within 8" of Joint:	<b>NO</b>
Remarks:

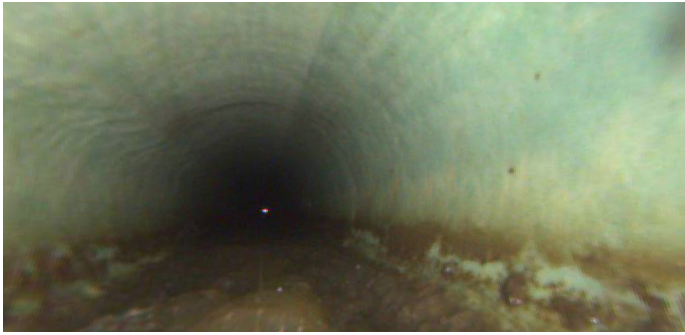
Code: **MGO**  
Description: **General Observation**

Distance (ft): **16.2**  
Structural Grade: **0**  
O&M Grade: **0**  
Clock Start/From:  
Clock To:  
1st Value:  
2nd Value:  
Value Percent:  
Continuous Index:  
Within 8" of Joint: **NO**  
Remarks: **rear camera/mcu**

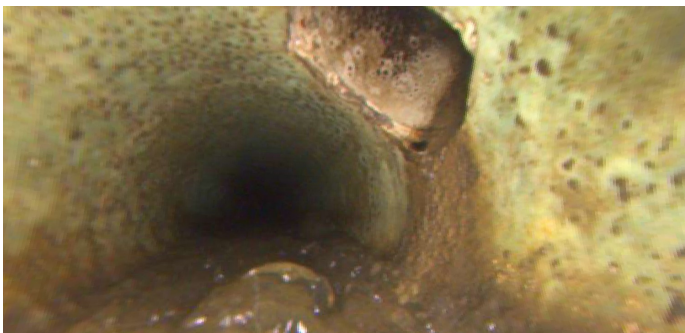
Code: **TB**  
Description: **Tap Break-in**

Distance (ft): **26.5**  
Structural Grade: **0**  
O&M Grade: **0**  
Clock Start/From: **11**  
Clock To:  
1st Value: **4.000**  
2nd Value:  
Value Percent:  
Continuous Index:  
Within 8" of Joint:  
Remarks:

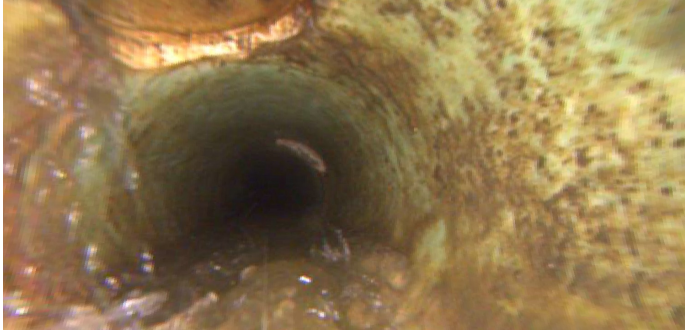
Code: **TBA**  
Description: **Tap Break-in Active**

Distance (ft): **28.1**  
Structural Grade: **0**  
O&M Grade: **0**  
Clock Start/From: **1**  
Clock To:  
1st Value: **4.000**  
2nd Value:  
Value Percent:  
Continuous Index:  
Within 8" of Joint:  
Remarks:

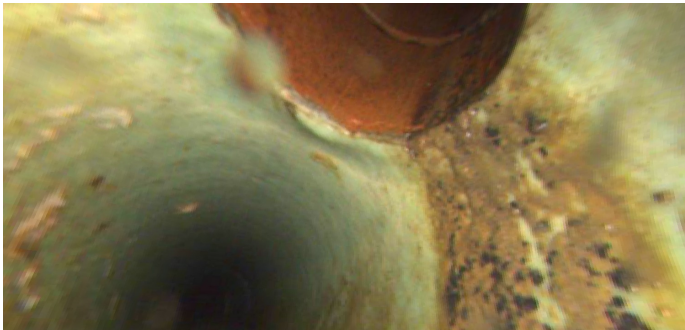
Code: **TB**  
Description: **Tap Break-in**

Distance (ft): **101.3**  
Structural Grade: **0**  
O&M Grade: **0**  
Clock Start/From: **11**  
Clock To:  
1st Value: **4.000**  
2nd Value:  
Value Percent:  
Continuous Index:  
Within 8" of Joint:  
Remarks:

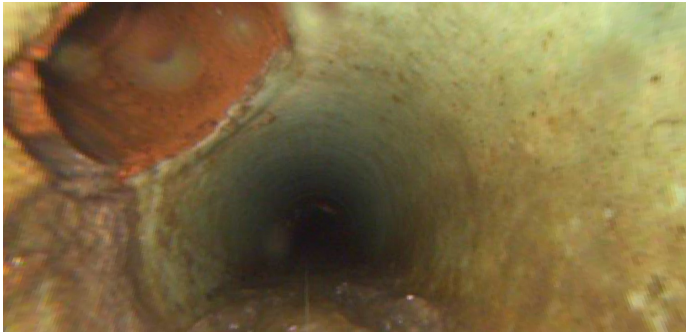
Code: **TB**  
Description: **Tap Break-in**

Distance (ft): **105.5**  
Structural Grade: **0**  
O&M Grade: **0**  
Clock Start/From: **1**  
Clock To:  
1st Value: **4.000**  
2nd Value:  
Value Percent:  
Continuous Index:  
Within 8" of Joint:  
Remarks:

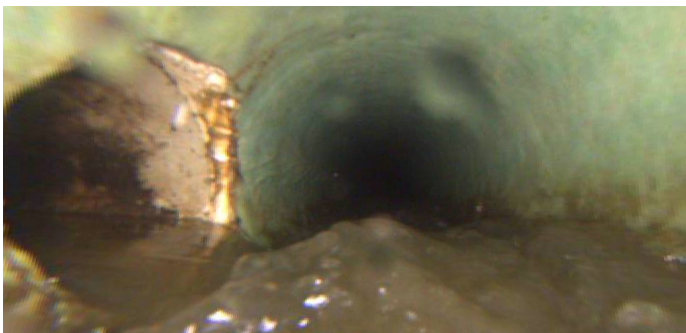
Code: **TB**  
Description: **Tap Break-in**

Distance (ft): **180.7**  
Structural Grade: **0**  
O&M Grade: **0**  
Clock Start/From: **3**  
Clock To:  
1st Value: **4.000**  
2nd Value:  
Value Percent:  
Continuous Index:  
Within 8" of Joint:  
Remarks:

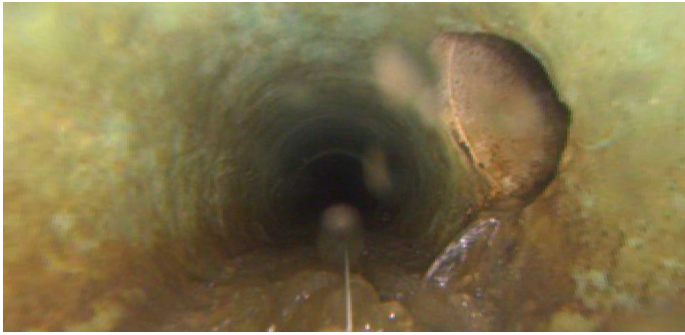
Code: **TBA**  
Description: **Tap Break-in Active**

Distance (ft): **193.5**  
Structural Grade: **0**  
O&M Grade: **0**  
Clock Start/From: **10**  
Clock To:  
1st Value: **4.000**  
2nd Value:  
Value Percent:  
Continuous Index:  
Within 8" of Joint:  
Remarks:

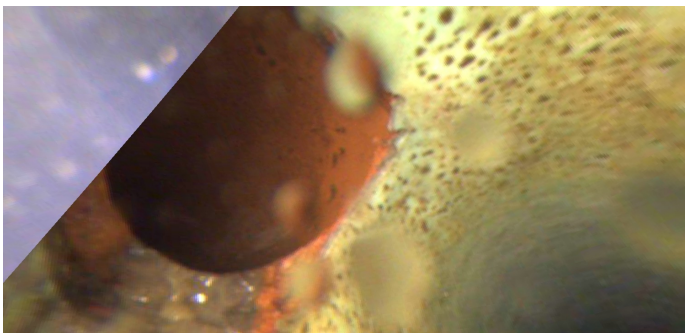
Code: **TB**  
Description: **Tap Break-in**

Distance (ft): **254.4**  
Structural Grade: **0**  
O&M Grade: **0**  
Clock Start/From: **2**  
Clock To:  
1st Value: **4.000**  
2nd Value:  
Value Percent:  
Continuous Index:  
Within 8" of Joint:  
Remarks:

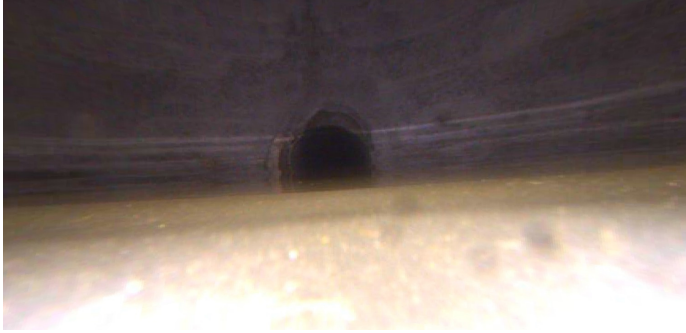
Code: **AMH**  
Description: **Manhole**

Distance (ft): **264.9**  
Structural Grade: **0**  
O&M Grade: **0**  
Clock Start/From:  
Clock To:  
1st Value:  
2nd Value:  
Value Percent:  
Continuous Index:  
Within 8" of Joint: **NO**  
Remarks: **M-305-024**

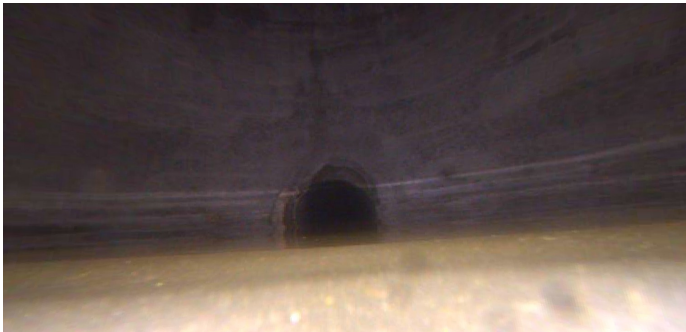
Code: **MCU**  
Description: **Camera Underwater**

Distance (ft): **264.9**  
Structural Grade: **0**  
O&M Grade: **4**  
Clock Start/From:  
Clock To:  
1st Value:  
2nd Value:  
Value Percent:  
Continuous Index: **F01**  
Within 8" of Joint: **NO**  
Remarks:
