## Profile/Photo Observation Report

Street:	<b>WOODLAND CT &amp; W 3RD PL</b>	Flow Control:	<b>Not Controlled</b>
City:	<b>Hobart, IN</b>	Year Renewed:	
Location:	<b>Yard</b>	Tape/Media #:	
Purpose:	<b>Routine Assessment</b>	Dia/Height:	<b>10"</b>
Use:	<b>Sanitary</b>	Material:	<b>PVC</b>
Drain Area:	<b>NA</b>	Lining:	<b>Cured in Place</b>
Category:	<b>NA</b>		
Comment:

Location Details:		Direction of Survey:	<b>Upstream</b>
US MH:	<b>M-305-026</b>	DS MH:	<b>M-305-025</b>
		Total Length Surveyed (ft):	<b>279.0</b>

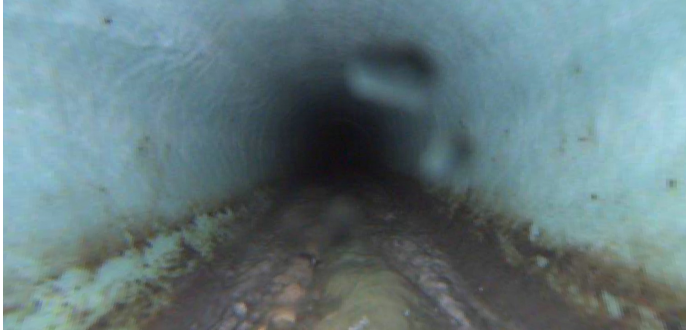
Code: **AMH**  
Description: **Manhole**

Distance (ft): **.0**  
Structural Grade: **0**  
O&M Grade: **0**  
Clock Start/From:  
Clock To:  
1st Value:  
2nd Value:  
Value Percent:  
Continuous Index:  
Within 8" of Joint: **NO**  
Remarks: **M-305-025**

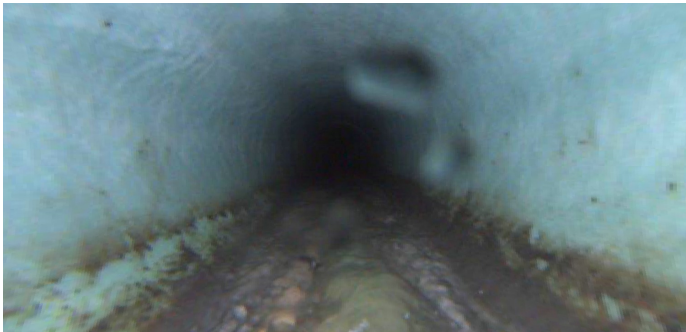
Code: **MWL**  
Description: **Water Level**

Distance (ft): **.0**  
Structural Grade: **0**  
O&M Grade: **0**  
Clock Start/From:  
Clock To:  
1st Value:  
2nd Value:  
Value Percent: **5.000**  
Continuous Index:  
Within 8" of Joint: **NO**  
Remarks:

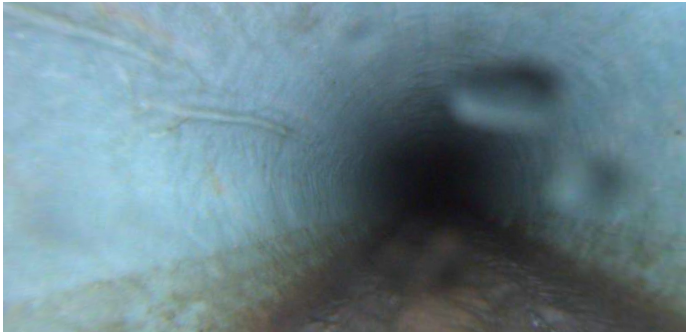
Code: **LFW**  
Description: **Lining Failure Wrinkled**

Distance (ft): **14.5**  
Structural Grade: **3**  
O&M Grade: **0**  
Clock Start/From: **10**  
Clock To:  
1st Value:  
2nd Value:  
Value Percent:  
Continuous Index:  
Within 8" of Joint: **NO**  
Remarks:

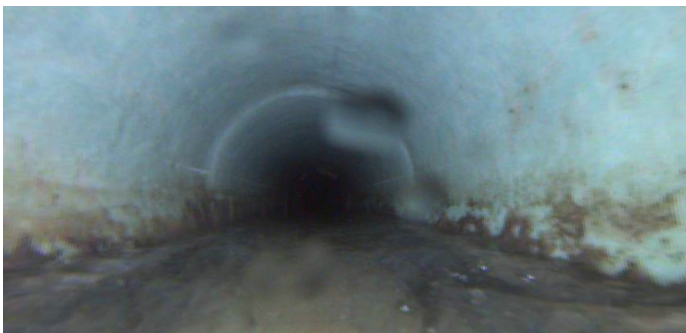
Code: **MWL**  
Description: **Water Level**

Distance (ft): **53.0**  
Structural Grade: **0**  
O&M Grade: **0**  
Clock Start/From:  
Clock To:  
1st Value:  
2nd Value:  
Value Percent: **10.000**  
Continuous Index:  
Within 8" of Joint: **NO**  
Remarks:

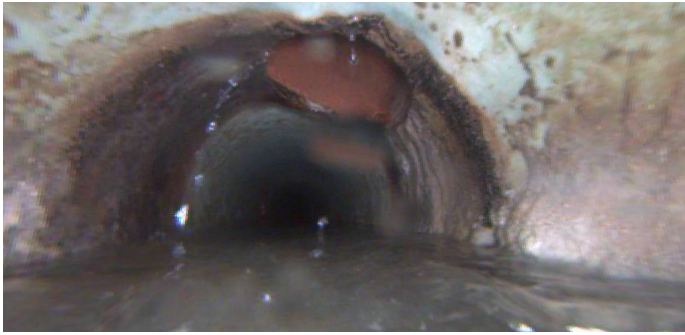
Code: **DAZ**  
Description: **Deposits Attached Other**

Distance (ft): **56.2**  
Structural Grade: **0**  
O&M Grade: **2**  
Clock Start/From: **7**  
Clock To: **5**  
1st Value:  
2nd Value:  
Value Percent: **5.000**  
Continuous Index:  
Within 8" of Joint: **NO**  
Remarks:

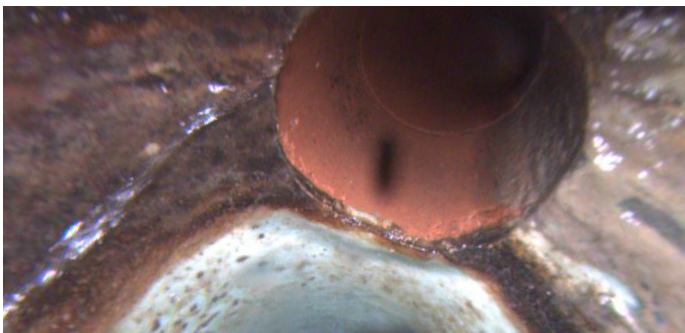
Code: **TFA**  
Description: **Tap Factory Active**

Distance (ft): **56.8**  
Structural Grade: **0**  
O&M Grade: **0**  
Clock Start/From: **1**  
Clock To:  
1st Value: **4.000**  
2nd Value:  
Value Percent:  
Continuous Index:  
Within 8" of Joint:  
Remarks:

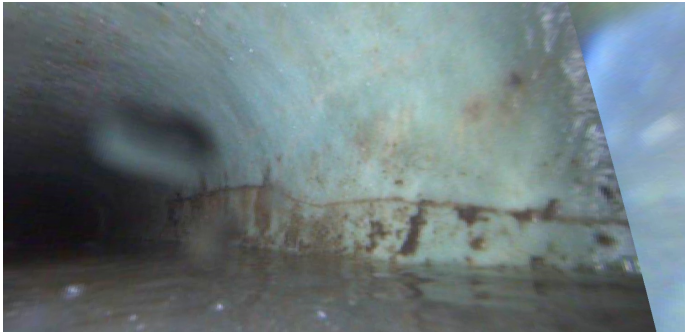
Code: **LFZ**  
Description: **Lining Failure Other**

Distance (ft): **58.5**  
Structural Grade: **0**  
O&M Grade: **0**  
Clock Start/From: **3**  
Clock To:  
1st Value:  
2nd Value:  
Value Percent:  
Continuous Index:  
Within 8" of Joint: **NO**  
Remarks: **crack**

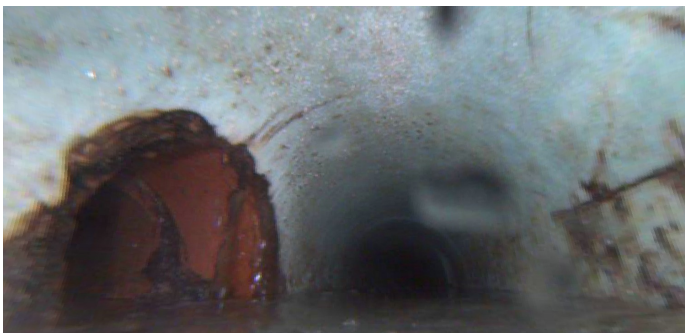
Code: **TFA**  
Description: **Tap Factory Active**

Distance (ft): **59.3**  
Structural Grade: **0**  
O&M Grade: **0**  
Clock Start/From: **9**  
Clock To:  
1st Value: **4.000**  
2nd Value:  
Value Percent:  
Continuous Index:  
Within 8" of Joint:  
Remarks:

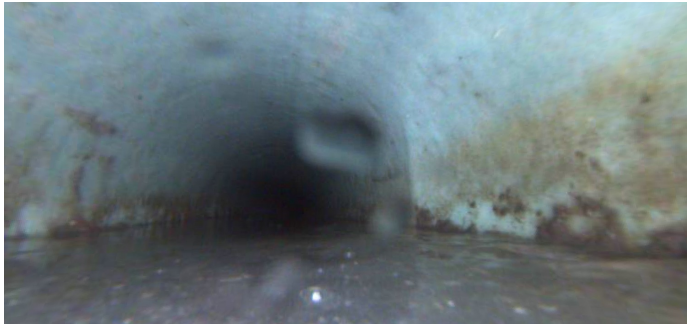
Code:	<b>LFAC</b>
Description:	<b>Lining Failure Abandoned Connection</b>
Distance (ft):	<b>61.4</b>
Structural Grade:	<b>0</b>
O&M Grade:	<b>0</b>
Clock Start/From:	<b>3</b>
Clock To:	
1st Value:	
2nd Value:	
Value Percent:	
Continuous Index:	
Within 8" of Joint:	<b>NO</b>
Remarks:

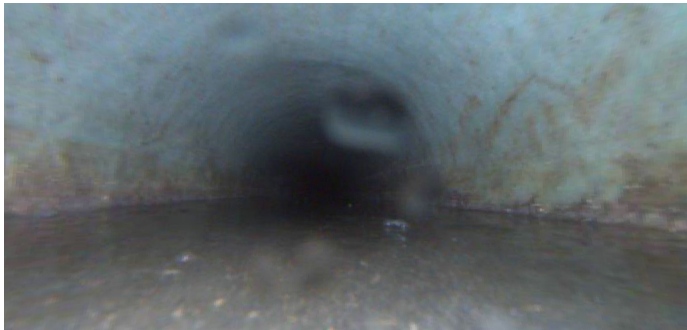
Code:	<b>MWL</b>
Description:	<b>Water Level</b>
Distance (ft):	<b>67.4</b>
Structural Grade:	<b>0</b>
O&M Grade:	<b>0</b>
Clock Start/From:	
Clock To:	
1st Value:	
2nd Value:	
Value Percent:	<b>15.000</b>
Continuous Index:	
Within 8" of Joint:	<b>NO</b>
Remarks:

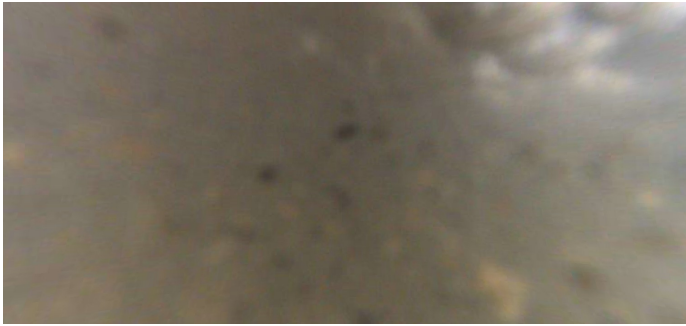
Code: **MWL**  
Description: **Water Level**

Distance (ft): **86.9**  
Structural Grade: **0**  
O&M Grade: **0**  
Clock Start/From:  
Clock To:  
1st Value:  
2nd Value:  
Value Percent: **100.000**  
Continuous Index:  
Within 8" of Joint: **NO**  
Remarks:

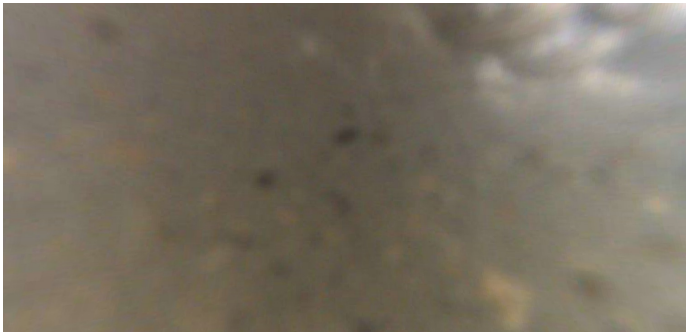
Code: **MCU**  
Description: **Camera Underwater**

Distance (ft): **86.9**  
Structural Grade: **0**  
O&M Grade: **4**  
Clock Start/From:  
Clock To:  
1st Value:  
2nd Value:  
Value Percent:  
Continuous Index: **S01**  
Within 8" of Joint: **NO**  
Remarks:

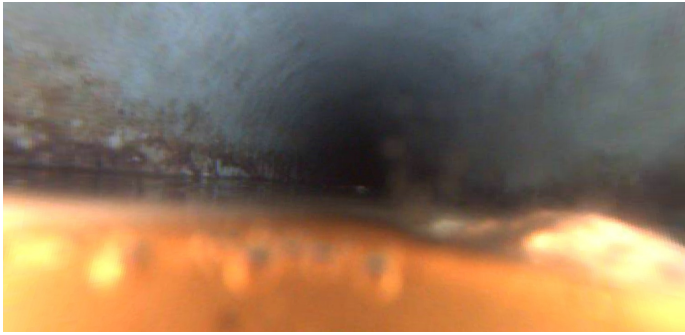
Code: **MCU**  
Description: **Camera Underwater**

Distance (ft): **112.5**  
Structural Grade: **0**  
O&M Grade: **4**  
Clock Start/From:  
Clock To:  
1st Value:  
2nd Value:  
Value Percent:  
Continuous Index: **F01**  
Within 8" of Joint: **NO**  
Remarks: **CAMERA EMERGED**

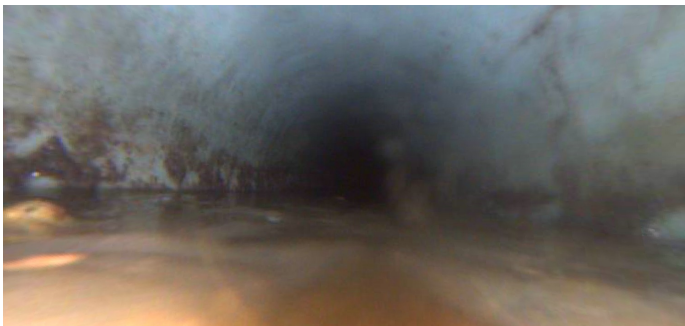
Code: **MWL**  
Description: **Water Level**

Distance (ft): **113.6**  
Structural Grade: **0**  
O&M Grade: **0**  
Clock Start/From:  
Clock To:  
1st Value:  
2nd Value:  
Value Percent: **40.000**  
Continuous Index:  
Within 8" of Joint: **NO**  
Remarks:

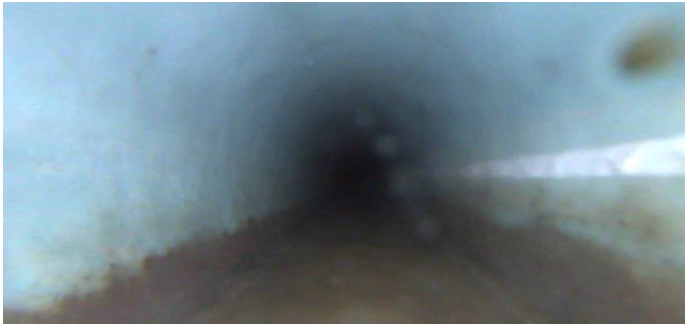
Code: **MWL**  
Description: **Water Level**

Distance (ft): **194.0**  
Structural Grade: **0**  
O&M Grade: **0**  
Clock Start/From:  
Clock To:  
1st Value:  
2nd Value:  
Value Percent: **15.000**  
Continuous Index:  
Within 8" of Joint: **NO**  
Remarks:

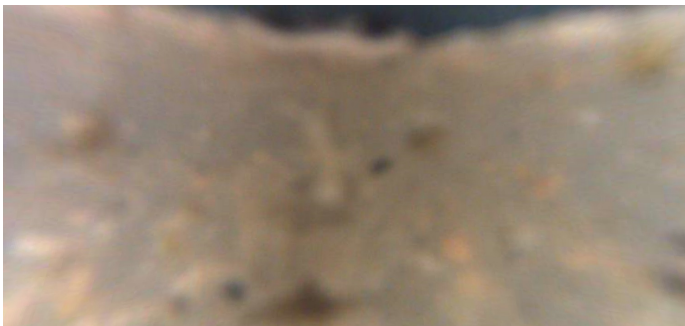
Code: **MWL**  
Description: **Water Level**

Distance (ft): **206.9**  
Structural Grade: **0**  
O&M Grade: **0**  
Clock Start/From:  
Clock To:  
1st Value:  
2nd Value:  
Value Percent: **70.000**  
Continuous Index:  
Within 8" of Joint: **NO**  
Remarks:

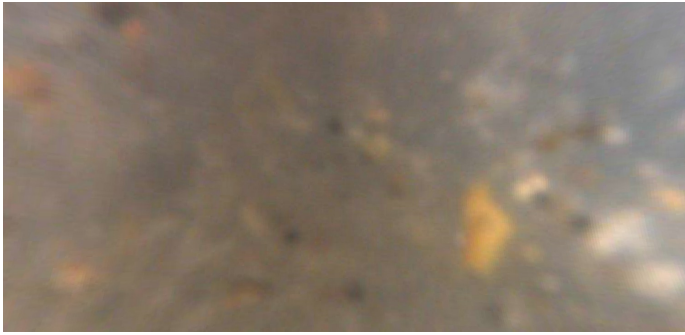
Code: **MCU**  
Description: **Camera Underwater**

Distance (ft): **207.2**  
Structural Grade: **0**  
O&M Grade: **4**  
Clock Start/From:  
Clock To:  
1st Value:  
2nd Value:  
Value Percent:  
Continuous Index:  
Within 8" of Joint: **NO**  
Remarks:

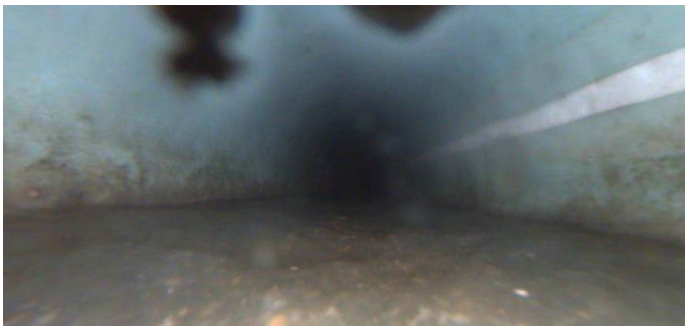
Code: **MWL**  
Description: **Water Level**

Distance (ft): **209.0**  
Structural Grade: **0**  
O&M Grade: **0**  
Clock Start/From:  
Clock To:  
1st Value:  
2nd Value:  
Value Percent: **40.000**  
Continuous Index:  
Within 8" of Joint: **NO**  
Remarks:

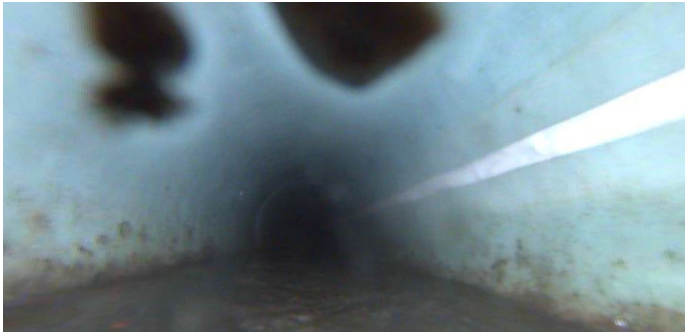
Code: **MGO**  
Description: **General Observation**

Distance (ft): **209.9**  
Structural Grade: **0**  
O&M Grade: **0**  
Clock Start/From:  
Clock To:  
1st Value:  
2nd Value:  
Value Percent:  
Continuous Index:  
Within 8" of Joint: **NO**  
Remarks: **DEPOSIT LEFT ON LENS**

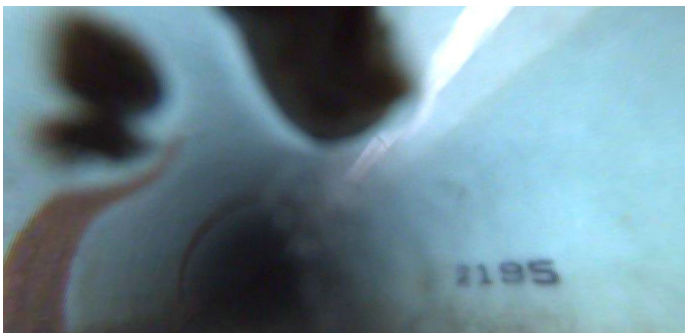
Code: **IS**  
Description: **Infil Stain**

Distance (ft): **230.5**  
Structural Grade: **0**  
O&M Grade: **0**  
Clock Start/From: **7**  
Clock To: **11**  
1st Value:  
2nd Value:  
Value Percent:  
Continuous Index:  
Within 8" of Joint:  
Remarks:

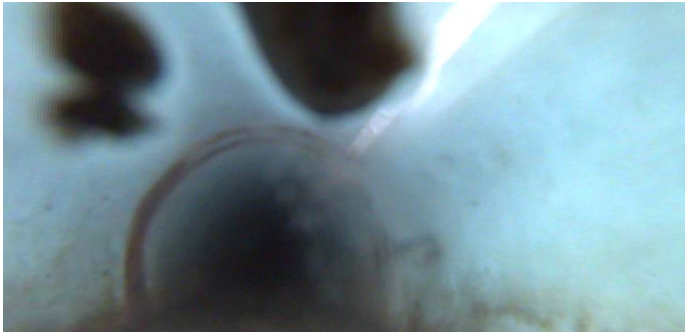
Code: **IS**  
Description: **Infil Stain**

Distance (ft): **231.1**  
Structural Grade: **0**  
O&M Grade: **0**  
Clock Start/From: **7**  
Clock To: **1**  
1st Value:  
2nd Value:  
Value Percent:  
Continuous Index:  
Within 8" of Joint:  
Remarks:

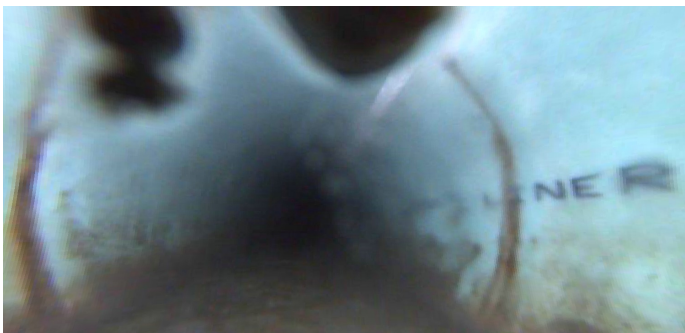
Code: **IS**  
Description: **Infil Stain**

Distance (ft): **236.7**  
Structural Grade: **0**  
O&M Grade: **0**  
Clock Start/From: **7**  
Clock To: **5**  
1st Value:  
2nd Value:  
Value Percent:  
Continuous Index:  
Within 8" of Joint:  
Remarks:

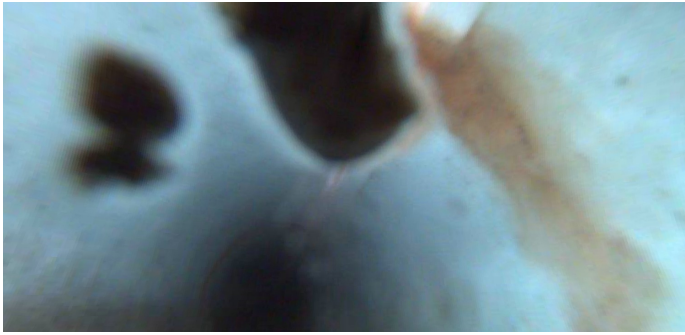
Code: **IS**  
Description: **Infil Stain**

Distance (ft): **255.4**  
Structural Grade: **0**  
O&M Grade: **0**  
Clock Start/From: **7**  
Clock To: **5**  
1st Value:  
2nd Value:  
Value Percent:  
Continuous Index: **S02**  
Within 8" of Joint: **YES**  
Remarks: **WANDER**

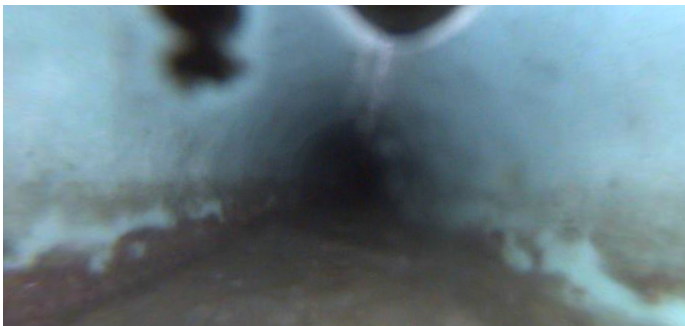
Code: **IS**  
Description: **Infil Stain**

Distance (ft): **265.5**  
Structural Grade: **0**  
O&M Grade: **0**  
Clock Start/From: **7**  
Clock To: **5**  
1st Value:  
2nd Value:  
Value Percent:  
Continuous Index: **F02**  
Within 8" of Joint: **YES**  
Remarks: **WANDER**

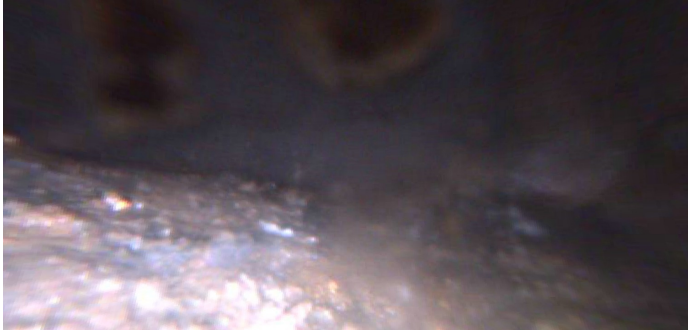
Code:	AMH
Description:	Manhole
Distance (ft):	279.0
Structural Grade:	0
O&M Grade:	0
Clock Start/From:	
Clock To:	
1st Value:	
2nd Value:	
Value Percent:	
Continuous Index:	
Within 8" of Joint:	NO
Remarks:	M-305-026
