## Profile/Photo Observation Report

Street:	<b>FOXCROFT STREET</b>	Flow Control:	<b>Not Controlled</b>
City:	<b>Hobart, IN</b>	Year Renewed:	
Location:	<b>Yard</b>	Tape/Media #:	
Purpose:	<b>Routine Assessment</b>	Dia/Height:	<b>10"</b>
Use:	<b>Sanitary</b>	Material:	<b>PVC</b>
Drain Area:	<b>NA</b>	Lining:	<b>Cured in Place</b>
Category:	<b>NA</b>		
Comment:

Location Details:		Direction of Survey:	<b>Upstream</b>
US MH:	<b>M-305-026</b>	DS MH:	<b>M-305-025</b>
		Total Length Surveyed (ft):	<b>279.0</b>

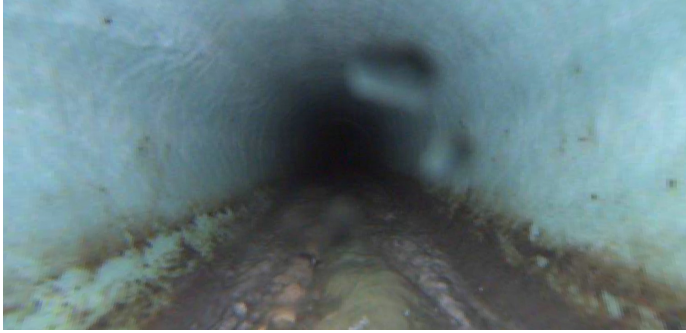
Code: **AMH**  
Description: **Manhole**

Distance (ft): **.0**  
Structural Grade: **0**  
O&M Grade: **0**  
Clock Start/From:  
Clock To:  
1st Value:  
2nd Value:  
Value Percent:  
Continuous Index:  
Within 8" of Joint: **NO**  
Remarks: **M-305-025**

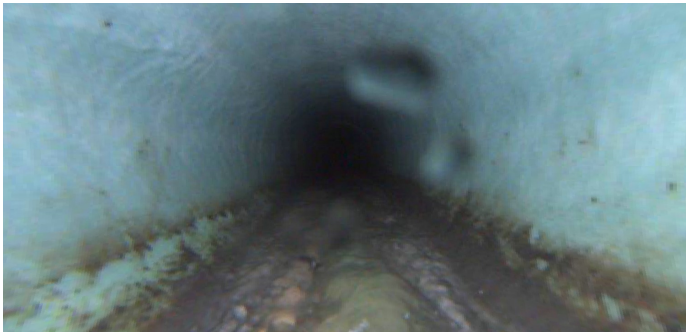
Code: **MWL**  
Description: **Water Level**

Distance (ft): **.0**  
Structural Grade: **0**  
O&M Grade: **0**  
Clock Start/From:  
Clock To:  
1st Value:  
2nd Value:  
Value Percent: **5.000**  
Continuous Index:  
Within 8" of Joint: **NO**  
Remarks:

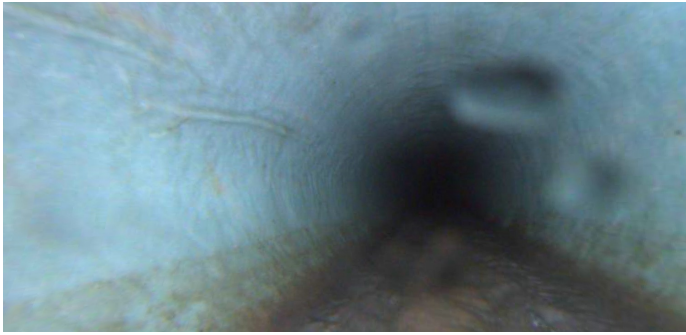
Code: **LFW**  
Description: **Lining Failure Wrinkled**

Distance (ft): **14.5**  
Structural Grade: **3**  
O&M Grade: **0**  
Clock Start/From: **10**  
Clock To:  
1st Value:  
2nd Value:  
Value Percent:  
Continuous Index:  
Within 8" of Joint: **NO**  
Remarks:

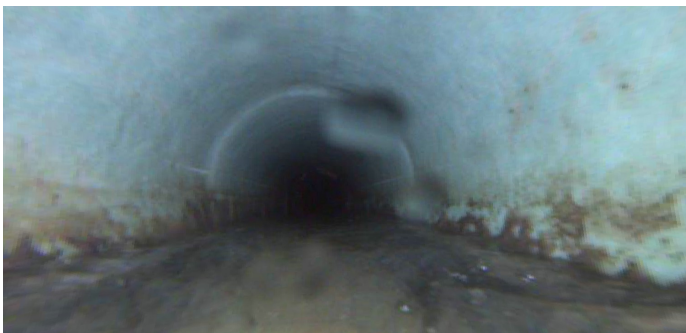
Code: **MWL**  
Description: **Water Level**

Distance (ft): **53.0**  
Structural Grade: **0**  
O&M Grade: **0**  
Clock Start/From:  
Clock To:  
1st Value:  
2nd Value:  
Value Percent: **10.000**  
Continuous Index:  
Within 8" of Joint: **NO**  
Remarks:

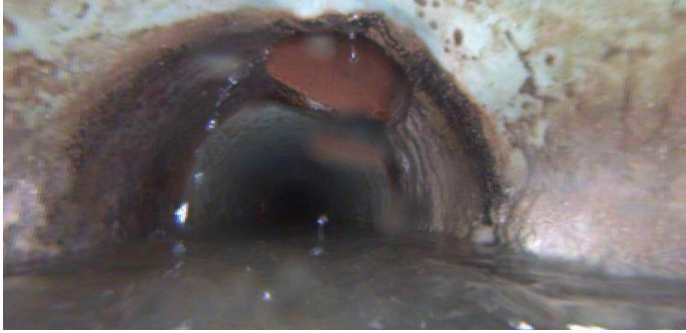
Code: **DAZ**  
Description: **Deposits Attached Other**

Distance (ft): **56.2**  
Structural Grade: **0**  
O&M Grade: **2**  
Clock Start/From: **7**  
Clock To: **5**  
1st Value:  
2nd Value:  
Value Percent: **5.000**  
Continuous Index:  
Within 8" of Joint: **NO**  
Remarks:

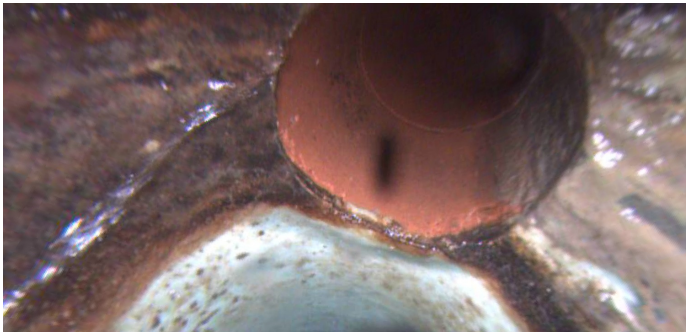
Code: **TFA**  
Description: **Tap Factory Active**

Distance (ft): **56.8**  
Structural Grade: **0**  
O&M Grade: **0**  
Clock Start/From: **1**  
Clock To:  
1st Value: **4.000**  
2nd Value:  
Value Percent:  
Continuous Index:  
Within 8" of Joint:  
Remarks:

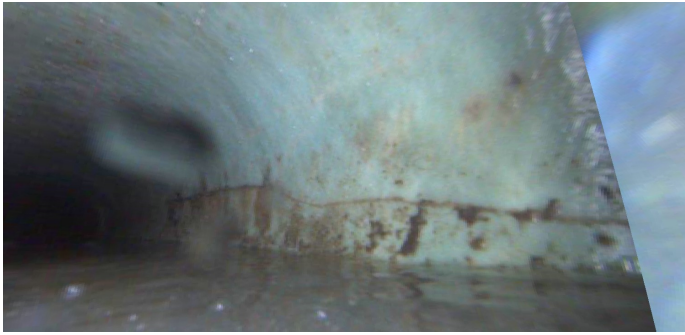
Code: **LFZ**  
Description: **Lining Failure Other**

Distance (ft): **58.5**  
Structural Grade: **0**  
O&M Grade: **0**  
Clock Start/From: **3**  
Clock To:  
1st Value:  
2nd Value:  
Value Percent:  
Continuous Index:  
Within 8" of Joint: **NO**  
Remarks: **crack**

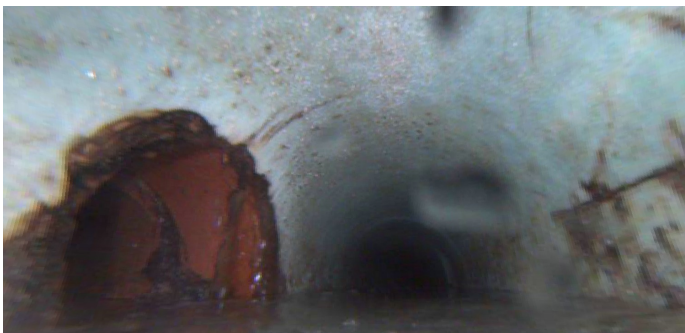
Code: **TFA**  
Description: **Tap Factory Active**

Distance (ft): **59.3**  
Structural Grade: **0**  
O&M Grade: **0**  
Clock Start/From: **9**  
Clock To:  
1st Value: **4.000**  
2nd Value:  
Value Percent:  
Continuous Index:  
Within 8" of Joint:  
Remarks:

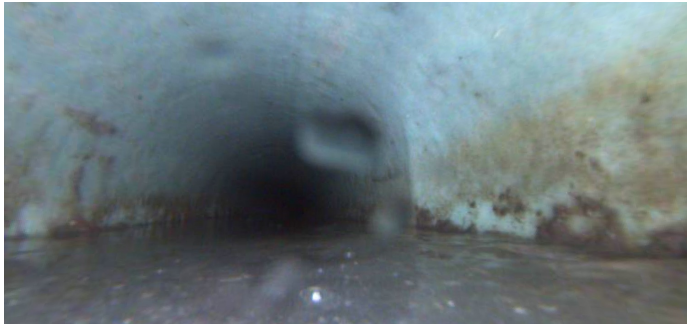
Code:	<b>LFAC</b>
Description:	<b>Lining Failure Abandoned Connection</b>
Distance (ft):	<b>61.4</b>
Structural Grade:	<b>0</b>
O&M Grade:	<b>0</b>
Clock Start/From:	<b>3</b>
Clock To:	
1st Value:	
2nd Value:	
Value Percent:	
Continuous Index:	
Within 8" of Joint:	<b>NO</b>
Remarks:

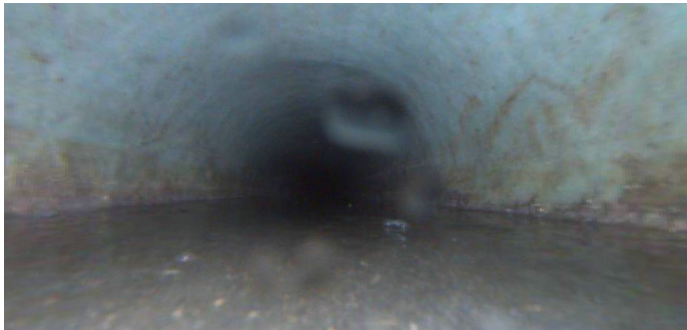
Code:	<b>MWL</b>
Description:	<b>Water Level</b>
Distance (ft):	<b>67.4</b>
Structural Grade:	<b>0</b>
O&M Grade:	<b>0</b>
Clock Start/From:	
Clock To:	
1st Value:	
2nd Value:	
Value Percent:	<b>15.000</b>
Continuous Index:	
Within 8" of Joint:	<b>NO</b>
Remarks:

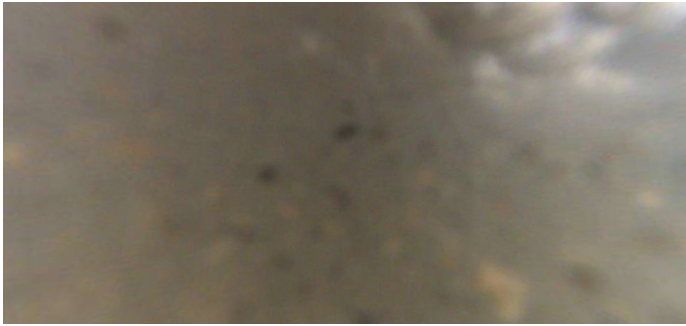
Code: **MWL**  
Description: **Water Level**

Distance (ft): **86.9**  
Structural Grade: **0**  
O&M Grade: **0**  
Clock Start/From:  
Clock To:  
1st Value:  
2nd Value:  
Value Percent: **100.000**  
Continuous Index:  
Within 8" of Joint: **NO**  
Remarks:

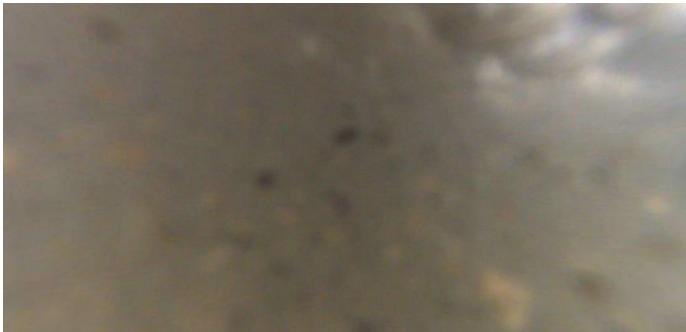
Code: **MCU**  
Description: **Camera Underwater**

Distance (ft): **86.9**  
Structural Grade: **0**  
O&M Grade: **4**  
Clock Start/From:  
Clock To:  
1st Value:  
2nd Value:  
Value Percent:  
Continuous Index: **S01**  
Within 8" of Joint: **NO**  
Remarks:

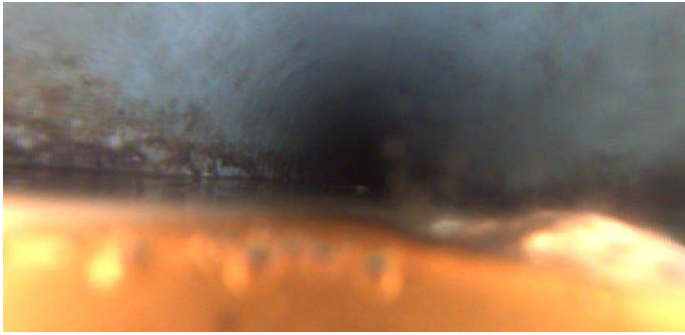
Code: **MCU**  
Description: **Camera Underwater**

Distance (ft): **112.5**  
Structural Grade: **0**  
O&M Grade: **4**  
Clock Start/From:  
Clock To:  
1st Value:  
2nd Value:  
Value Percent:  
Continuous Index: **F01**  
Within 8" of Joint: **NO**  
Remarks: **CAMERA EMERGED**

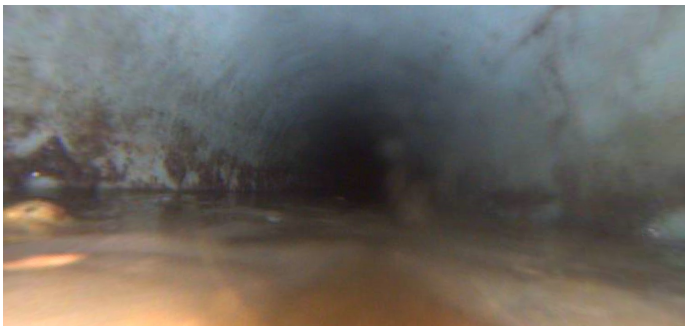
Code: **MWL**  
Description: **Water Level**

Distance (ft): **113.6**  
Structural Grade: **0**  
O&M Grade: **0**  
Clock Start/From:  
Clock To:  
1st Value:  
2nd Value:  
Value Percent: **40.000**  
Continuous Index:  
Within 8" of Joint: **NO**  
Remarks:

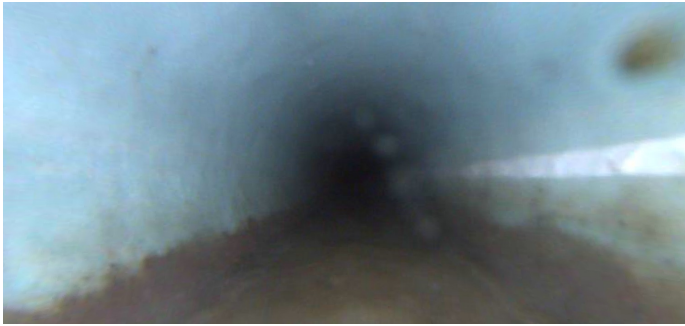
Code: **MWL**  
Description: **Water Level**

Distance (ft): **194.0**  
Structural Grade: **0**  
O&M Grade: **0**  
Clock Start/From:  
Clock To:  
1st Value:  
2nd Value:  
Value Percent: **15.000**  
Continuous Index:  
Within 8" of Joint: **NO**  
Remarks:

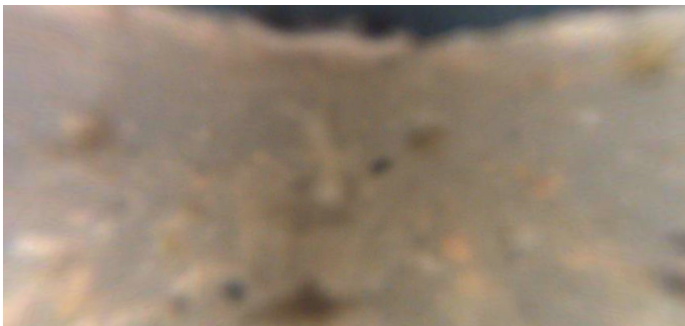
Code: **MWL**  
Description: **Water Level**

Distance (ft): **206.9**  
Structural Grade: **0**  
O&M Grade: **0**  
Clock Start/From:  
Clock To:  
1st Value:  
2nd Value:  
Value Percent: **70.000**  
Continuous Index:  
Within 8" of Joint: **NO**  
Remarks:

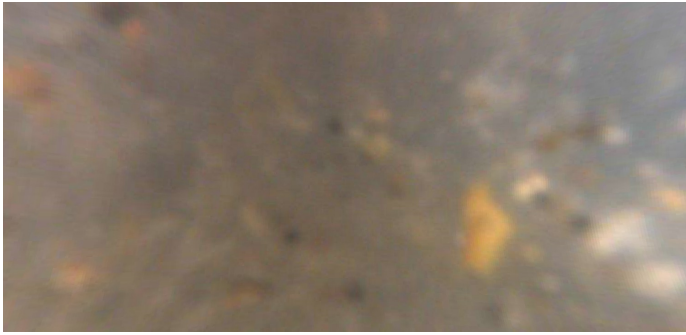
Code: **MCU**  
Description: **Camera Underwater**

Distance (ft): **207.2**  
Structural Grade: **0**  
O&M Grade: **4**  
Clock Start/From:  
Clock To:  
1st Value:  
2nd Value:  
Value Percent:  
Continuous Index:  
Within 8" of Joint: **NO**  
Remarks:

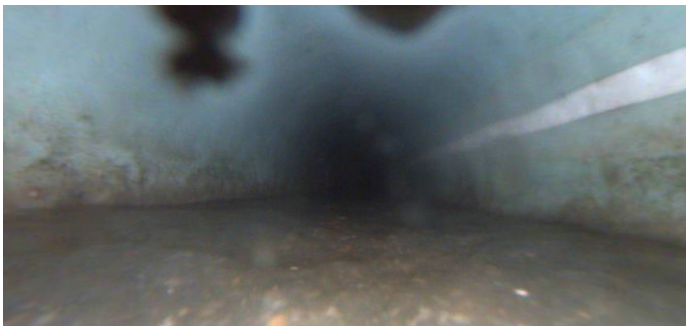
Code: **MWL**  
Description: **Water Level**

Distance (ft): **209.0**  
Structural Grade: **0**  
O&M Grade: **0**  
Clock Start/From:  
Clock To:  
1st Value:  
2nd Value:  
Value Percent: **40.000**  
Continuous Index:  
Within 8" of Joint: **NO**  
Remarks:

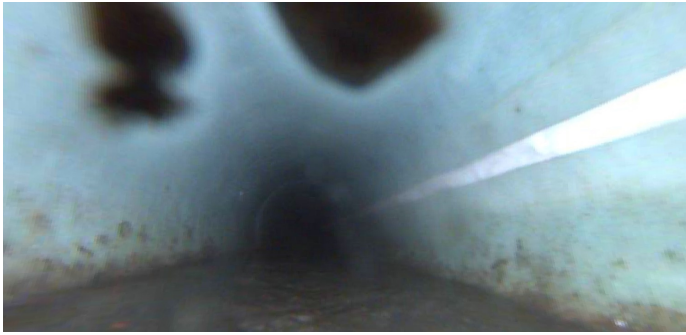
Code: **MGO**  
Description: **General Observation**

Distance (ft): **209.9**  
Structural Grade: **0**  
O&M Grade: **0**  
Clock Start/From:  
Clock To:  
1st Value:  
2nd Value:  
Value Percent:  
Continuous Index:  
Within 8" of Joint: **NO**  
Remarks: **DEPOSIT LEFT ON LENS**

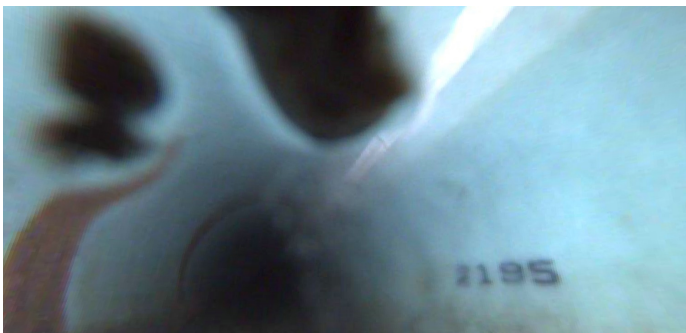
Code: **IS**  
Description: **Infil Stain**

Distance (ft): **230.5**  
Structural Grade: **0**  
O&M Grade: **0**  
Clock Start/From: **7**  
Clock To: **11**  
1st Value:  
2nd Value:  
Value Percent:  
Continuous Index:  
Within 8" of Joint:  
Remarks:

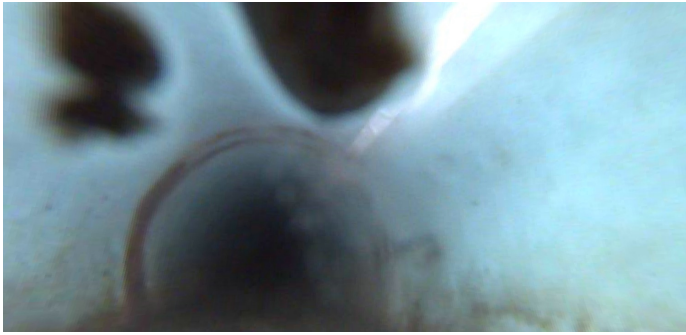
Code: **IS**  
Description: **Infil Stain**

Distance (ft): **231.1**  
Structural Grade: **0**  
O&M Grade: **0**  
Clock Start/From: **7**  
Clock To: **1**  
1st Value:  
2nd Value:  
Value Percent:  
Continuous Index:  
Within 8" of Joint:  
Remarks:

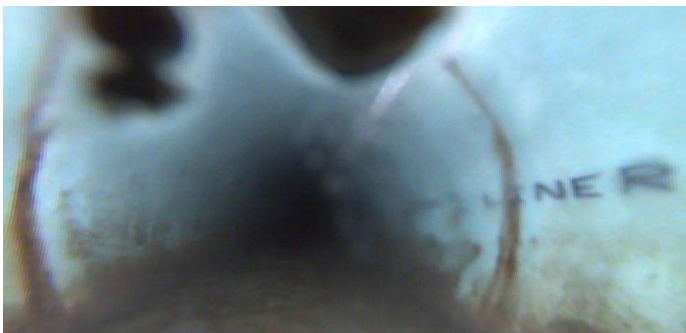
Code: **IS**  
Description: **Infil Stain**

Distance (ft): **236.7**  
Structural Grade: **0**  
O&M Grade: **0**  
Clock Start/From: **7**  
Clock To: **5**  
1st Value:  
2nd Value:  
Value Percent:  
Continuous Index:  
Within 8" of Joint:  
Remarks:

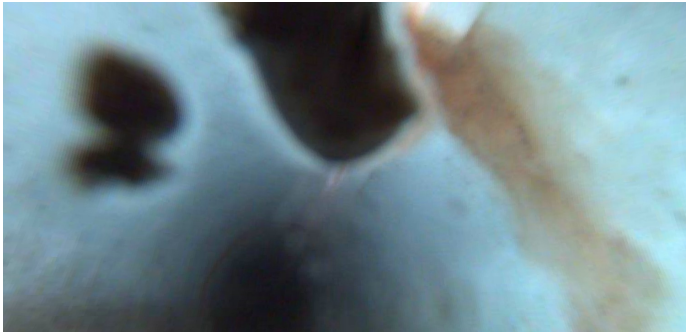
Code: **IS**  
Description: **Infil Stain**

Distance (ft): **255.4**  
Structural Grade: **0**  
O&M Grade: **0**  
Clock Start/From: **7**  
Clock To: **5**  
1st Value:  
2nd Value:  
Value Percent:  
Continuous Index: **S02**  
Within 8" of Joint: **YES**  
Remarks: **WANDER**

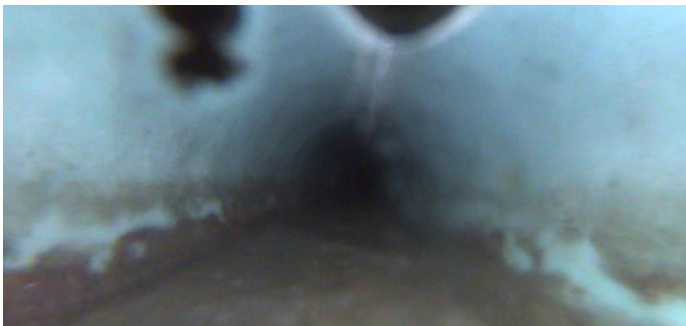
Code: **IS**  
Description: **Infil Stain**

Distance (ft): **265.5**  
Structural Grade: **0**  
O&M Grade: **0**  
Clock Start/From: **7**  
Clock To: **5**  
1st Value:  
2nd Value:  
Value Percent:  
Continuous Index: **F02**  
Within 8" of Joint: **YES**  
Remarks: **WANDER**

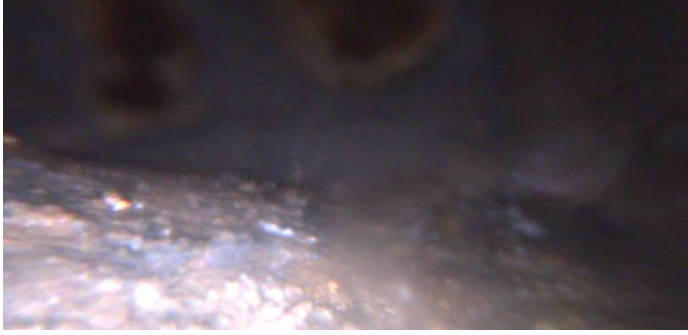
Code:	<b>AMH</b>
Description:	<b>Manhole</b>
Distance (ft):	<b>279.0</b>
Structural Grade:	<b>0</b>
O&M Grade:	<b>0</b>
Clock Start/From:	
Clock To:	
1st Value:	
2nd Value:	
Value Percent:	
Continuous Index:	
Within 8" of Joint:	<b>NO</b>
Remarks:	<b>M-305-026</b>
