Profile/Photo Observation Report

Date:	04/19/2018	Weather:		Coding:	PACP 6.0
Pipe Length (ft):	294.5	Owner:	NA	Pre Clean:	No Pre-Cleaning
P.O.#:		Surveyor:	Justin Gonzales	PSR:	P-305-027-026
Customer:		Clean Date:	01/01/1900	Shape:	C

Street:	ALLEY BETWEEN CROWSNEST DR &	Flow Control:	Not Controlled
City:	Hobart, IN	Year Renewed:	
Location:	Yard	Tape/Media #:	
Purpose:	Routine Assessment	Dia/Height:	10"
Use:	Sanitary	Material:	PVC
Drain Area:	NA	Lining:	Cured in Place
Category:	NA		
Comment:			
Location Details:		Direction of Survey:	Downstream
US MH:	M-305-027	DS MH:	M-305-026
		Total Length Surveyed (ft):	286.3

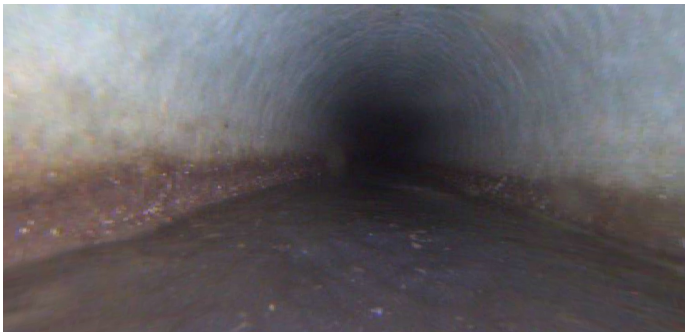
Code:	MWLS
Description:	Water Level Sag

Distance (ft):	19.4
Structural Grade:	2
O&M Grade:	3
Clock Start/From:	
Clock To:	
1st Value:	
2nd Value:	
Value Percent:	15.000
Continuous Index:	
Within 8" of Joint:	NO
Remarks:

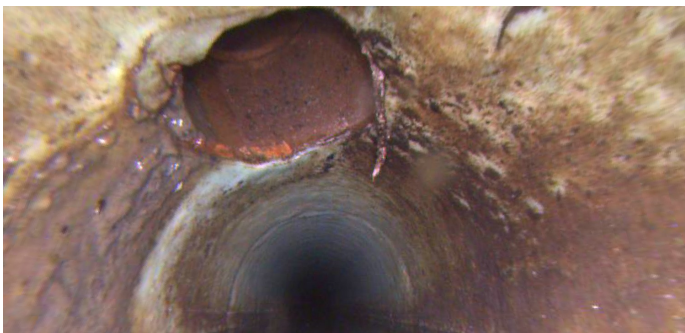
Code: **TB**
Description: **Tap Break-in**

Distance (ft): **33.0**
Structural Grade: **0**
O&M Grade: **0**
Clock Start/From: **12**
Clock To:
1st Value: **4.000**
2nd Value:
Value Percent:
Continuous Index:
Within 8" of Joint:
Remarks:

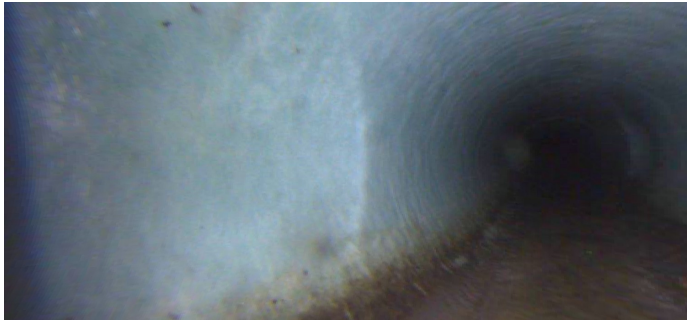
Code:	LFAC
Description:	Lining Failure Abandoned Connection
Distance (ft):	44.7
Structural Grade:	0
O&M Grade:	0
Clock Start/From:	9
Clock To:	
1st Value:	
2nd Value:	
Value Percent:	
Continuous Index:	
Within 8" of Joint:	NO
Remarks:

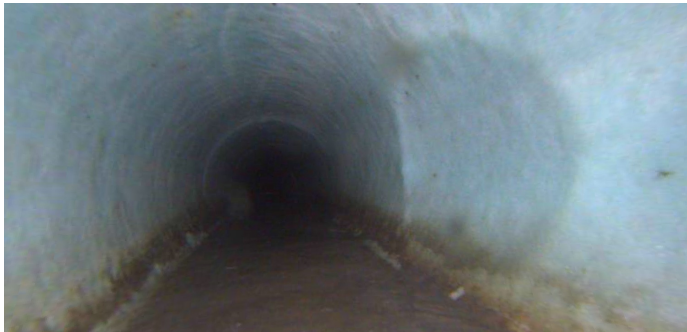
Code:	LFAC
Description:	Lining Failure Abandoned Connection
Distance (ft):	46.5
Structural Grade:	0
O&M Grade:	0
Clock Start/From:	3
Clock To:	
1st Value:	
2nd Value:	
Value Percent:	
Continuous Index:	
Within 8" of Joint:	NO
Remarks:

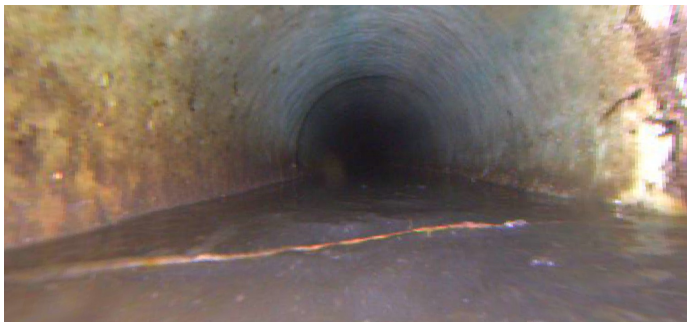
Code: **MGO**
Description: **General Observation**

Distance (ft): **52.4**
Structural Grade: **0**
O&M Grade: **0**
Clock Start/From:
Clock To:
1st Value:
2nd Value:
Value Percent:
Continuous Index:
Within 8" of Joint: **NO**
Remarks: **STICK OR ROOT**

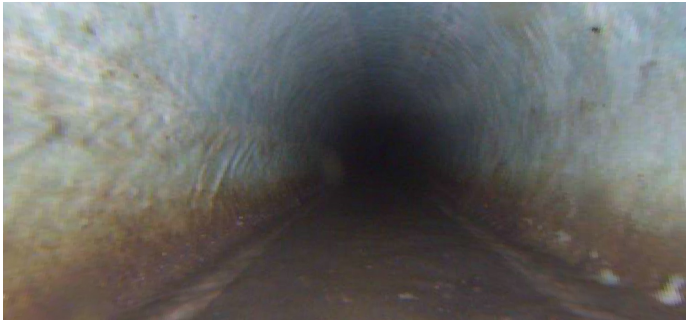
Code: **LFW**
Description: **Lining Failure Wrinkled**

Distance (ft): **72.1**
Structural Grade: **3**
O&M Grade: **0**
Clock Start/From: **9**
Clock To:
1st Value:
2nd Value:
Value Percent:
Continuous Index: **S02**
Within 8" of Joint: **NO**
Remarks: **WANDER**

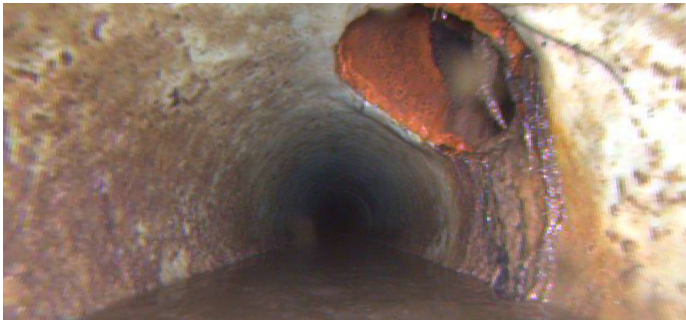
Code: **RFC**
Description: **Roots Fine Connection**

Distance (ft): **182.8**
Structural Grade: **0**
O&M Grade: **1**
Clock Start/From: **2**
Clock To: **5**
1st Value:
2nd Value:
Value Percent:
Continuous Index:
Within 8" of Joint: **NO**
Remarks:

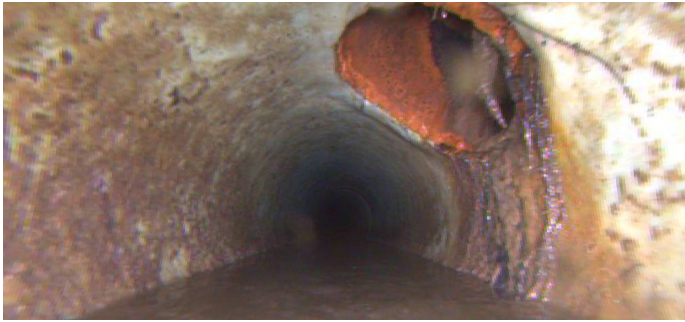
Code: **TFD**
Description: **Tap Factory Defective**

Distance (ft): **182.8**
Structural Grade: **0**
O&M Grade: **2**
Clock Start/From: **2**
Clock To:
1st Value: **4.000**
2nd Value:
Value Percent:
Continuous Index:
Within 8" of Joint:
Remarks: **ROOTS COMING FROM TAP**

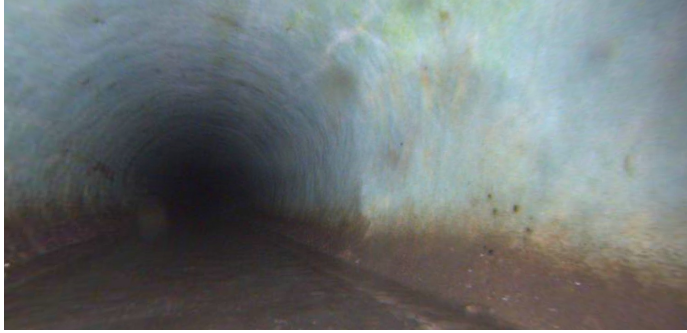
Code:	LFAC
Description:	Lining Failure Abandoned Connection
Distance (ft):	214.1
Structural Grade:	0
O&M Grade:	0
Clock Start/From:	3
Clock To:	
1st Value:	
2nd Value:	
Value Percent:	
Continuous Index:	
Within 8" of Joint:	NO
Remarks:

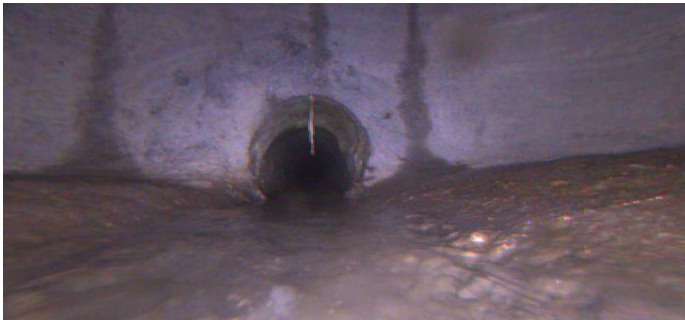
Code: **LFW**
Description: **Lining Failure Wrinkled**

Distance (ft): **286.3**
Structural Grade: **3**
O&M Grade: **0**
Clock Start/From: **9**
Clock To:
1st Value:
2nd Value:
Value Percent:
Continuous Index: **F02**
Within 8" of Joint: **NO**
Remarks: **WANDER**
