## Profile/Photo Observation Report

Street:	<b>FOXCROFT STREET</b>	Flow Control:	<b>Not Controlled</b>
City:	<b>Hobart, IN</b>	Year Renewed:	
Location:	<b>Yard</b>	Tape/Media #:	
Purpose:	<b>Routine Assessment</b>	Dia/Height:	<b>10"</b>
Use:	<b>Sanitary</b>	Material:	<b>PVC</b>
Drain Area:	<b>NA</b>	Lining:	<b>Cured in Place</b>
Category:	<b>NA</b>		
Comment:

Location Details:		Direction of Survey:	<b>Downstream</b>
US MH:	<b>M-305-027</b>	DS MH:	<b>M-305-026</b>
		Total Length Surveyed (ft):	<b>286.3</b>

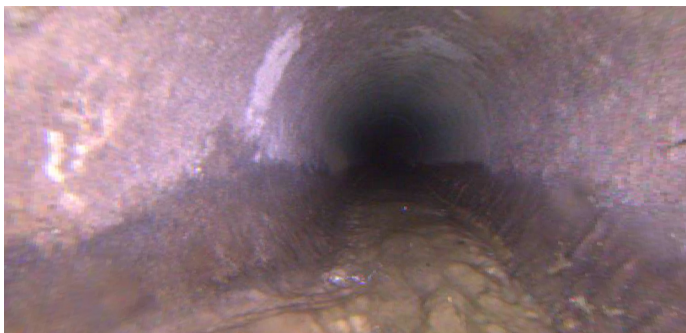
Code: **AMH**  
Description: **Manhole**

Distance (ft): **.0**  
Structural Grade: **0**  
O&M Grade: **0**  
Clock Start/From:  
Clock To:  
1st Value:  
2nd Value:  
Value Percent:  
Continuous Index:  
Within 8" of Joint: **NO**  
Remarks: **M-305-027**

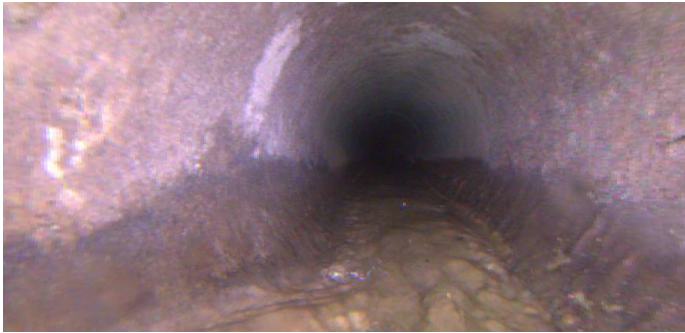
Code:	<b>MWL</b>
Description:	<b>Water Level</b>

Distance (ft):	<b>.0</b>
Structural Grade:	<b>0</b>
O&M Grade:	<b>0</b>
Clock Start/From:	
Clock To:	
1st Value:	
2nd Value:	
Value Percent:	<b>5.000</b>
Continuous Index:	
Within 8" of Joint:	<b>NO</b>
Remarks:

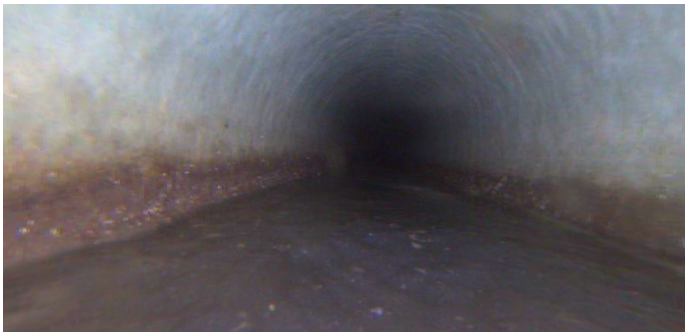
Code:	<b>MWLS</b>
Description:	<b>Water Level Sag</b>

Distance (ft):	<b>19.4</b>
Structural Grade:	<b>2</b>
O&M Grade:	<b>3</b>
Clock Start/From:	
Clock To:	
1st Value:	
2nd Value:	
Value Percent:	<b>15.000</b>
Continuous Index:	
Within 8" of Joint:	<b>NO</b>
Remarks:

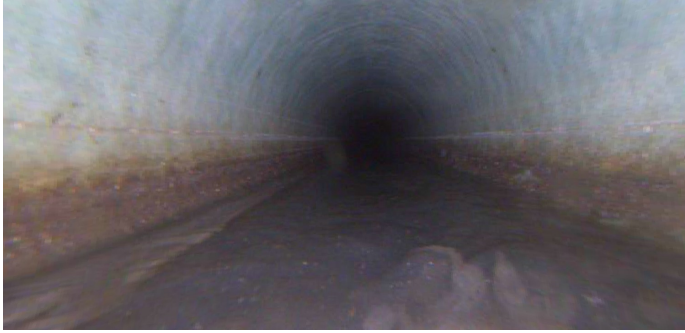
Code: **MWL**  
Description: **Water Level**

Distance (ft): **27.1**  
Structural Grade: **0**  
O&M Grade: **0**  
Clock Start/From:  
Clock To:  
1st Value:  
2nd Value:  
Value Percent: **15.000**  
Continuous Index:  
Within 8" of Joint: **NO**  
Remarks:

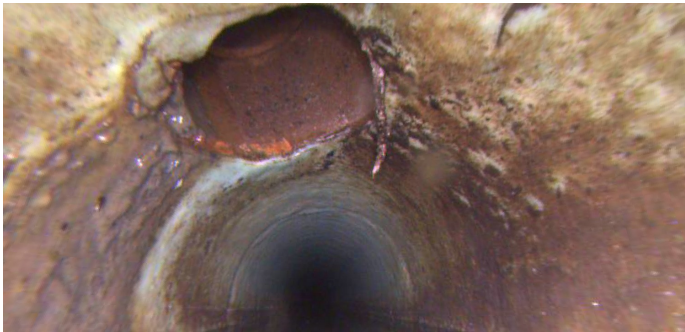
Code: **TB**  
Description: **Tap Break-in**

Distance (ft): **33.0**  
Structural Grade: **0**  
O&M Grade: **0**  
Clock Start/From: **12**  
Clock To:  
1st Value: **4.000**  
2nd Value:  
Value Percent:  
Continuous Index:  
Within 8" of Joint:  
Remarks:

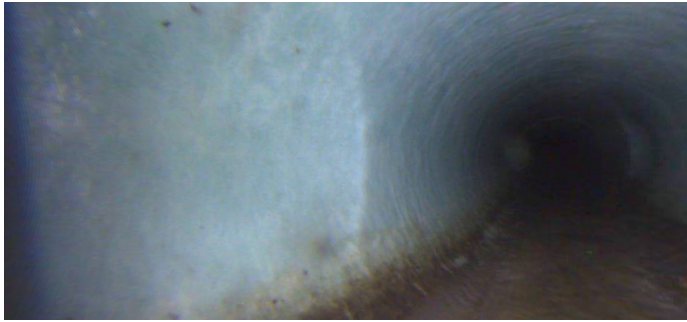
Code:	<b>LFAC</b>
Description:	<b>Lining Failure Abandoned Connection</b>
Distance (ft):	<b>44.7</b>
Structural Grade:	<b>0</b>
O&M Grade:	<b>0</b>
Clock Start/From:	<b>9</b>
Clock To:	
1st Value:	
2nd Value:	
Value Percent:	
Continuous Index:	
Within 8" of Joint:	<b>NO</b>
Remarks:

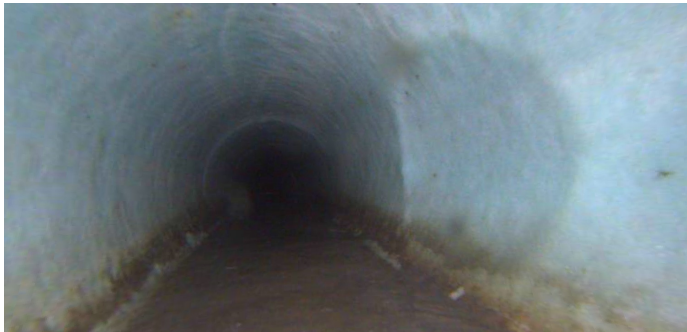
Code:	<b>LFAC</b>
Description:	<b>Lining Failure Abandoned Connection</b>
Distance (ft):	<b>46.5</b>
Structural Grade:	<b>0</b>
O&M Grade:	<b>0</b>
Clock Start/From:	<b>3</b>
Clock To:	
1st Value:	
2nd Value:	
Value Percent:	
Continuous Index:	
Within 8" of Joint:	<b>NO</b>
Remarks:

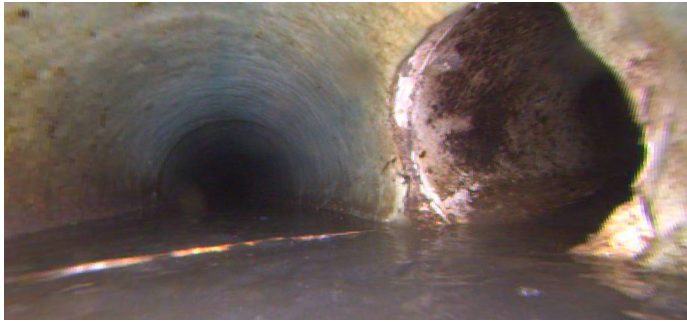
Code: **TFA**  
Description: **Tap Factory Active**

Distance (ft): **52.2**  
Structural Grade: **0**  
O&M Grade: **0**  
Clock Start/From: **3**  
Clock To:  
1st Value: **4.000**  
2nd Value:  
Value Percent:  
Continuous Index:  
Within 8" of Joint:  
Remarks:

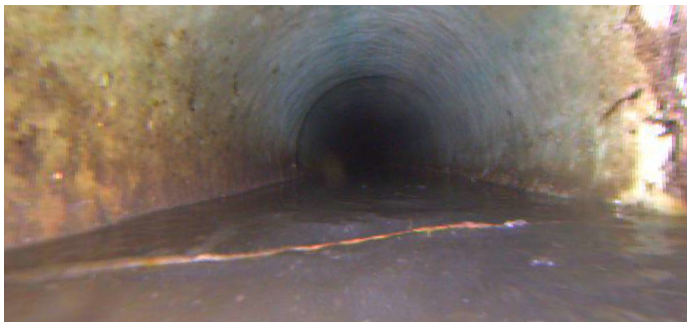
Code: **MGO**  
Description: **General Observation**

Distance (ft): **52.4**  
Structural Grade: **0**  
O&M Grade: **0**  
Clock Start/From:  
Clock To:  
1st Value:  
2nd Value:  
Value Percent:  
Continuous Index:  
Within 8" of Joint: **NO**  
Remarks: **STICK OR ROOT**

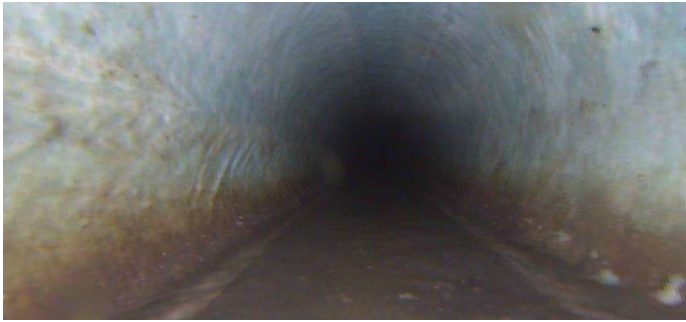
Code: **LFW**  
Description: **Lining Failure Wrinkled**

Distance (ft): **72.1**  
Structural Grade: **3**  
O&M Grade: **0**  
Clock Start/From: **9**  
Clock To:  
1st Value:  
2nd Value:  
Value Percent:  
Continuous Index: **S02**  
Within 8" of Joint: **NO**  
Remarks: **WANDER**

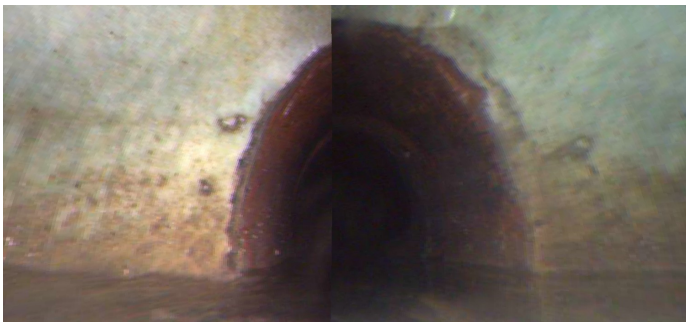
Code: **TFA**  
Description: **Tap Factory Active**

Distance (ft): **130.6**  
Structural Grade: **0**  
O&M Grade: **0**  
Clock Start/From: **3**  
Clock To:  
1st Value: **4.000**  
2nd Value:  
Value Percent:  
Continuous Index:  
Within 8" of Joint:  
Remarks:

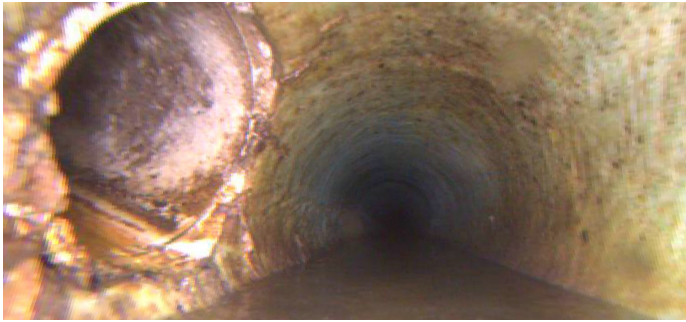
Code: **TF**  
Description: **Tap Factory**

Distance (ft): **133.7**  
Structural Grade: **0**  
O&M Grade: **0**  
Clock Start/From: **9**  
Clock To:  
1st Value: **4.000**  
2nd Value:  
Value Percent:  
Continuous Index:  
Within 8" of Joint:  
Remarks:

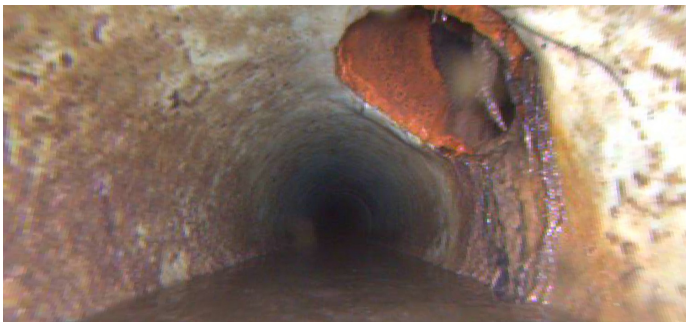
Code: **RFC**  
Description: **Roots Fine Connection**

Distance (ft): **182.8**  
Structural Grade: **0**  
O&M Grade: **1**  
Clock Start/From: **2**  
Clock To: **5**  
1st Value:  
2nd Value:  
Value Percent:  
Continuous Index:  
Within 8" of Joint: **NO**  
Remarks:

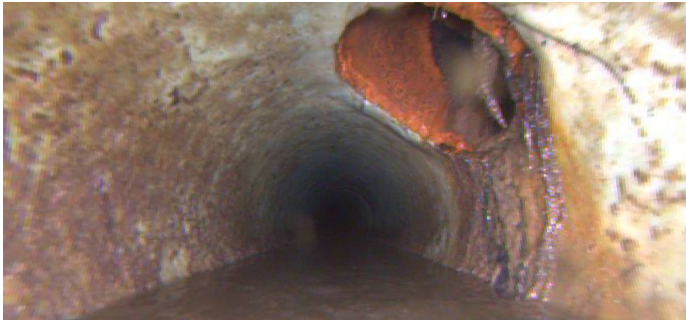
Code: **TFD**  
Description: **Tap Factory Defective**

Distance (ft): **182.8**  
Structural Grade: **0**  
O&M Grade: **2**  
Clock Start/From: **2**  
Clock To:  
1st Value: **4.000**  
2nd Value:  
Value Percent:  
Continuous Index:  
Within 8" of Joint:  
Remarks: **ROOTS COMING FROM TAP**

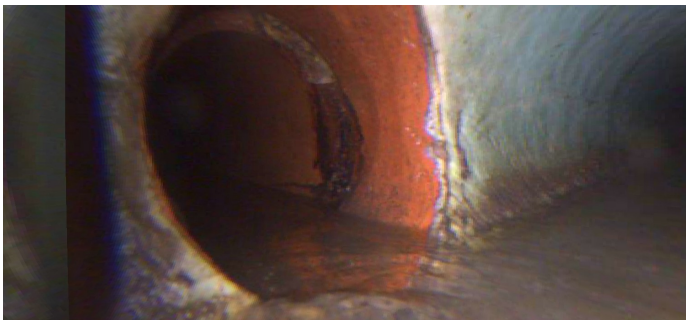
Code: **TF**  
Description: **Tap Factory**

Distance (ft): **212.2**  
Structural Grade: **0**  
O&M Grade: **0**  
Clock Start/From: **9**  
Clock To:  
1st Value: **4.000**  
2nd Value:  
Value Percent:  
Continuous Index:  
Within 8" of Joint:  
Remarks:

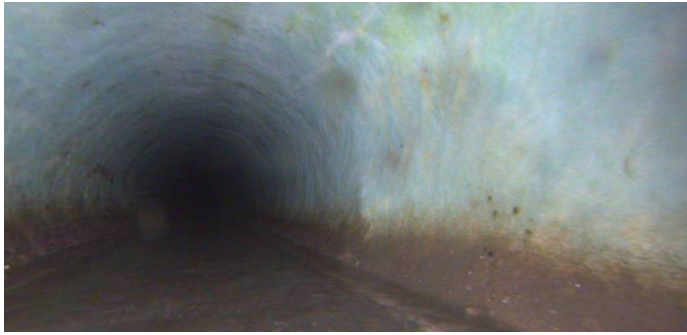
Code:	<b>LFAC</b>
Description:	<b>Lining Failure Abandoned Connection</b>
Distance (ft):	<b>214.1</b>
Structural Grade:	<b>0</b>
O&M Grade:	<b>0</b>
Clock Start/From:	<b>3</b>
Clock To:	
1st Value:	
2nd Value:	
Value Percent:	
Continuous Index:	
Within 8" of Joint:	<b>NO</b>
Remarks:

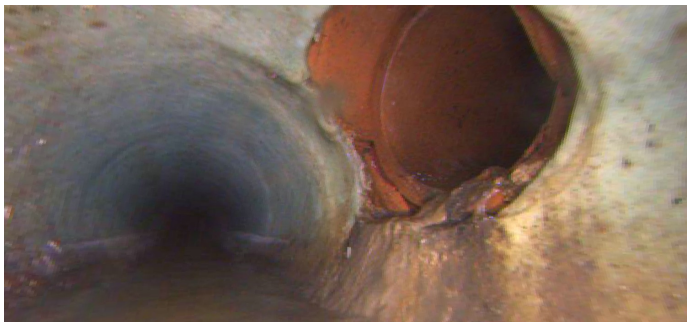
Code:	<b>TF</b>
Description:	<b>Tap Factory</b>
Distance (ft):	<b>274.2</b>
Structural Grade:	<b>0</b>
O&M Grade:	<b>0</b>
Clock Start/From:	<b>3</b>
Clock To:	
1st Value:	<b>4.000</b>
2nd Value:	
Value Percent:	
Continuous Index:	
Within 8" of Joint:	
Remarks:

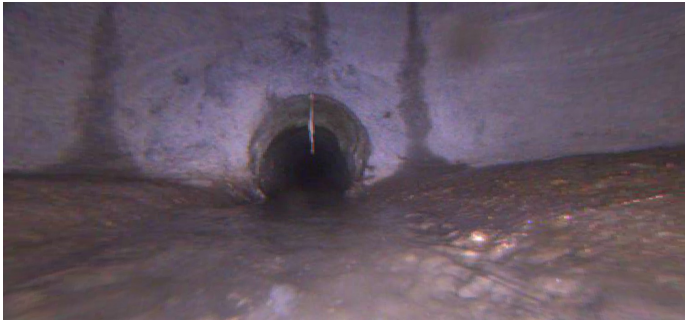
Code: **AMH**  
Description: **Manhole**

Distance (ft): **286.3**  
Structural Grade: **0**  
O&M Grade: **0**  
Clock Start/From:  
Clock To:  
1st Value:  
2nd Value:  
Value Percent:  
Continuous Index:  
Within 8" of Joint: **NO**  
Remarks: **M-305-026**

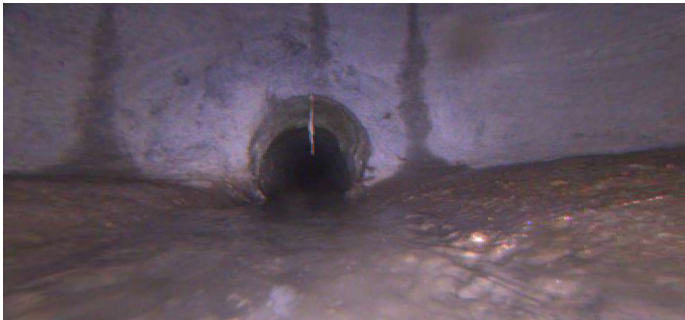
Code: **LFW**  
Description: **Lining Failure Wrinkled**

Distance (ft): **286.3**  
Structural Grade: **3**  
O&M Grade: **0**  
Clock Start/From: **9**  
Clock To:  
1st Value:  
2nd Value:  
Value Percent:  
Continuous Index: **F02**  
Within 8" of Joint: **NO**  
Remarks: **WANDER**
