Profile/Photo Observation Report

Date:	04/19/2018	Weather:		Coding:	PACP 6.0
Pipe Length (ft):	268.7	Owner:	NA	Pre Clean:	No Pre-Cleaning
P.O.#:		Surveyor:	Byrd Fitzgerald	PSR:	P-305-028-027
Customer:		Clean Date:	01/01/1900	Shape:	C

Street:	ALLEY BETWEEN CROWSNEST DR &	Flow Control:	Not Controlled
City:	Hobart, IN	Year Renewed:	
Location:	Yard	Tape/Media #:	
Purpose:	Routine Assessment	Dia/Height:	10"
Use:	Sanitary	Material:	XXX
Drain Area:	NA	Lining:	Cured in Place
Category:	NA		
Comment:

Location Details:		Direction of Survey:	Upstream
US MH:	M-305-028	DS MH:	M-305-027
		Total Length Surveyed (ft):	270.0

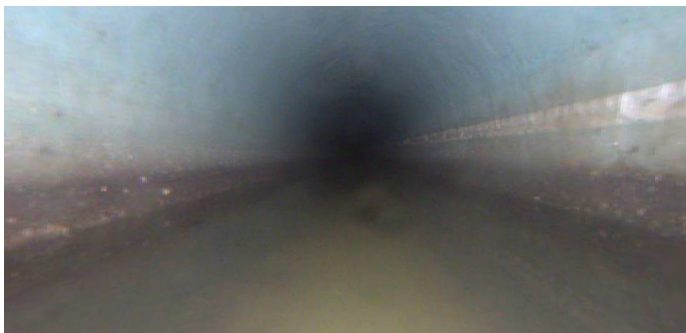
Code: **AMH**
Description: **Manhole**

Distance (ft): **.0**
Structural Grade: **0**
O&M Grade: **0**
Clock Start/From:
Clock To:
1st Value:
2nd Value:
Value Percent:
Continuous Index:
Within 8" of Joint: **NO**
Remarks: **M-305-027**

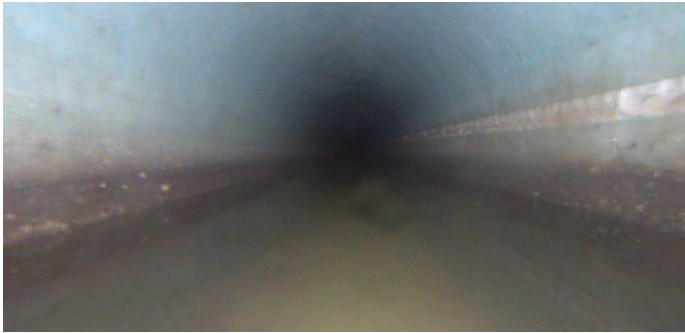
Code:	MWL
Description:	Water Level

Distance (ft):	.0
Structural Grade:	0
O&M Grade:	0
Clock Start/From:	
Clock To:	
1st Value:	
2nd Value:	
Value Percent:	10.000
Continuous Index:	
Within 8" of Joint:	NO
Remarks:

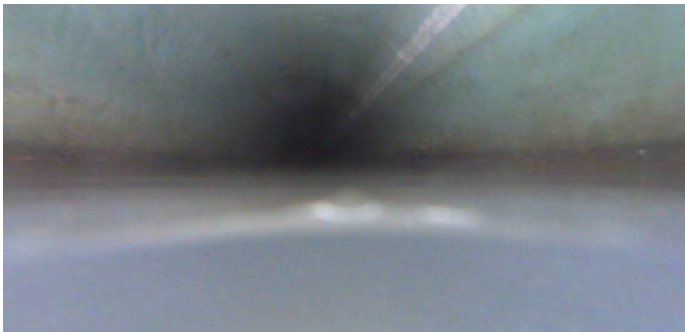
Code:	MWL
Description:	Water Level

Distance (ft):	18.0
Structural Grade:	0
O&M Grade:	0
Clock Start/From:	
Clock To:	
1st Value:	
2nd Value:	
Value Percent:	25.000
Continuous Index:	
Within 8" of Joint:	NO
Remarks:

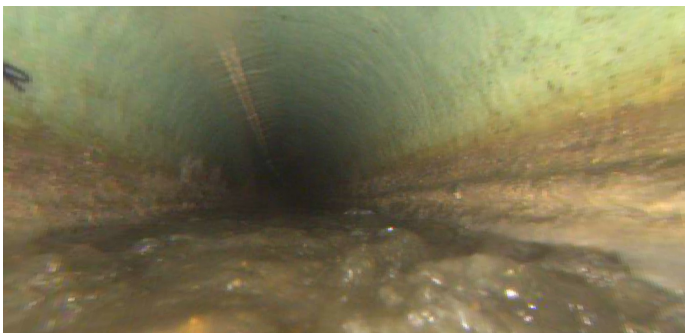
Code: **MGO**
Description: **General Observation**

Distance (ft): **35.5**
Structural Grade: **0**
O&M Grade: **0**
Clock Start/From:
Clock To:
1st Value:
2nd Value:
Value Percent:
Continuous Index:
Within 8" of Joint: **NO**
Remarks: **rear camera/mcu**

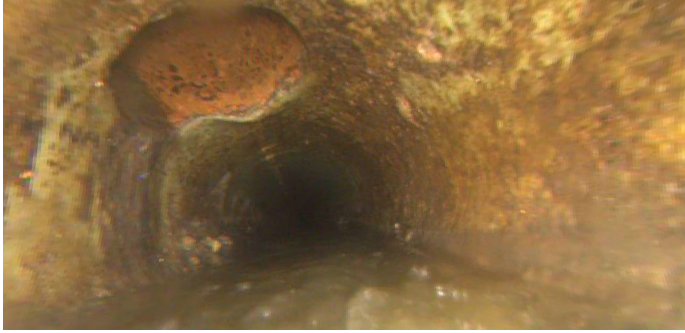
Code: **TB**
Description: **Tap Break-in**

Distance (ft): **41.3**
Structural Grade: **0**
O&M Grade: **0**
Clock Start/From: **1**
Clock To:
1st Value: **4.000**
2nd Value:
Value Percent:
Continuous Index:
Within 8" of Joint:
Remarks:

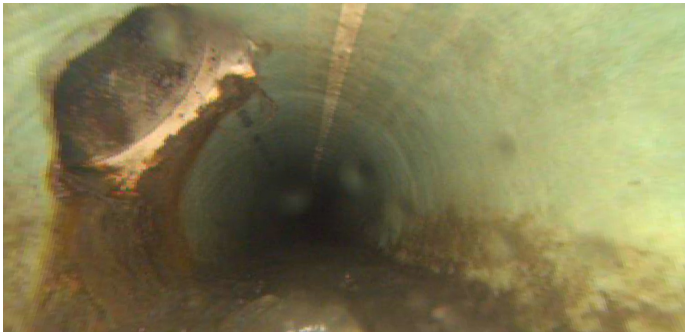
Code: **TB**
Description: **Tap Break-in**

Distance (ft): **123.6**
Structural Grade: **0**
O&M Grade: **0**
Clock Start/From: **2**
Clock To:
1st Value: **4.000**
2nd Value:
Value Percent:
Continuous Index:
Within 8" of Joint:
Remarks:

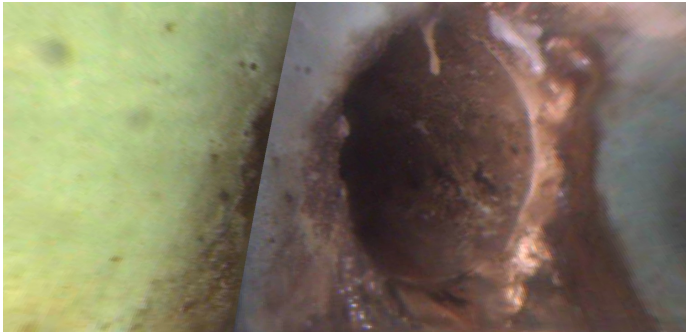
Code: **TB**
Description: **Tap Break-in**

Distance (ft): **131.8**
Structural Grade: **0**
O&M Grade: **0**
Clock Start/From: **10**
Clock To:
1st Value: **4.000**
2nd Value:
Value Percent:
Continuous Index:
Within 8" of Joint:
Remarks:

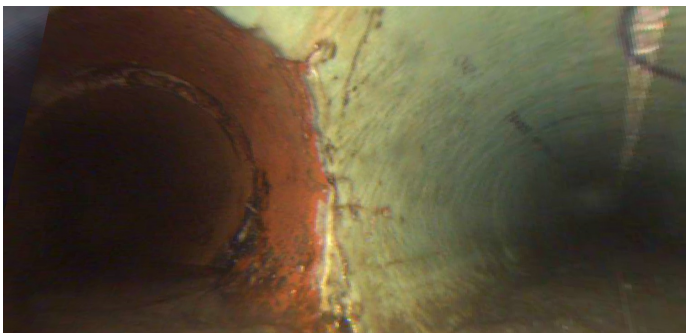
Code: **TB**
Description: **Tap Break-in**

Distance (ft): **190.2**
Structural Grade: **0**
O&M Grade: **0**
Clock Start/From: **3**
Clock To:
1st Value: **4.000**
2nd Value:
Value Percent:
Continuous Index:
Within 8" of Joint:
Remarks:

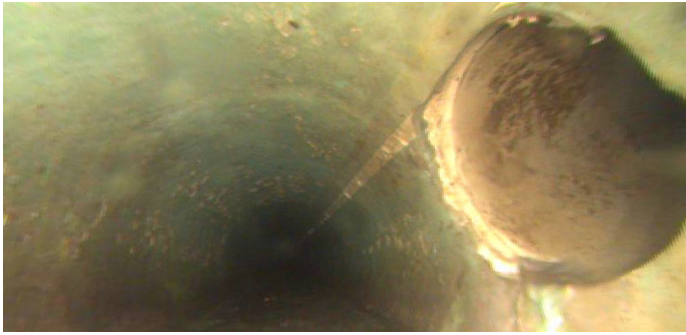
Code: **TB**
Description: **Tap Break-in**

Distance (ft): **216.9**
Structural Grade: **0**
O&M Grade: **0**
Clock Start/From: **10**
Clock To:
1st Value: **4.000**
2nd Value:
Value Percent:
Continuous Index:
Within 8" of Joint:
Remarks:

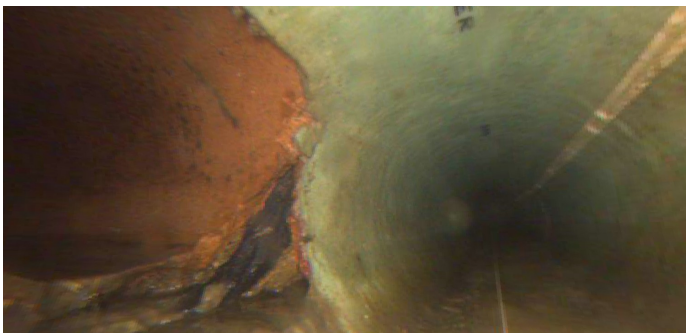
Code: **TB**
Description: **Tap Break-in**

Distance (ft): **259.5**
Structural Grade: **0**
O&M Grade: **0**
Clock Start/From: **9**
Clock To:
1st Value: **4.000**
2nd Value:
Value Percent:
Continuous Index:
Within 8" of Joint:
Remarks:

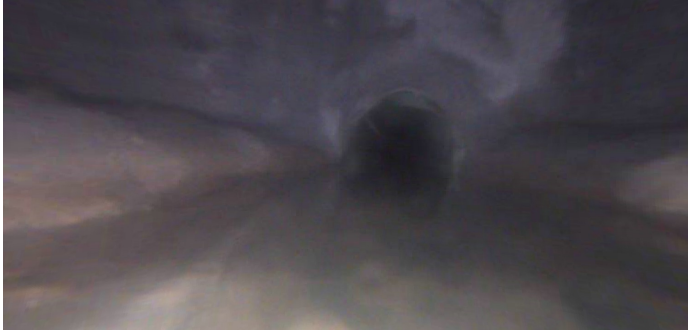
Code:	AMH
Description:	Manhole
Distance (ft):	270.0
Structural Grade:	0
O&M Grade:	0
Clock Start/From:	
Clock To:	
1st Value:	
2nd Value:	
Value Percent:	
Continuous Index:	
Within 8" of Joint:	NO
Remarks:	M-305-028
