Profile/Photo Observation Report

Date:	04/17/2018	Weather:		Coding:	PACP 6.0
Pipe Length (ft):	278.5	Owner:	NA	Pre Clean:	No Pre-Cleaning
P.O.#:		Surveyor:	Justin Gonzales	PSR:	P-305-029-028
Customer:		Clean Date:	01/01/1900	Shape:	C

Street:	WILDROSE DR	Flow Control:	Not Controlled
City:	Hobart, IN	Year Renewed:	
Location:	Sidewalk	Tape/Media #:	
Purpose:	Routine Assessment	Dia/Height:	10"
Use:	Sanitary	Material:	PVC
Drain Area:	NA	Lining:	Cured in Place
Category:	NA		
Comment:

Location Details:		Direction of Survey:	Downstream
US MH:	M-305-029	DS MH:	M-305-028
		Total Length Surveyed (ft):	267.8

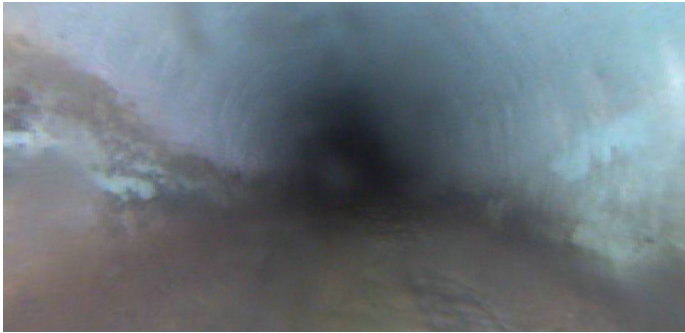
Code:	MWL
Description:	Water Level

Distance (ft):	.0
Structural Grade:	0
O&M Grade:	0
Clock Start/From:	
Clock To:	
1st Value:	
2nd Value:	
Value Percent:	10.000
Continuous Index:	
Within 8" of Joint:	NO
Remarks:

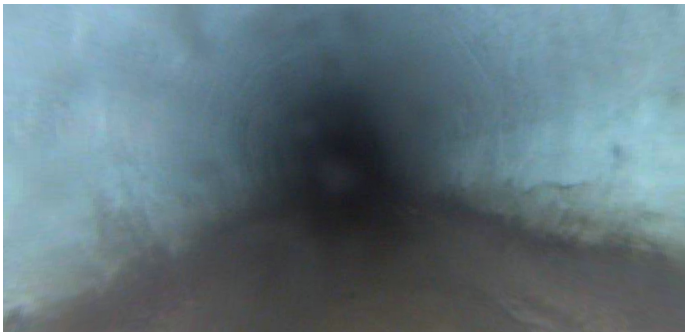
Code:	DAZ
Description:	Deposits Attached Other

Distance (ft):	5.1
Structural Grade:	0
O&M Grade:	2
Clock Start/From:	7
Clock To:	5
1st Value:	
2nd Value:	
Value Percent:	5.000
Continuous Index:	S01
Within 8" of Joint:	YES
Remarks:	WANDER

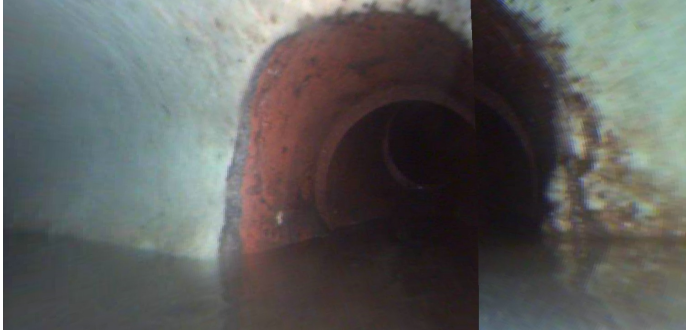
Code: **TF**
Description: **Tap Factory**

Distance (ft): **104.7**
Structural Grade: **0**
O&M Grade: **0**
Clock Start/From: **3**
Clock To:
1st Value: **4.000**
2nd Value:
Value Percent:
Continuous Index:
Within 8" of Joint:
Remarks:

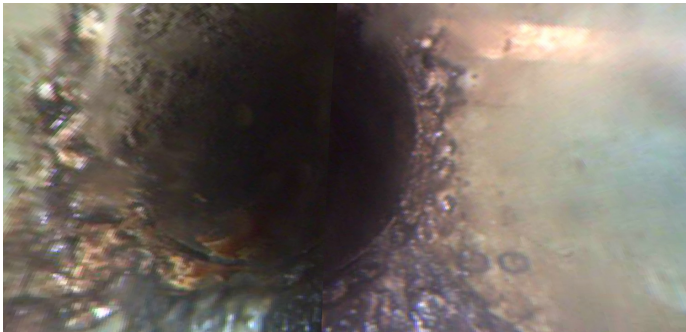
Code: **TF**
Description: **Tap Factory**

Distance (ft): **123.9**
Structural Grade: **0**
O&M Grade: **0**
Clock Start/From: **10**
Clock To:
1st Value: **4.000**
2nd Value:
Value Percent:
Continuous Index:
Within 8" of Joint:
Remarks:

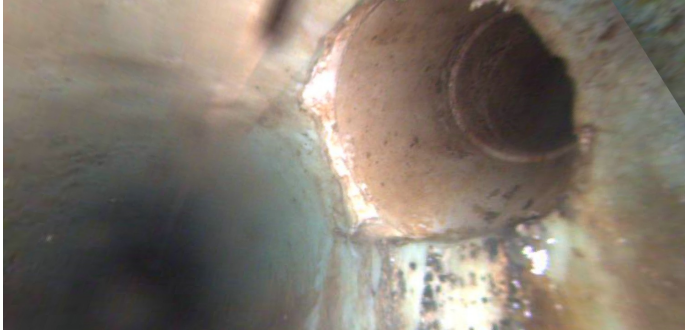
Code: **TF**
Description: **Tap Factory**

Distance (ft): **173.6**
Structural Grade: **0**
O&M Grade: **0**
Clock Start/From: **2**
Clock To:
1st Value: **4.000**
2nd Value:
Value Percent:
Continuous Index:
Within 8" of Joint:
Remarks:

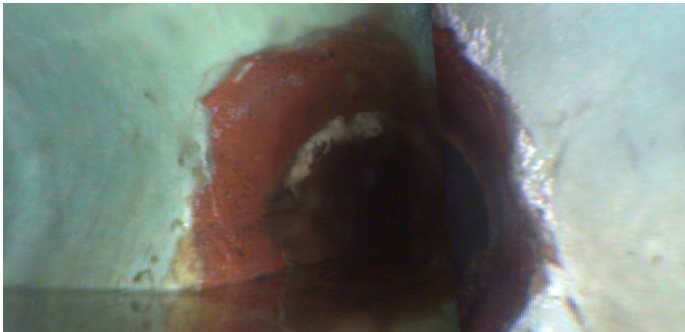
Code: **TF**
Description: **Tap Factory**

Distance (ft): **186.1**
Structural Grade: **0**
O&M Grade: **0**
Clock Start/From: **9**
Clock To:
1st Value: **4.000**
2nd Value:
Value Percent:
Continuous Index:
Within 8" of Joint:
Remarks:

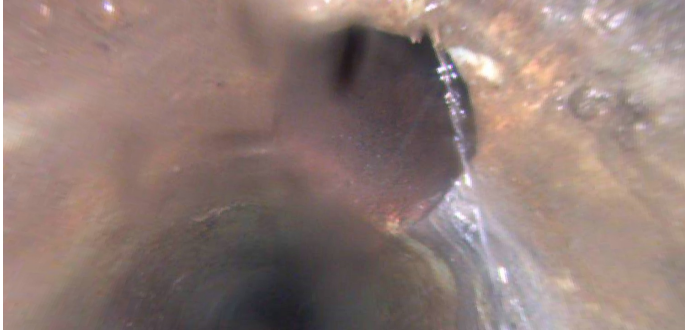
Code: **TFA**
Description: **Tap Factory Active**

Distance (ft): **256.9**
Structural Grade: **0**
O&M Grade: **0**
Clock Start/From: **2**
Clock To:
1st Value: **4.000**
2nd Value:
Value Percent:
Continuous Index:
Within 8" of Joint:
Remarks:

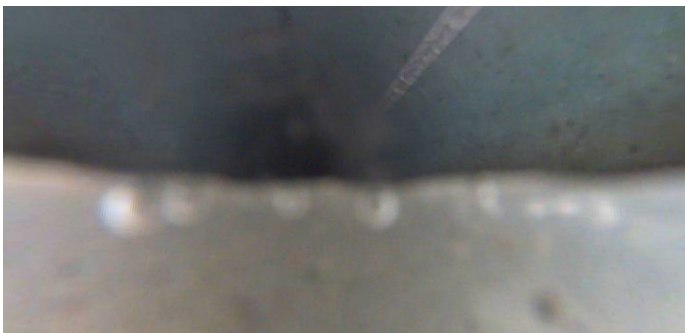
Code: **MWLS**
Description: **Water Level Sag**

Distance (ft): **258.6**
Structural Grade: **3**
O&M Grade: **3**
Clock Start/From:
Clock To:
1st Value:
2nd Value:
Value Percent: **50.000**
Continuous Index:
Within 8" of Joint: **NO**
Remarks:

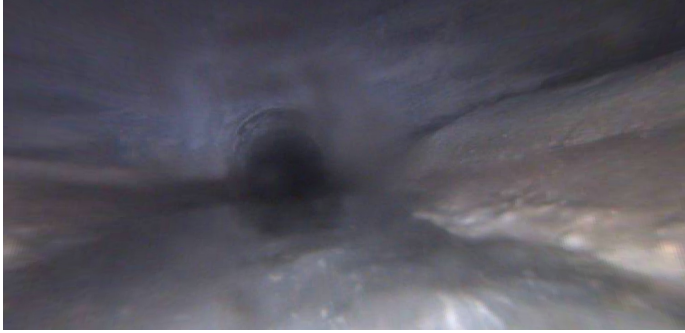
Code: **AMH**
Description: **Manhole**

Distance (ft): **267.8**
Structural Grade: **0**
O&M Grade: **0**
Clock Start/From:
Clock To:
1st Value:
2nd Value:
Value Percent:
Continuous Index:
Within 8" of Joint: **NO**
Remarks: **M-305-028**

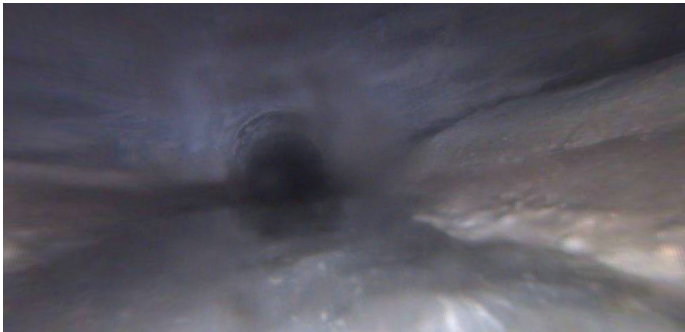
Code: **DAZ**
Description: **Deposits Attached Other**

Distance (ft): **267.8**
Structural Grade: **0**
O&M Grade: **2**
Clock Start/From: **7**
Clock To: **5**
1st Value:
2nd Value:
Value Percent: **5.000**
Continuous Index: **F01**
Within 8" of Joint: **YES**
Remarks: **WANDER**
