## Profile/Photo Observation Report

Street:	<b>FOXCROFT STREET</b>	Flow Control:	<b>Not Controlled</b>
City:	<b>Hobart, IN</b>	Year Renewed:	
Location:	<b>Sidewalk</b>	Tape/Media #:	
Purpose:	<b>Routine Assessment</b>	Dia/Height:	<b>10"</b>
Use:	<b>Sanitary</b>	Material:	<b>PVC</b>
Drain Area:	<b>NA</b>	Lining:	<b>Cured in Place</b>
Category:	<b>NA</b>		
Comment:

Location Details:		Direction of Survey:	<b>Downstream</b>
US MH:	<b>M-305-029</b>	DS MH:	<b>M-305-028</b>
		Total Length Surveyed (ft):	<b>267.8</b>

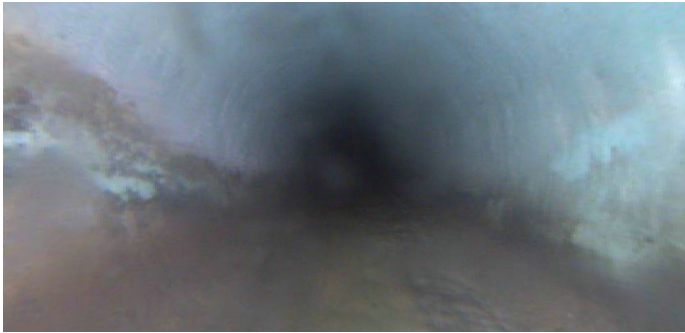
Code:	<b>MWL</b>
Description:	<b>Water Level</b>

Distance (ft):	<b>.0</b>
Structural Grade:	<b>0</b>
O&M Grade:	<b>0</b>
Clock Start/From:	
Clock To:	
1st Value:	
2nd Value:	
Value Percent:	<b>10.000</b>
Continuous Index:	
Within 8" of Joint:	<b>NO</b>
Remarks:

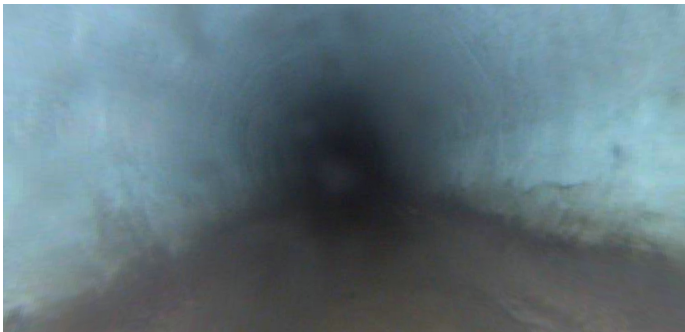
Code:	<b>DAZ</b>
Description:	<b>Deposits Attached Other</b>

Distance (ft):	<b>5.1</b>
Structural Grade:	<b>0</b>
O&M Grade:	<b>2</b>
Clock Start/From:	<b>7</b>
Clock To:	<b>5</b>
1st Value:	
2nd Value:	
Value Percent:	<b>5.000</b>
Continuous Index:	<b>S01</b>
Within 8" of Joint:	<b>YES</b>
Remarks:	<b>WANDER</b>

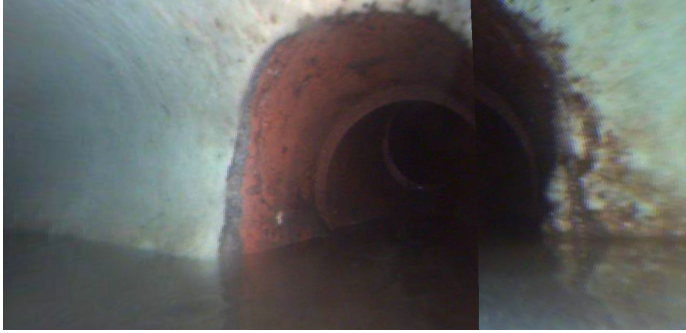
Code: **TF**  
Description: **Tap Factory**

Distance (ft): **104.7**  
Structural Grade: **0**  
O&M Grade: **0**  
Clock Start/From: **3**  
Clock To:  
1st Value: **4.000**  
2nd Value:  
Value Percent:  
Continuous Index:  
Within 8" of Joint:  
Remarks:

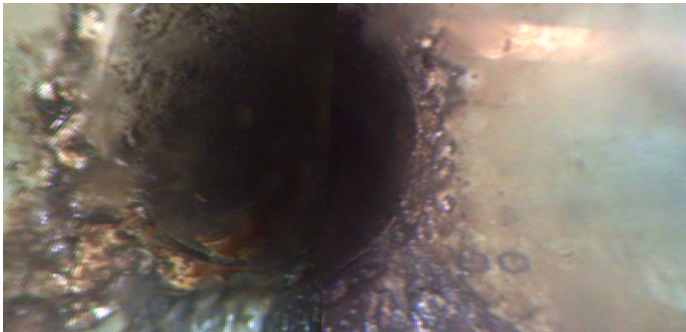
Code: **TF**  
Description: **Tap Factory**

Distance (ft): **123.9**  
Structural Grade: **0**  
O&M Grade: **0**  
Clock Start/From: **10**  
Clock To:  
1st Value: **4.000**  
2nd Value:  
Value Percent:  
Continuous Index:  
Within 8" of Joint:  
Remarks:

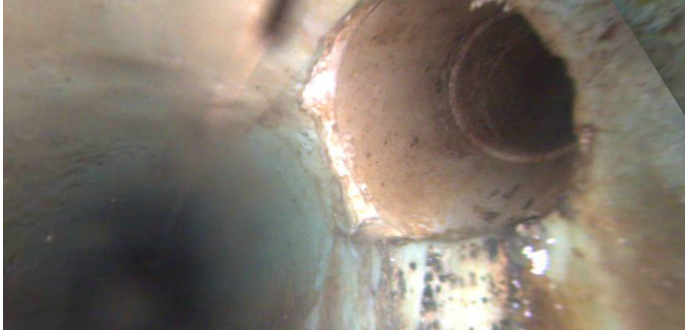
Code: **TF**  
Description: **Tap Factory**

Distance (ft): **173.6**  
Structural Grade: **0**  
O&M Grade: **0**  
Clock Start/From: **2**  
Clock To:  
1st Value: **4.000**  
2nd Value:  
Value Percent:  
Continuous Index:  
Within 8" of Joint:  
Remarks:

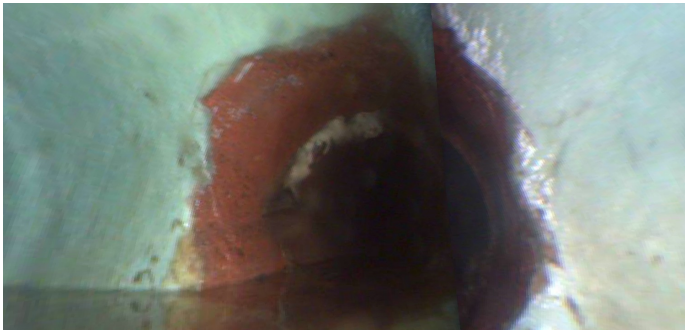
Code: **TF**  
Description: **Tap Factory**

Distance (ft): **186.1**  
Structural Grade: **0**  
O&M Grade: **0**  
Clock Start/From: **9**  
Clock To:  
1st Value: **4.000**  
2nd Value:  
Value Percent:  
Continuous Index:  
Within 8" of Joint:  
Remarks:

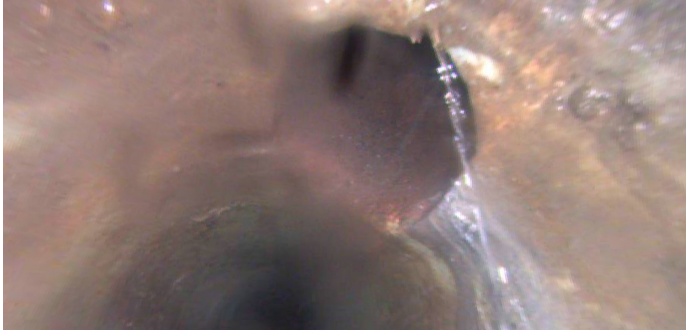
Code: **TFA**  
Description: **Tap Factory Active**

Distance (ft): **256.9**  
Structural Grade: **0**  
O&M Grade: **0**  
Clock Start/From: **2**  
Clock To:  
1st Value: **4.000**  
2nd Value:  
Value Percent:  
Continuous Index:  
Within 8" of Joint:  
Remarks:

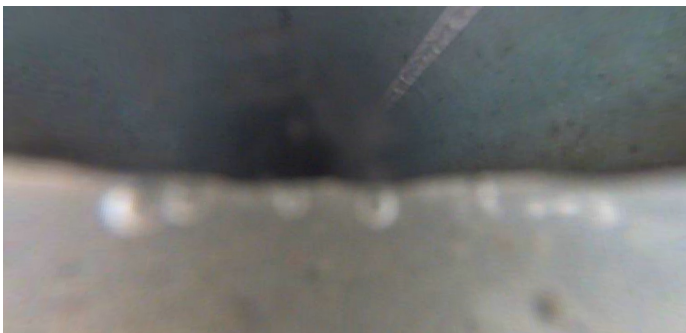
Code: **MWLS**  
Description: **Water Level Sag**

Distance (ft): **258.6**  
Structural Grade: **3**  
O&M Grade: **3**  
Clock Start/From:  
Clock To:  
1st Value:  
2nd Value:  
Value Percent: **50.000**  
Continuous Index:  
Within 8" of Joint: **NO**  
Remarks:

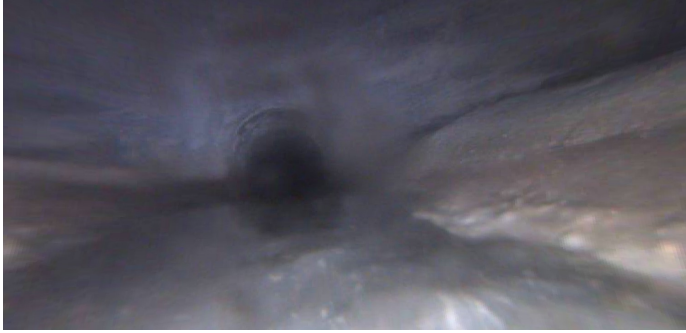
Code: **AMH**  
Description: **Manhole**

Distance (ft): **267.8**  
Structural Grade: **0**  
O&M Grade: **0**  
Clock Start/From:  
Clock To:  
1st Value:  
2nd Value:  
Value Percent:  
Continuous Index:  
Within 8" of Joint: **NO**  
Remarks: **M-305-028**

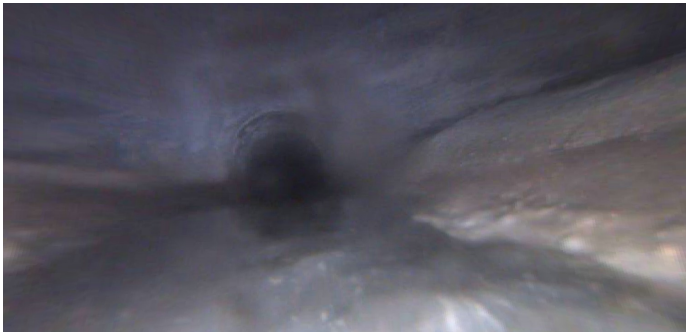
Code: **DAZ**  
Description: **Deposits Attached Other**

Distance (ft): **267.8**  
Structural Grade: **0**  
O&M Grade: **2**  
Clock Start/From: **7**  
Clock To: **5**  
1st Value:  
2nd Value:  
Value Percent: **5.000**  
Continuous Index: **F01**  
Within 8" of Joint: **YES**  
Remarks: **WANDER**
