Profile/Photo Observation Report

| Street: | CRABAPPLE LN & WILDROSE DR | Flow Control: | Not Controlled |
| City: | Hobart, IN | Year Renewed: | |
| US MH: | M-305-029 | DS MH: | M-305-037 |

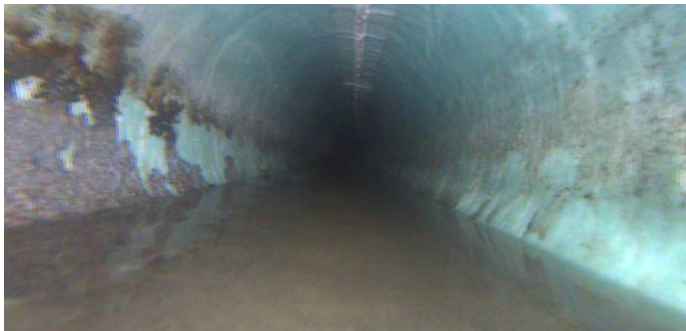
Code: **AMH**
Description: **Manhole**

Distance (ft): **.0**
Structural Grade: **0**
O&M Grade: **0**
Clock Start/From:
Clock To:
1st Value:
2nd Value:
Value Percent:
Continuous Index:
Within 8" of Joint: **NO**
Remarks: **M-305-029**

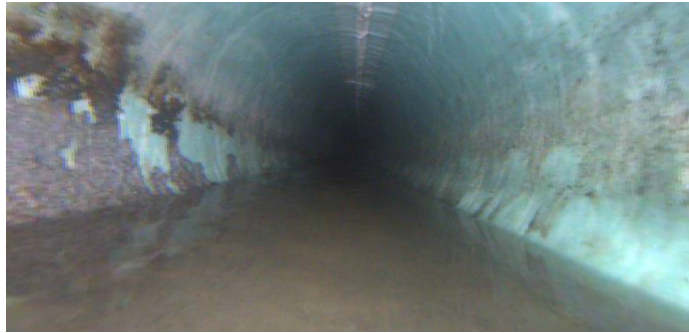
Code: **MWL**
Description: **Water Level**

Distance (ft): **.0**
Structural Grade: **0**
O&M Grade: **0**
Clock Start/From:
Clock To:
1st Value:
2nd Value:
Value Percent: **10.000**
Continuous Index:
Within 8" of Joint: **NO**
Remarks:

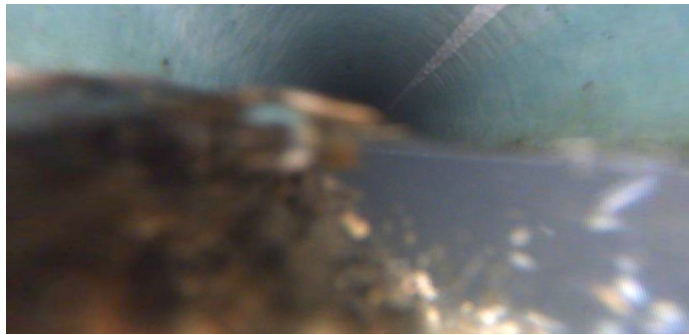
Code: **MWLS**
Description: **Water Level Sag**

Distance (ft): **39.6**
Structural Grade: **3**
O&M Grade: **3**
Clock Start/From:
Clock To:
1st Value:
2nd Value:
Value Percent: **40.000**
Continuous Index:
Within 8" of Joint: **NO**
Remarks:

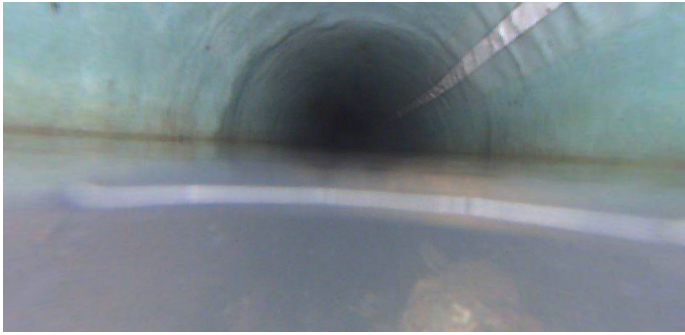
Code: **MWLS**
Description: **Water Level Sag**

Distance (ft): **47.8**
Structural Grade: **3**
O&M Grade: **3**
Clock Start/From:
Clock To:
1st Value:
2nd Value:
Value Percent: **45.000**
Continuous Index:
Within 8" of Joint: **NO**
Remarks:

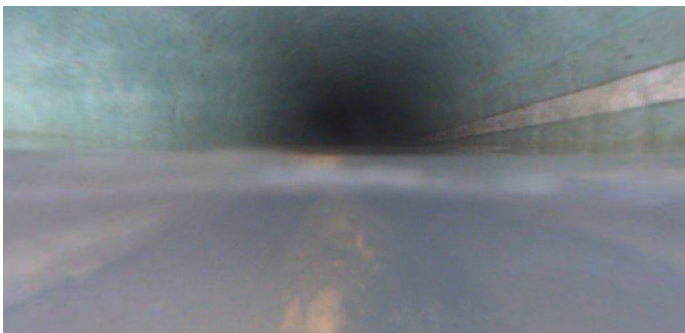
Code: **MWLS**
Description: **Water Level Sag**

Distance (ft): **66.7**
Structural Grade: **3**
O&M Grade: **3**
Clock Start/From:
Clock To:
1st Value:
2nd Value:
Value Percent: **45.000**
Continuous Index:
Within 8" of Joint: **NO**
Remarks:

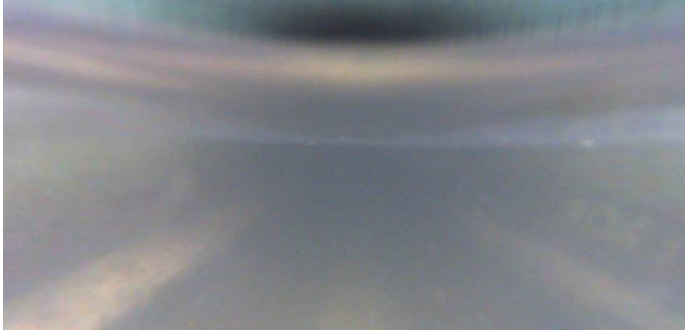
Code: **MWLS**
Description: **Water Level Sag**

Distance (ft): **96.1**
Structural Grade: **3**
O&M Grade: **3**
Clock Start/From:
Clock To:
1st Value:
2nd Value:
Value Percent: **50.000**
Continuous Index:
Within 8" of Joint: **NO**
Remarks:

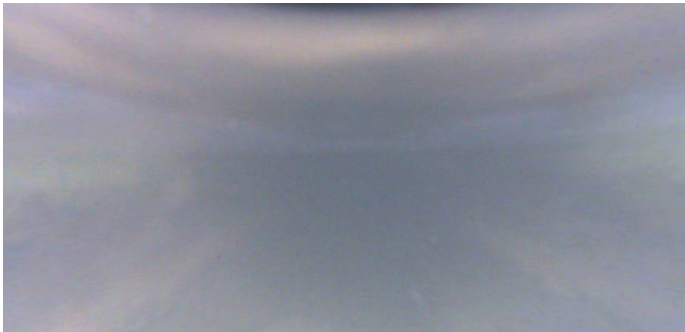
Code: **MCU**
Description: **Camera Underwater**

Distance (ft): **103.3**
Structural Grade: **0**
O&M Grade: **4**
Clock Start/From:
Clock To:
1st Value:
2nd Value:
Value Percent:
Continuous Index: **S03**
Within 8" of Joint: **NO**
Remarks:

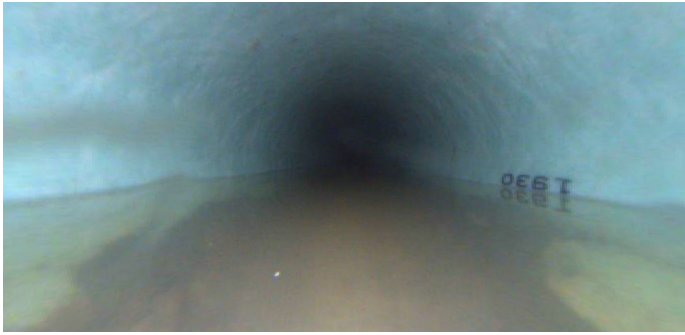
Code: **MCU**
Description: **Camera Underwater**

Distance (ft): **113.0**
Structural Grade: **0**
O&M Grade: **4**
Clock Start/From:
Clock To:
1st Value:
2nd Value:
Value Percent:
Continuous Index: **F03**
Within 8" of Joint: **NO**
Remarks: **EMERGED**

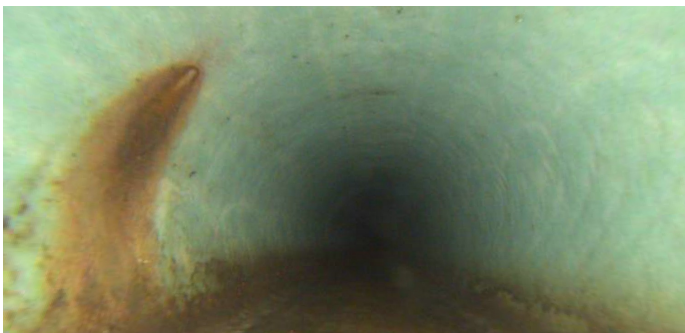
Code: **IS**
Description: **Infil Stain**

Distance (ft): **141.2**
Structural Grade: **0**
O&M Grade: **0**
Clock Start/From: **2**
Clock To: **3**
1st Value:
2nd Value:
Value Percent:
Continuous Index:
Within 8" of Joint:
Remarks:

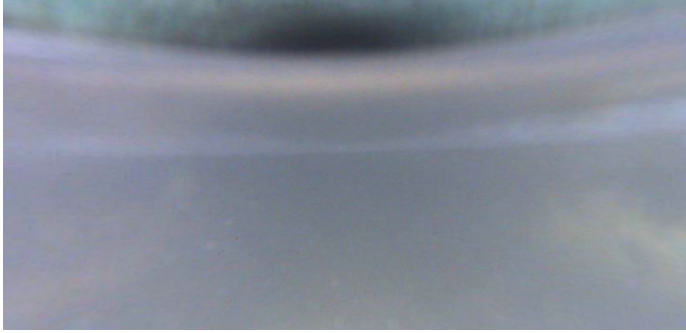
Code: **MWLS**
Description: **Water Level Sag**

Distance (ft): **146.8**
Structural Grade: **3**
O&M Grade: **3**
Clock Start/From:
Clock To:
1st Value:
2nd Value:
Value Percent: **50.000**
Continuous Index:
Within 8" of Joint: **NO**
Remarks:

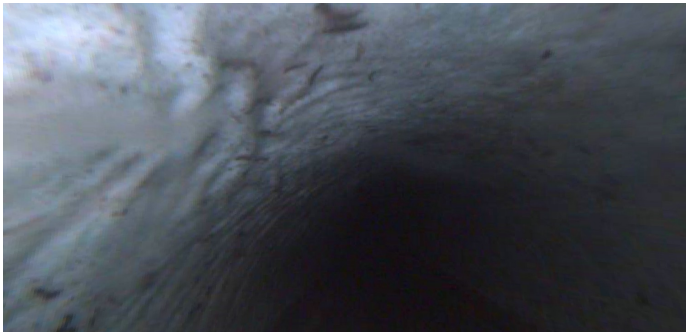
| Comment: | R_M at 185 ft debris . Flow direction | | |

Code: **MSA**
Description: **Abandoned Survey**

Distance (ft): **186.1**
Structural Grade: **0**
O&M Grade: **0**
Clock Start/From:
Clock To:
1st Value:
2nd Value:
Value Percent:
Continuous Index:
Within 8" of Joint: **NO**
Remarks: **ROBOT HAS STOPPED**
