Profile/Photo Observation Report

Date:	04/17/2018	Weather:		Coding:	PACP 6.0
Pipe Length (ft):	304.5	Owner:	NA	Pre Clean:	No Pre-Cleaning
P.O.#:		Surveyor:	Justin Gonzales	PSR:	P-305-037-029
Customer:		Clean Date:	01/01/1900	Shape:	C

Street:	FOXCROFT STREET	Flow Control:	Not Controlled
City:	Hobart, IN	Year Renewed:	
Location:	Sidewalk	Tape/Media #:	
Purpose:	Routine Assessment	Dia/Height:	10"
Use:	Sanitary	Material:	PVC
Drain Area:	NA	Lining:	Cured in Place
Category:	NA		
Comment:	R_M at 185 ft debris . Flow direction		
Location Details:		Direction of Survey:	Downstream
US MH:	M-305-029	DS MH:	M-305-037
		Total Length Surveyed (ft):	186.1

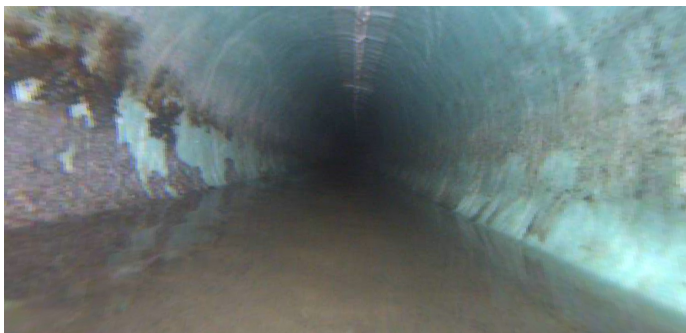
Code: **AMH**
Description: **Manhole**

Distance (ft): **.0**
Structural Grade: **0**
O&M Grade: **0**
Clock Start/From:
Clock To:
1st Value:
2nd Value:
Value Percent:
Continuous Index:
Within 8" of Joint: **NO**
Remarks: **M-305-029**

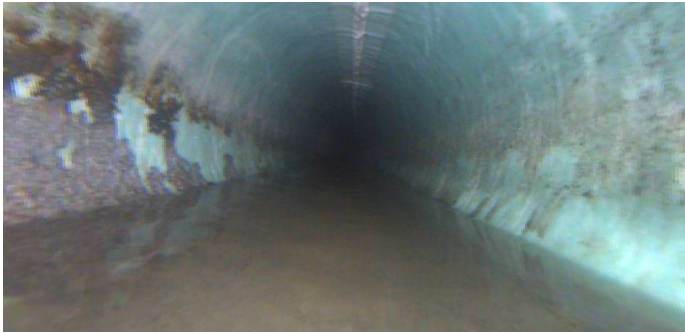
Code:	MWL
Description:	Water Level

Distance (ft):	.0
Structural Grade:	0
O&M Grade:	0
Clock Start/From:	
Clock To:	
1st Value:	
2nd Value:	
Value Percent:	10.000
Continuous Index:	
Within 8" of Joint:	NO
Remarks:

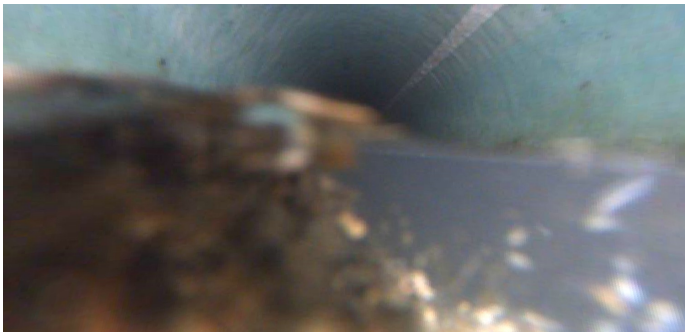
Code:	MWLS
Description:	Water Level Sag

Distance (ft):	39.6
Structural Grade:	3
O&M Grade:	3
Clock Start/From:	
Clock To:	
1st Value:	
2nd Value:	
Value Percent:	40.000
Continuous Index:	
Within 8" of Joint:	NO
Remarks:

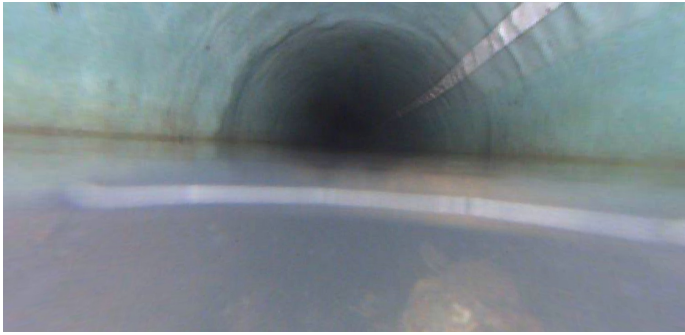
Code: **MWLS**
Description: **Water Level Sag**

Distance (ft): **47.8**
Structural Grade: **3**
O&M Grade: **3**
Clock Start/From:
Clock To:
1st Value:
2nd Value:
Value Percent: **45.000**
Continuous Index:
Within 8" of Joint: **NO**
Remarks:

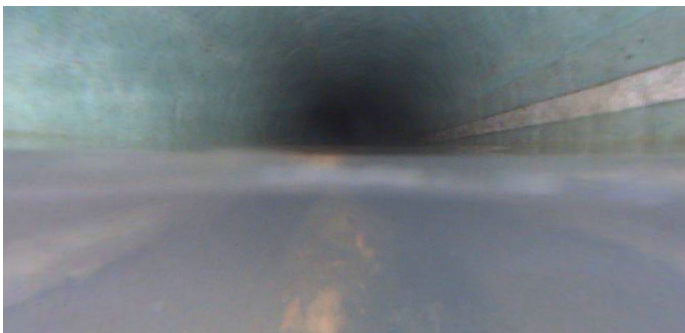
Code: **MWLS**
Description: **Water Level Sag**

Distance (ft): **66.7**
Structural Grade: **3**
O&M Grade: **3**
Clock Start/From:
Clock To:
1st Value:
2nd Value:
Value Percent: **45.000**
Continuous Index:
Within 8" of Joint: **NO**
Remarks:

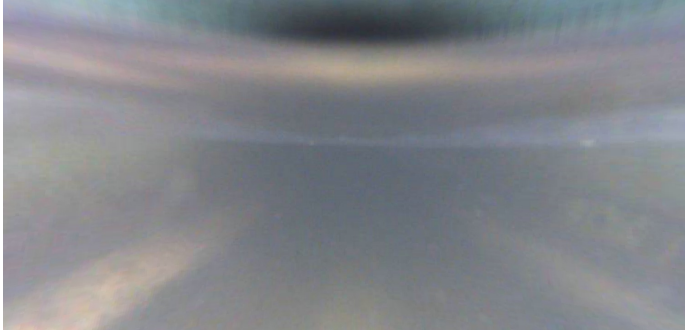
Code: **MWLS**
Description: **Water Level Sag**

Distance (ft): **96.1**
Structural Grade: **3**
O&M Grade: **3**
Clock Start/From:
Clock To:
1st Value:
2nd Value:
Value Percent: **50.000**
Continuous Index:
Within 8" of Joint: **NO**
Remarks:

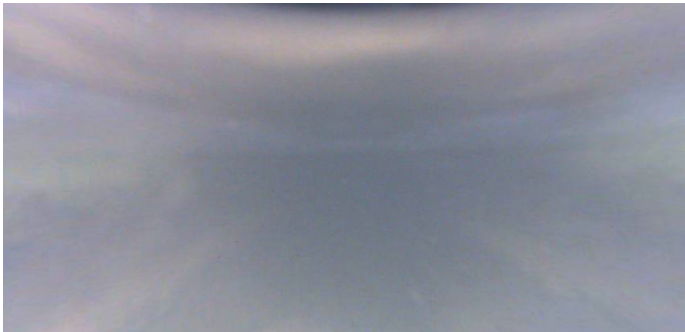
Code: **MCU**
Description: **Camera Underwater**

Distance (ft): **103.3**
Structural Grade: **0**
O&M Grade: **4**
Clock Start/From:
Clock To:
1st Value:
2nd Value:
Value Percent:
Continuous Index: **S03**
Within 8" of Joint: **NO**
Remarks:

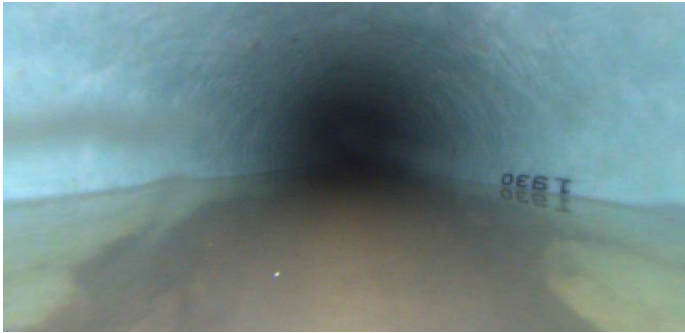
Code: **MCU**
Description: **Camera Underwater**

Distance (ft): **113.0**
Structural Grade: **0**
O&M Grade: **4**
Clock Start/From:
Clock To:
1st Value:
2nd Value:
Value Percent:
Continuous Index: **F03**
Within 8" of Joint: **NO**
Remarks: **EMERGED**

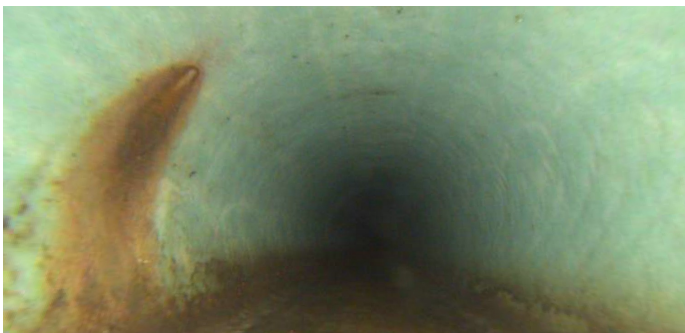
Code: **IS**
Description: **Infil Stain**

Distance (ft): **141.2**
Structural Grade: **0**
O&M Grade: **0**
Clock Start/From: **2**
Clock To: **3**
1st Value:
2nd Value:
Value Percent:
Continuous Index:
Within 8" of Joint:
Remarks:

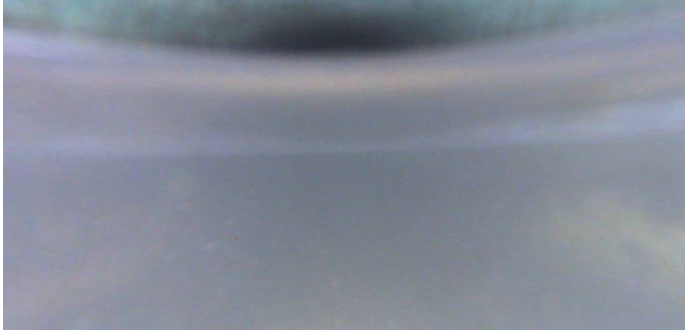
Code: **MWLS**
Description: **Water Level Sag**

Distance (ft): **146.8**
Structural Grade: **3**
O&M Grade: **3**
Clock Start/From:
Clock To:
1st Value:
2nd Value:
Value Percent: **50.000**
Continuous Index:
Within 8" of Joint: **NO**
Remarks:

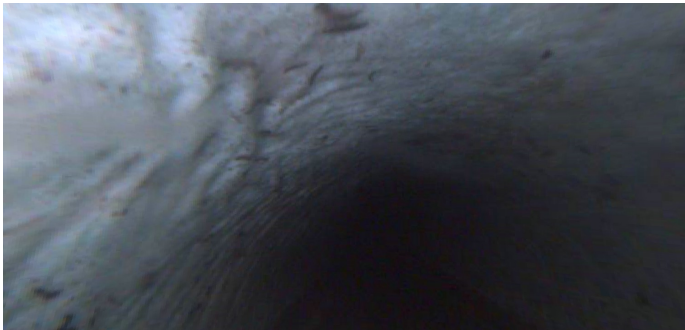
Code: **MSA**
Description: **Abandoned Survey**

Distance (ft): **186.1**
Structural Grade: **0**
O&M Grade: **0**
Clock Start/From:
Clock To:
1st Value:
2nd Value:
Value Percent:
Continuous Index:
Within 8" of Joint: **NO**
Remarks: **ROBOT HAS STOPPED**
