Profile/Photo Observation Report

Street:	FOXCROFT STREET	Flow Control:	Not Controlled
City:	Hobart, IN	Year Renewed:	
Location:	Sidewalk	Tape/Media #:	
Purpose:	Routine Assessment	Dia/Height:	10"
Use:	Sanitary	Material:	PVC
Drain Area:	NA	Lining:	Cured in Place
Category:	NA		
Comment:

Location Details:		Direction of Survey:	Upstream
US MH:	M-305-030	DS MH:	M-305-029
		Total Length Surveyed (ft):	280.6

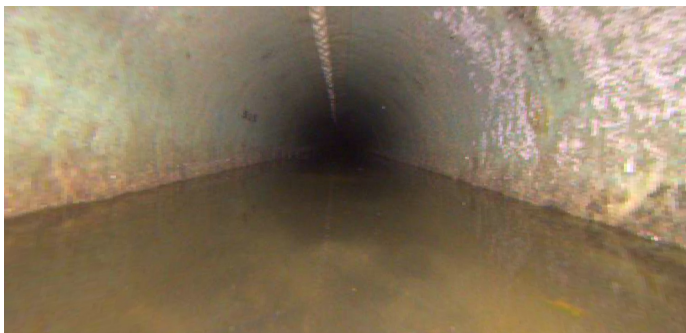
Code: **AMH**
Description: **Manhole**

Distance (ft): **.0**
Structural Grade: **0**
O&M Grade: **0**
Clock Start/From:
Clock To:
1st Value:
2nd Value:
Value Percent:
Continuous Index:
Within 8" of Joint: **NO**
Remarks: **M-305-029**

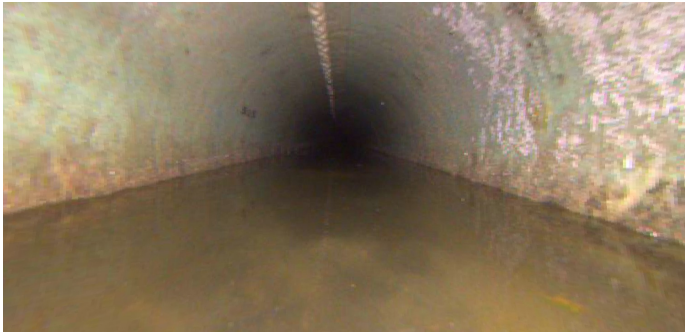
Code:	MWL
Description:	Water Level

Distance (ft):	.0
Structural Grade:	0
O&M Grade:	0
Clock Start/From:	
Clock To:	
1st Value:	
2nd Value:	
Value Percent:	10.000
Continuous Index:	
Within 8" of Joint:	NO
Remarks:

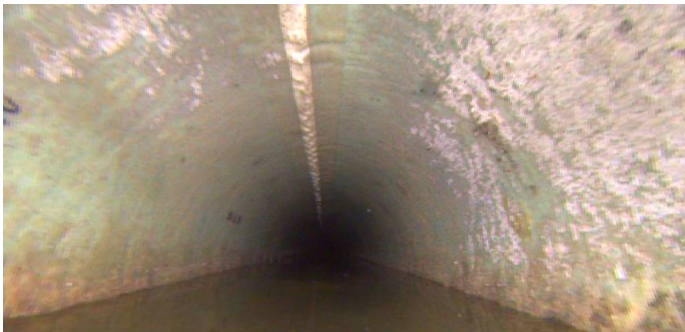
Code:	DAGS
Description:	Deposits Attached Grease

Distance (ft):	.0
Structural Grade:	0
O&M Grade:	2
Clock Start/From:	10
Clock To:	5
1st Value:	
2nd Value:	
Value Percent:	5.000
Continuous Index:	
Within 8" of Joint:	NO
Remarks:

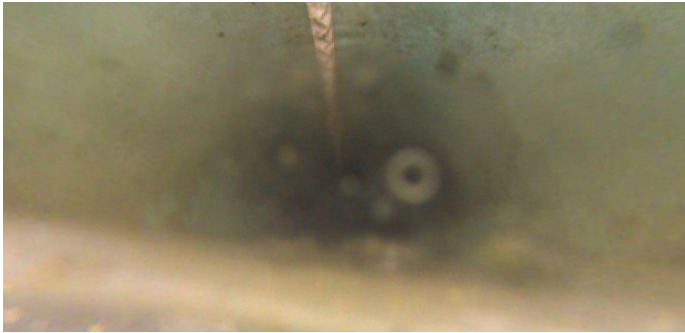
Code: **MWLS**
Description: **Water Level Sag**

Distance (ft): **9.1**
Structural Grade: **3**
O&M Grade: **3**
Clock Start/From:
Clock To:
1st Value:
2nd Value:
Value Percent: **40.000**
Continuous Index:
Within 8" of Joint: **NO**
Remarks:

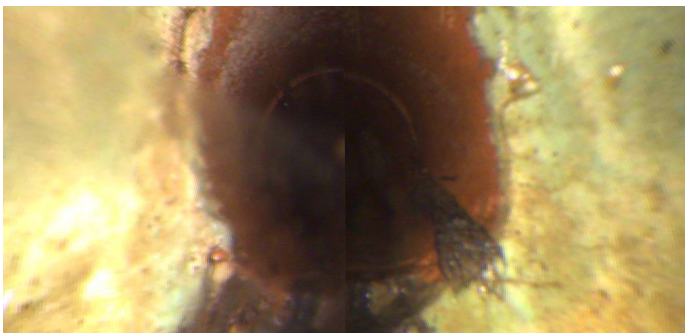
Code: **TF**
Description: **Tap Factory**

Distance (ft): **24.5**
Structural Grade: **0**
O&M Grade: **0**
Clock Start/From: **3**
Clock To:
1st Value: **4.000**
2nd Value:
Value Percent:
Continuous Index:
Within 8" of Joint:
Remarks:

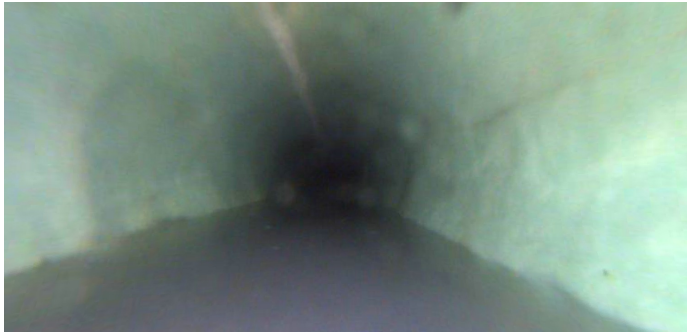
Code:	LFAC
Description:	Lining Failure Abandoned Connection
Distance (ft):	48.7
Structural Grade:	0
O&M Grade:	0
Clock Start/From:	9
Clock To:	
1st Value:	
2nd Value:	
Value Percent:	
Continuous Index:	
Within 8" of Joint:	NO
Remarks:

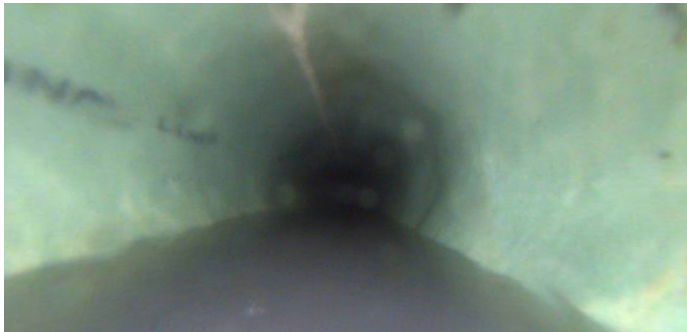
Code:	LFAC
Description:	Lining Failure Abandoned Connection
Distance (ft):	51.0
Structural Grade:	0
O&M Grade:	0
Clock Start/From:	3
Clock To:	
1st Value:	
2nd Value:	
Value Percent:	
Continuous Index:	
Within 8" of Joint:	NO
Remarks:

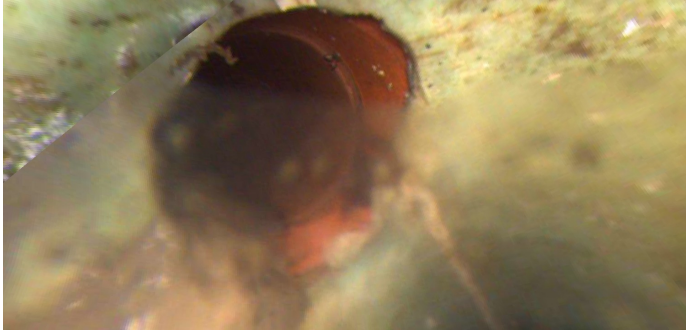
Code: **TF**
Description: **Tap Factory**

Distance (ft): **67.7**
Structural Grade: **0**
O&M Grade: **0**
Clock Start/From: **10**
Clock To:
1st Value: **4.000**
2nd Value:
Value Percent:
Continuous Index:
Within 8" of Joint:
Remarks:

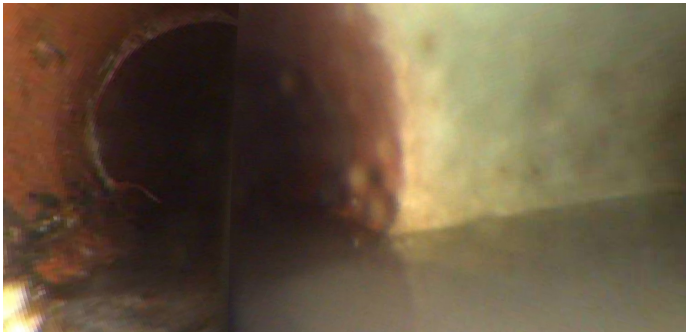
Code: **TFA**
Description: **Tap Factory Active**

Distance (ft): **122.0**
Structural Grade: **0**
O&M Grade: **0**
Clock Start/From: **9**
Clock To:
1st Value: **4.000**
2nd Value:
Value Percent:
Continuous Index:
Within 8" of Joint:
Remarks:

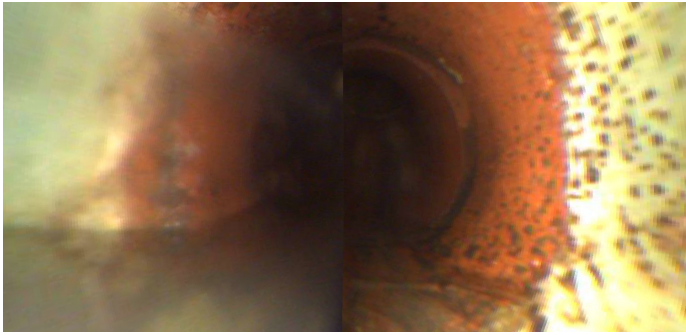
Code: **TF**
Description: **Tap Factory**

Distance (ft): **124.0**
Structural Grade: **0**
O&M Grade: **0**
Clock Start/From: **3**
Clock To:
1st Value: **4.000**
2nd Value:
Value Percent:
Continuous Index:
Within 8" of Joint:
Remarks:

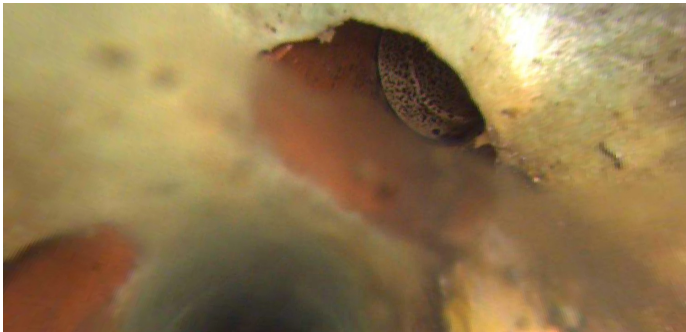
Code: **TF**
Description: **Tap Factory**

Distance (ft): **189.0**
Structural Grade: **0**
O&M Grade: **0**
Clock Start/From: **1**
Clock To:
1st Value: **4.000**
2nd Value:
Value Percent:
Continuous Index:
Within 8" of Joint:
Remarks:

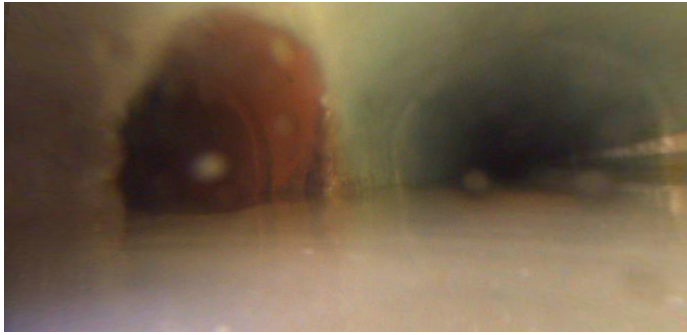
Code: **TFA**
Description: **Tap Factory Active**

Distance (ft): **189.3**
Structural Grade: **0**
O&M Grade: **0**
Clock Start/From: **9**
Clock To:
1st Value: **5.000**
2nd Value:
Value Percent:
Continuous Index:
Within 8" of Joint:
Remarks:

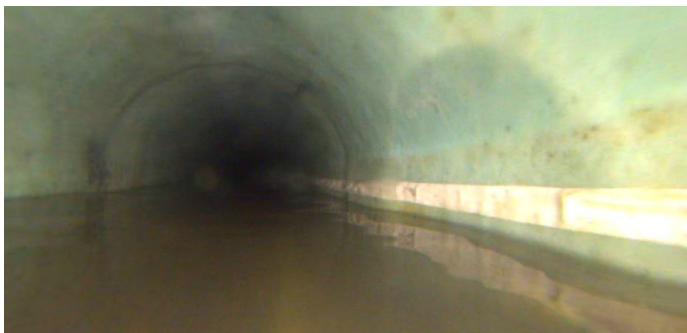
Code: **LFAC**
Description: **Lining Failure Abandoned Connection**

Distance (ft): **191.3**
Structural Grade: **0**
O&M Grade: **0**
Clock Start/From: **3**
Clock To:
1st Value:
2nd Value:
Value Percent:
Continuous Index:
Within 8" of Joint: **NO**
Remarks:

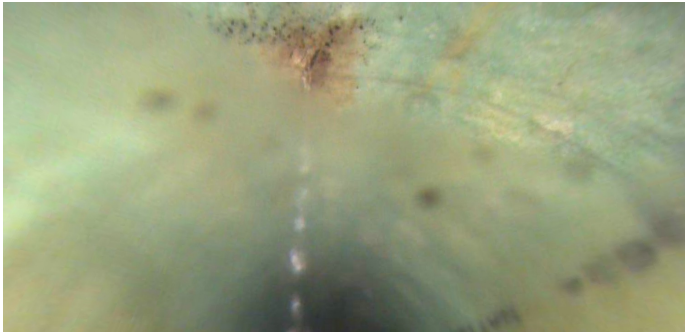
Code: **IR**
Description: **Infil Runner**

Distance (ft): **252.5**
Structural Grade: **0**
O&M Grade: **4**
Clock Start/From: **12**
Clock To:
1st Value:
2nd Value:
Value Percent:
Continuous Index:
Within 8" of Joint:
Remarks:

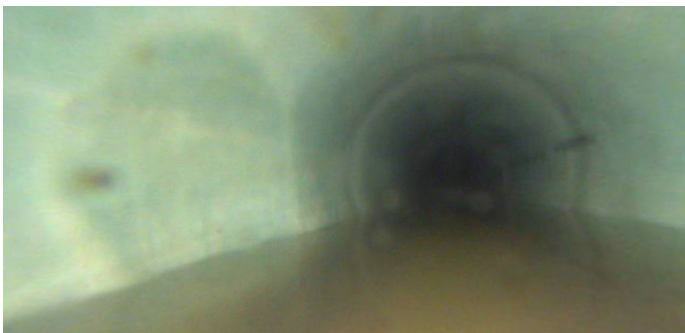
Code: **LFAC**
Description: **Lining Failure Abandoned Connection**

Distance (ft): **261.7**
Structural Grade: **0**
O&M Grade: **0**
Clock Start/From: **9**
Clock To:
1st Value:
2nd Value:
Value Percent:
Continuous Index:
Within 8" of Joint: **NO**
Remarks:

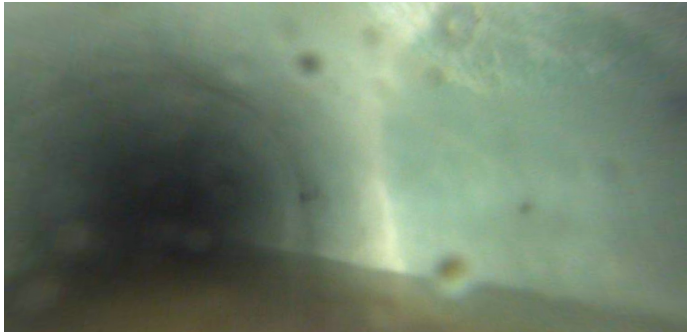
Code: **LFAC**
Description: **Lining Failure Abandoned Connection**

Distance (ft): **263.9**
Structural Grade: **0**
O&M Grade: **0**
Clock Start/From: **3**
Clock To:
1st Value:
2nd Value:
Value Percent:
Continuous Index:
Within 8" of Joint: **NO**
Remarks:

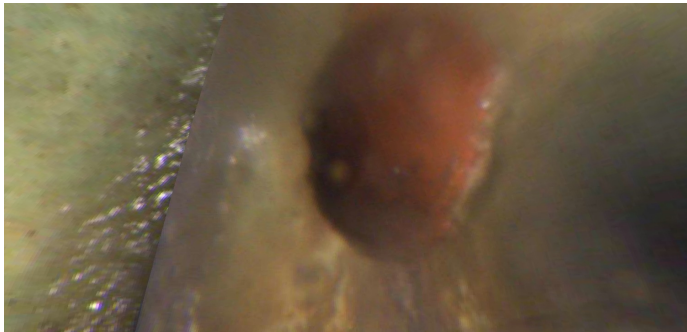
Code: **TF**
Description: **Tap Factory**

Distance (ft): **271.6**
Structural Grade: **0**
O&M Grade: **0**
Clock Start/From: **9**
Clock To:
1st Value: **4.000**
2nd Value:
Value Percent:
Continuous Index:
Within 8" of Joint:
Remarks:

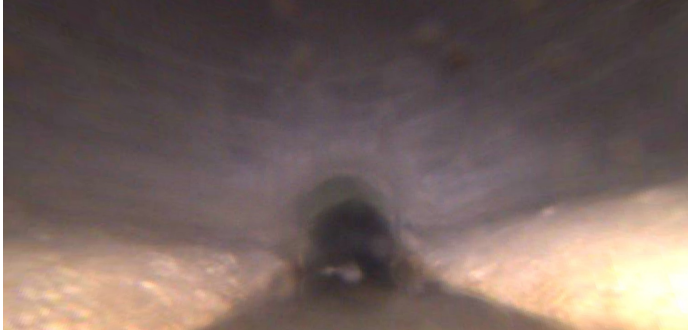
Code:	AMH
Description:	Manhole
Distance (ft):	280.6
Structural Grade:	0
O&M Grade:	0
Clock Start/From:	
Clock To:	
1st Value:	
2nd Value:	
Value Percent:	
Continuous Index:	
Within 8" of Joint:	NO
Remarks:	M-305-030
