## Profile/Photo Observation Report

Date:	<b>04/18/2018</b>	Weather:		Coding:	<b>PACP 6.0</b>
Pipe Length (ft):	<b>378.8</b>	Owner:	<b>NA</b>	Pre Clean:	<b>No Pre-Cleaning</b>
P.O.#:		Surveyor:	<b>Byrd Fitzgerald</b>	PSR:	<b>P-305-032-031</b>
Customer:		Clean Date:	<b>01/01/1900</b>	Shape:	<b>C</b>

Street:	<b>ALLEY BETWEEN CROWSNEST DR &amp;</b>	Flow Control:	<b>Not Controlled</b>
City:	<b>Hobart, IN</b>	Year Renewed:	
Location:	<b>Yard</b>	Tape/Media #:	
Purpose:	<b>Routine Assessment</b>	Dia/Height:	<b>10"</b>
Use:	<b>Sanitary</b>	Material:	<b>XXX</b>
Drain Area:	<b>NA</b>	Lining:	<b>Cured in Place</b>
Category:	<b>NA</b>		
Comment:

Location Details:		Direction of Survey:	<b>Downstream</b>
US MH:	<b>M-305-032</b>	DS MH:	<b>M-305-031</b>
		Total Length Surveyed (ft):	<b>272.3</b>

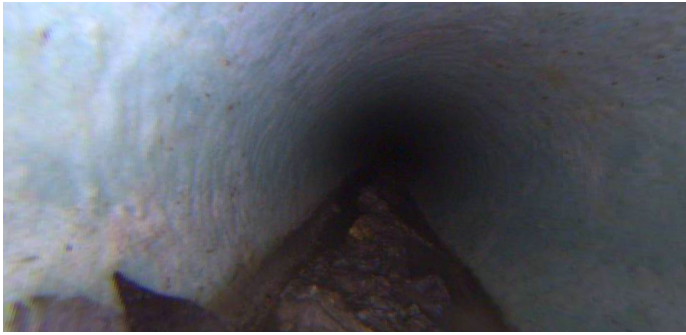
Code: **DSZ**  
Description: **Deposits Settled Other**

Distance (ft): **.0**  
Structural Grade: **0**  
O&M Grade: **2**  
Clock Start/From: **6**  
Clock To:  
1st Value:  
2nd Value:  
Value Percent: **5.000**  
Continuous Index: **S01**  
Within 8" of Joint: **NO**  
Remarks: **tissue/debris**

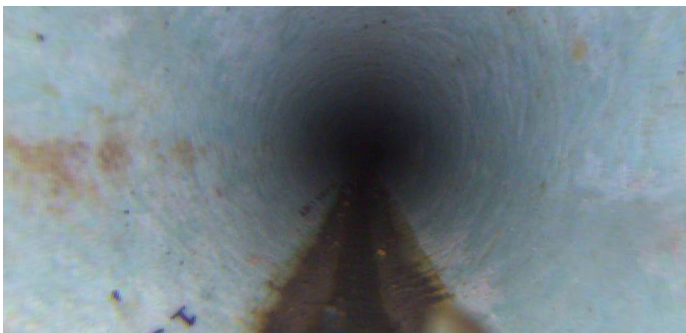
Code: **DSZ**  
Description: **Deposits Settled Other**

Distance (ft): **12.1**  
Structural Grade: **0**  
O&M Grade: **2**  
Clock Start/From: **6**  
Clock To:  
1st Value:  
2nd Value:  
Value Percent: **5.000**  
Continuous Index: **F01**  
Within 8" of Joint: **NO**  
Remarks: **tissue/debris**

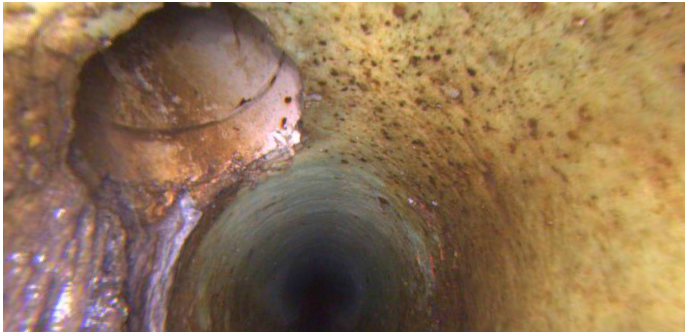
Code: **TBD**  
Description: **Tap Break-in Defective**

Distance (ft): **26.4**  
Structural Grade: **0**  
O&M Grade: **3**  
Clock Start/From: **11**  
Clock To:  
1st Value: **4.000**  
2nd Value:  
Value Percent:  
Continuous Index:  
Within 8" of Joint:  
Remarks: **dae**

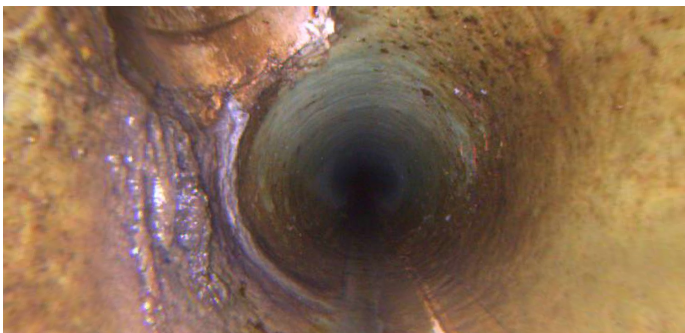
Code: **DAE**  
Description: **Deposits Attached Encrustation**

Distance (ft): **26.4**  
Structural Grade: **0**  
O&M Grade: **2**  
Clock Start/From: **7**  
Clock To: **9**  
1st Value:  
2nd Value:  
Value Percent: **5.000**  
Continuous Index:  
Within 8" of Joint: **NO**  
Remarks:

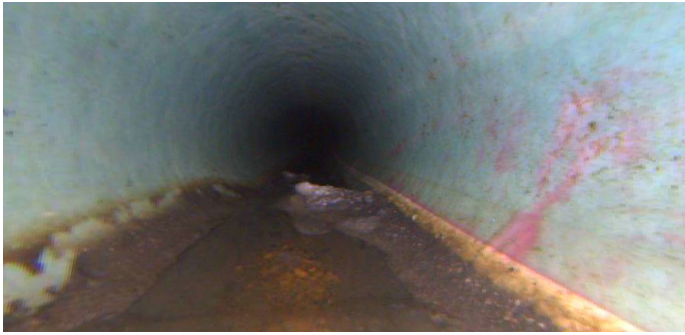
Code: **DSZ**  
Description: **Deposits Settled Other**

Distance (ft): **45.6**  
Structural Grade: **0**  
O&M Grade: **2**  
Clock Start/From: **6**  
Clock To:  
1st Value:  
2nd Value:  
Value Percent: **5.000**  
Continuous Index:  
Within 8" of Joint: **NO**  
Remarks: **tissue**

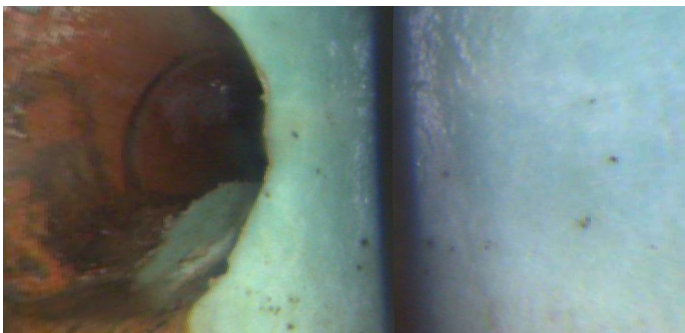
Code: **TBD**  
Description: **Tap Break-in Defective**

Distance (ft): **55.4**  
Structural Grade: **0**  
O&M Grade: **3**  
Clock Start/From: **9**  
Clock To:  
1st Value: **4.000**  
2nd Value:  
Value Percent:  
Continuous Index:  
Within 8" of Joint:  
Remarks: **partially blocked**

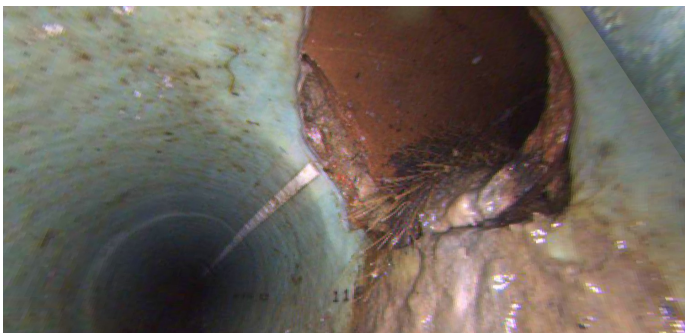
Code: **TBD**  
Description: **Tap Break-in Defective**

Distance (ft): **180.7**  
Structural Grade: **0**  
O&M Grade: **3**  
Clock Start/From: **2**  
Clock To:  
1st Value: **6.000**  
2nd Value:  
Value Percent:  
Continuous Index:  
Within 8" of Joint:  
Remarks: **roots**

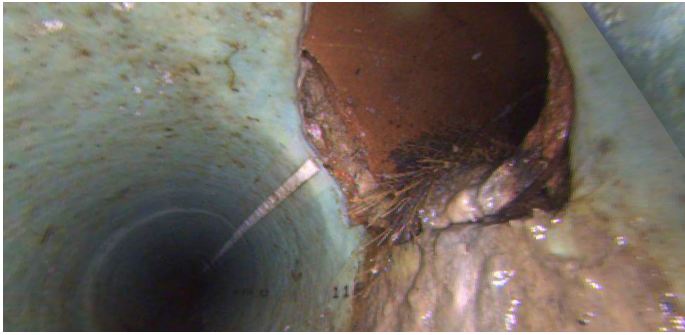
Code: **RFL**  
Description: **Roots Fine Lateral**

Distance (ft): **180.7**  
Structural Grade: **0**  
O&M Grade: **1**  
Clock Start/From: **2**  
Clock To:  
1st Value:  
2nd Value:  
Value Percent:  
Continuous Index:  
Within 8" of Joint: **NO**  
Remarks:

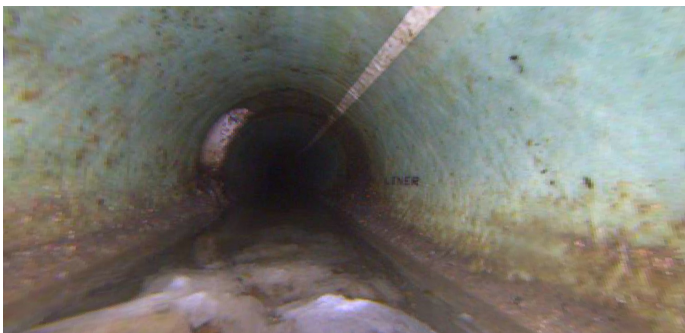
Code: **DSZ**  
Description: **Deposits Settled Other**

Distance (ft): **201.8**  
Structural Grade: **0**  
O&M Grade: **2**  
Clock Start/From: **6**  
Clock To:  
1st Value:  
2nd Value:  
Value Percent: **5.000**  
Continuous Index:  
Within 8" of Joint: **NO**  
Remarks: **tissue**

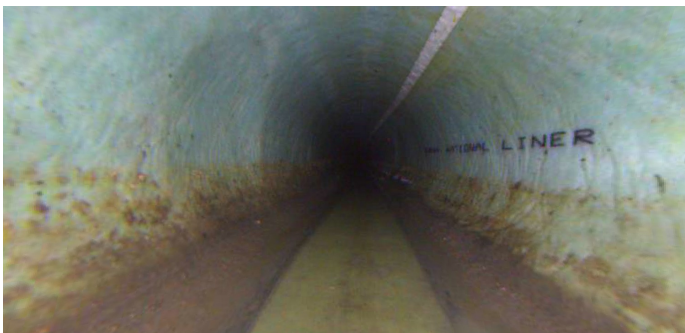
Code: **LFAC**  
Description: **Lining Failure Abandoned Connection**

Distance (ft): **207.3**  
Structural Grade: **0**  
O&M Grade: **0**  
Clock Start/From: **9**  
Clock To:  
1st Value:  
2nd Value:  
Value Percent:  
Continuous Index:  
Within 8" of Joint: **NO**  
Remarks:

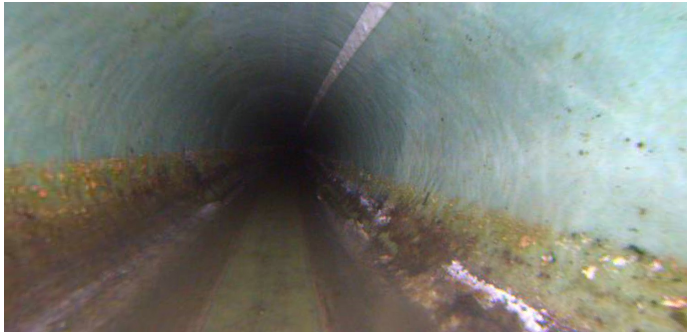
Code:	<b>LFAC</b>
Description:	<b>Lining Failure Abandoned Connection</b>
Distance (ft):	<b>209.6</b>
Structural Grade:	<b>0</b>
O&M Grade:	<b>0</b>
Clock Start/From:	<b>3</b>
Clock To:	
1st Value:	
2nd Value:	
Value Percent:	
Continuous Index:	
Within 8" of Joint:	<b>NO</b>
Remarks:

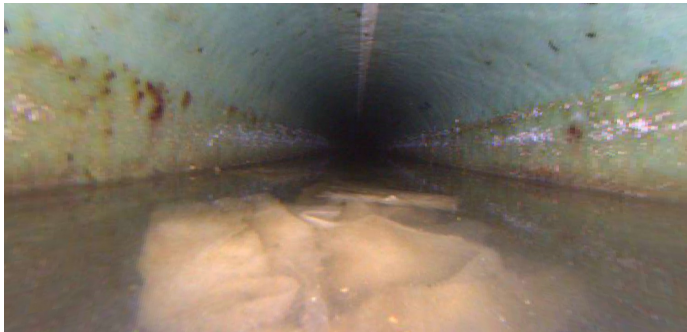
Code:	<b>DSZ</b>
Description:	<b>Deposits Settled Other</b>
Distance (ft):	<b>231.1</b>
Structural Grade:	<b>0</b>
O&M Grade:	<b>2</b>
Clock Start/From:	<b>6</b>
Clock To:	
1st Value:	
2nd Value:	
Value Percent:	<b>5.000</b>
Continuous Index:	<b>S02</b>
Within 8" of Joint:	<b>NO</b>
Remarks:	<b>tissue</b>

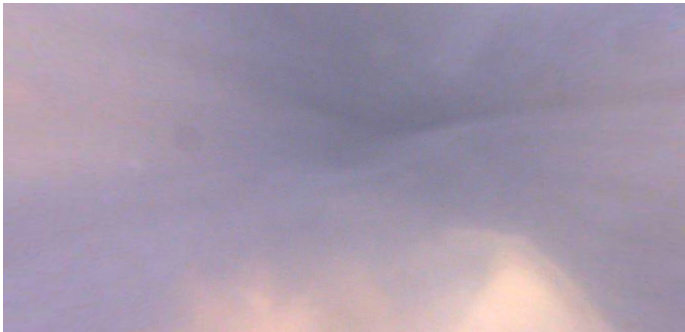
Code: **MCU**  
Description: **Camera Underwater**

Distance (ft): **255.7**  
Structural Grade: **0**  
O&M Grade: **4**  
Clock Start/From:  
Clock To:  
1st Value:  
2nd Value:  
Value Percent:  
Continuous Index: **S03**  
Within 8" of Joint: **NO**  
Remarks:

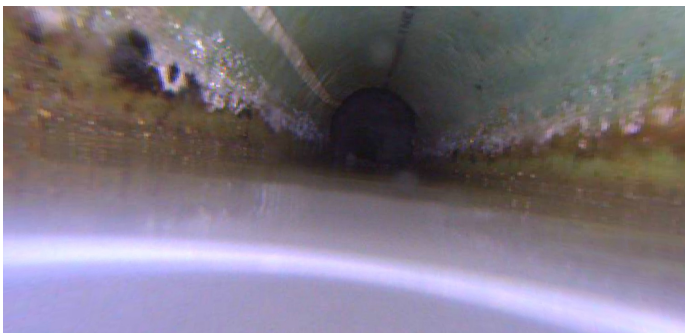
Code: **MCU**  
Description: **Camera Underwater**

Distance (ft): **268.1**  
Structural Grade: **0**  
O&M Grade: **4**  
Clock Start/From:  
Clock To:  
1st Value:  
2nd Value:  
Value Percent:  
Continuous Index: **F03**  
Within 8" of Joint: **NO**  
Remarks:

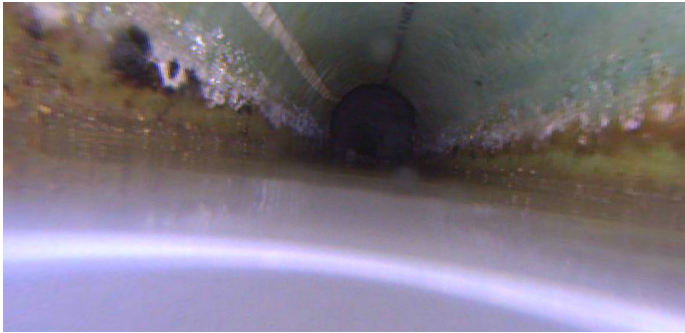
Code: **DSZ**  
Description: **Deposits Settled Other**

Distance (ft): **268.1**  
Structural Grade: **0**  
O&M Grade: **2**  
Clock Start/From: **6**  
Clock To:  
1st Value:  
2nd Value:  
Value Percent: **5.000**  
Continuous Index: **F02**  
Within 8" of Joint: **NO**  
Remarks: **tissue**
