Profile/Photo Observation Report

Street:	FOXCROFT STREET	Flow Control:	Not Controlled
City:	Hobart, IN	Year Renewed:	
Location:	Yard	Tape/Media #:	
Purpose:	Routine Assessment	Dia/Height:	10"
Use:	Sanitary	Material:	XXX
Drain Area:	NA	Lining:	Cured in Place
Category:	NA		
Comment:

Location Details:		Direction of Survey:	Downstream
US MH:	M-305-032	DS MH:	M-305-031
		Total Length Surveyed (ft):	272.3

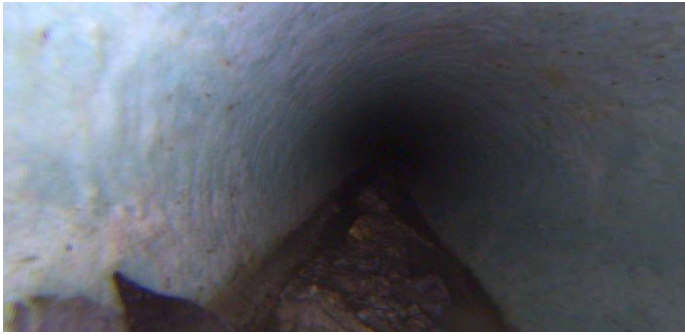
Code: **DSZ**
Description: **Deposits Settled Other**

Distance (ft): **.0**
Structural Grade: **0**
O&M Grade: **2**
Clock Start/From: **6**
Clock To:
1st Value:
2nd Value:
Value Percent: **5.000**
Continuous Index: **S01**
Within 8" of Joint: **NO**
Remarks: **tissue/debris**

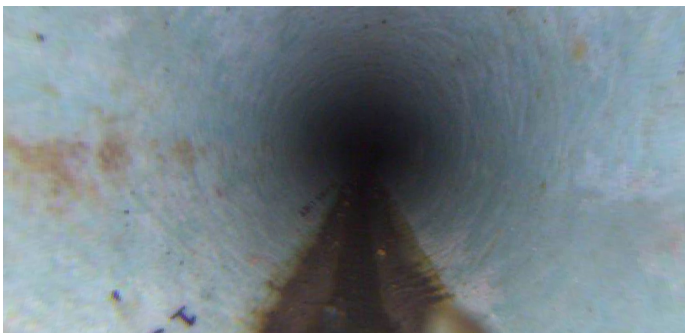
Code: **DSZ**
Description: **Deposits Settled Other**

Distance (ft): **12.1**
Structural Grade: **0**
O&M Grade: **2**
Clock Start/From: **6**
Clock To:
1st Value:
2nd Value:
Value Percent: **5.000**
Continuous Index: **F01**
Within 8" of Joint: **NO**
Remarks: **tissue/debris**

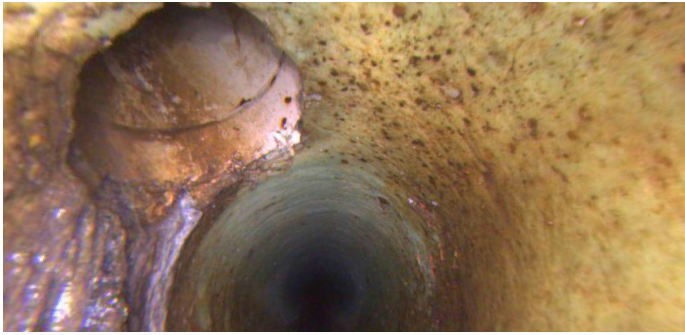
Code: **TBD**
Description: **Tap Break-in Defective**

Distance (ft): **26.4**
Structural Grade: **0**
O&M Grade: **3**
Clock Start/From: **11**
Clock To:
1st Value: **4.000**
2nd Value:
Value Percent:
Continuous Index:
Within 8" of Joint:
Remarks: **dae**

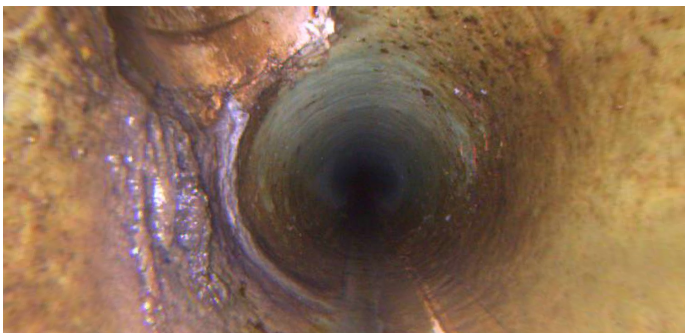
Code: **DAE**
Description: **Deposits Attached Encrustation**

Distance (ft): **26.4**
Structural Grade: **0**
O&M Grade: **2**
Clock Start/From: **7**
Clock To: **9**
1st Value:
2nd Value:
Value Percent: **5.000**
Continuous Index:
Within 8" of Joint: **NO**
Remarks:

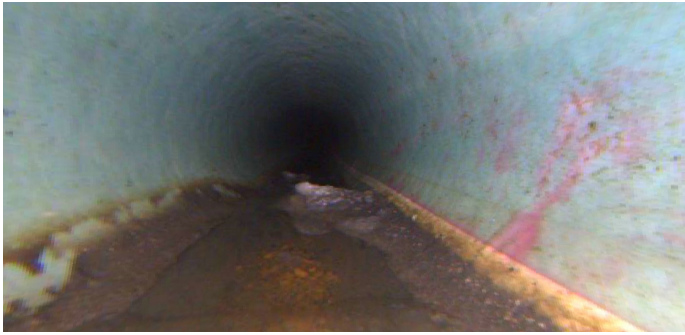
Code: **DSZ**
Description: **Deposits Settled Other**

Distance (ft): **45.6**
Structural Grade: **0**
O&M Grade: **2**
Clock Start/From: **6**
Clock To:
1st Value:
2nd Value:
Value Percent: **5.000**
Continuous Index:
Within 8" of Joint: **NO**
Remarks: **tissue**

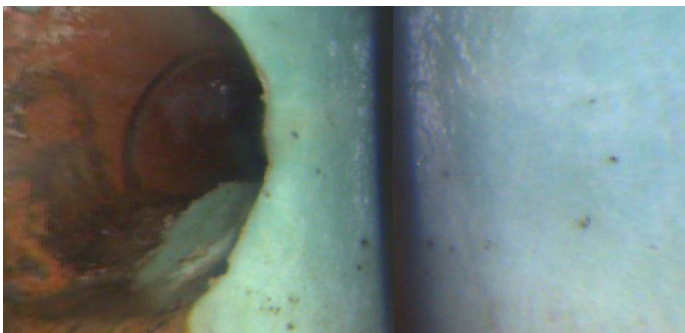
Code: **TBD**
Description: **Tap Break-in Defective**

Distance (ft): **55.4**
Structural Grade: **0**
O&M Grade: **3**
Clock Start/From: **9**
Clock To:
1st Value: **4.000**
2nd Value:
Value Percent:
Continuous Index:
Within 8" of Joint:
Remarks: **partially blocked**

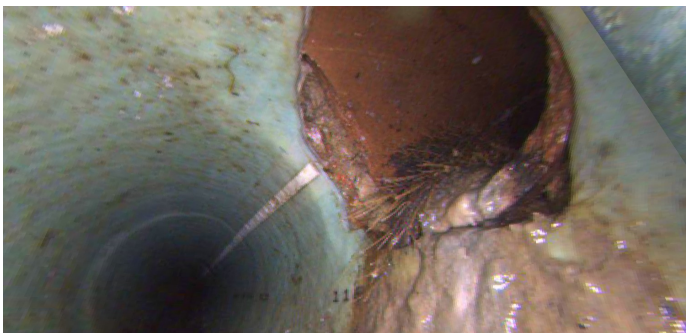
Code: **TBD**
Description: **Tap Break-in Defective**

Distance (ft): **180.7**
Structural Grade: **0**
O&M Grade: **3**
Clock Start/From: **2**
Clock To:
1st Value: **6.000**
2nd Value:
Value Percent:
Continuous Index:
Within 8" of Joint:
Remarks: **roots**

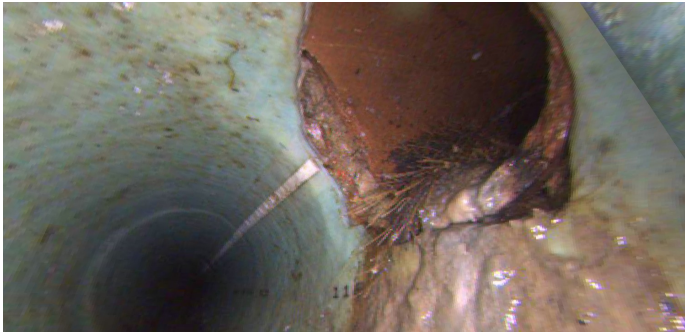
Code: **RFL**
Description: **Roots Fine Lateral**

Distance (ft): **180.7**
Structural Grade: **0**
O&M Grade: **1**
Clock Start/From: **2**
Clock To:
1st Value:
2nd Value:
Value Percent:
Continuous Index:
Within 8" of Joint: **NO**
Remarks:

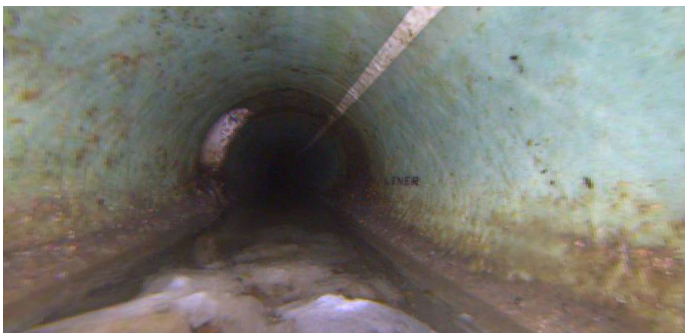
Code: **DSZ**
Description: **Deposits Settled Other**

Distance (ft): **201.8**
Structural Grade: **0**
O&M Grade: **2**
Clock Start/From: **6**
Clock To:
1st Value:
2nd Value:
Value Percent: **5.000**
Continuous Index:
Within 8" of Joint: **NO**
Remarks: **tissue**

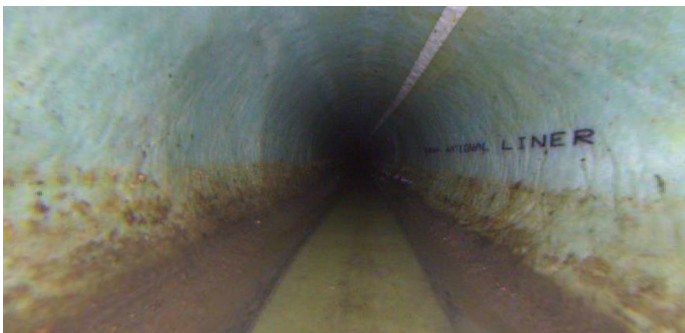
Code: **LFAC**
Description: **Lining Failure Abandoned Connection**

Distance (ft): **207.3**
Structural Grade: **0**
O&M Grade: **0**
Clock Start/From: **9**
Clock To:
1st Value:
2nd Value:
Value Percent:
Continuous Index:
Within 8" of Joint: **NO**
Remarks:

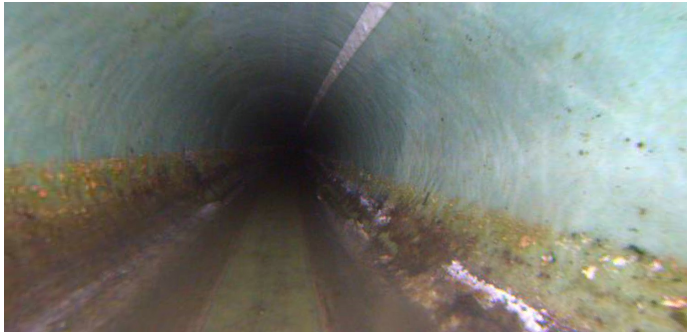
Code:	LFAC
Description:	Lining Failure Abandoned Connection
Distance (ft):	209.6
Structural Grade:	0
O&M Grade:	0
Clock Start/From:	3
Clock To:	
1st Value:	
2nd Value:	
Value Percent:	
Continuous Index:	
Within 8" of Joint:	NO
Remarks:

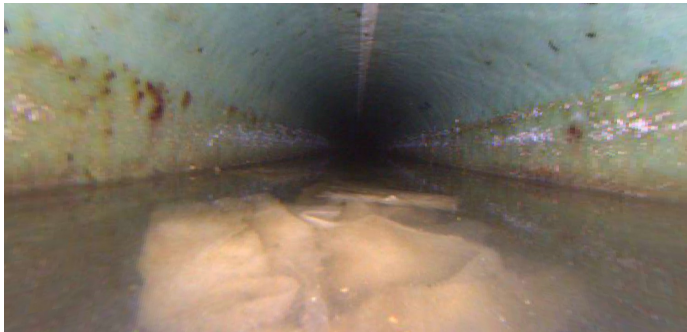
Code:	DSZ
Description:	Deposits Settled Other
Distance (ft):	231.1
Structural Grade:	0
O&M Grade:	2
Clock Start/From:	6
Clock To:	
1st Value:	
2nd Value:	
Value Percent:	5.000
Continuous Index:	S02
Within 8" of Joint:	NO
Remarks:	tissue

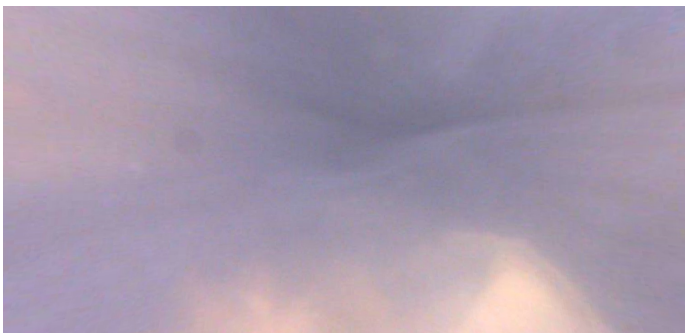
Code: **MCU**
Description: **Camera Underwater**

Distance (ft): **255.7**
Structural Grade: **0**
O&M Grade: **4**
Clock Start/From:
Clock To:
1st Value:
2nd Value:
Value Percent:
Continuous Index: **S03**
Within 8" of Joint: **NO**
Remarks:

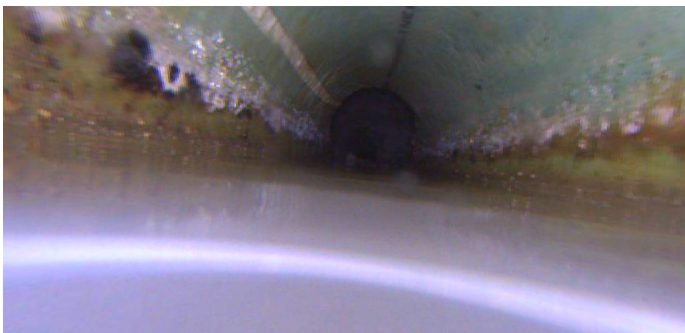
Code: **MCU**
Description: **Camera Underwater**

Distance (ft): **268.1**
Structural Grade: **0**
O&M Grade: **4**
Clock Start/From:
Clock To:
1st Value:
2nd Value:
Value Percent:
Continuous Index: **F03**
Within 8" of Joint: **NO**
Remarks:

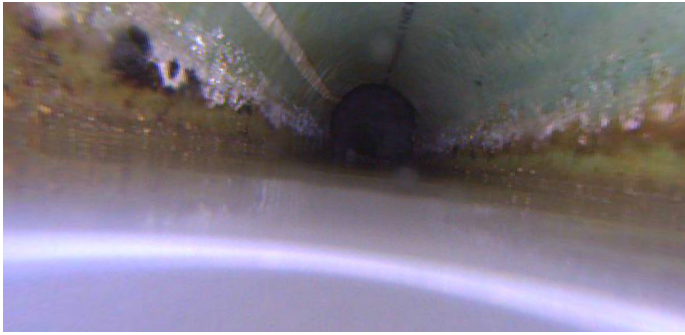
Code: **DSZ**
Description: **Deposits Settled Other**

Distance (ft): **268.1**
Structural Grade: **0**
O&M Grade: **2**
Clock Start/From: **6**
Clock To:
1st Value:
2nd Value:
Value Percent: **5.000**
Continuous Index: **F02**
Within 8" of Joint: **NO**
Remarks: **tissue**
