Profile/Photo Observation Report

Date:	04/18/2018	Weather:		Coding:	PACP 6.0
Pipe Length (ft):	321.1	Owner:	NA	Pre Clean:	No Pre-Cleaning
P.O.#:		Surveyor:	Byrd Fitzgerald	PSR:	P-305-033-034
Customer:		Clean Date:	01/01/1900	Shape:	C

Street:	OFF CRABAPPLE LN	Flow Control:	Not Controlled
City:	Hobart, IN	Year Renewed:	
Location:	Yard	Tape/Media #:	
Purpose:	Routine Assessment	Dia/Height:	8"
Use:	Sanitary	Material:	XXX
Drain Area:	NA	Lining:	Cured in Place
Category:	NA		
Comment:	Flow direction wrong		
Location Details:		Direction of Survey:	Downstream
US MH:	M-305-034	DS MH:	M-305-033
		Total Length Surveyed (ft):	320.1

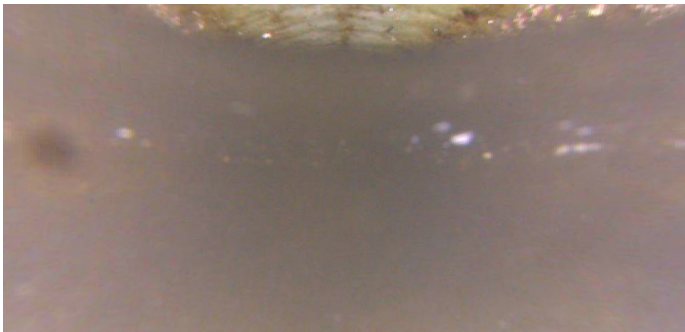
Code:	MCU
Description:	Camera Underwater

Distance (ft):	18.4
Structural Grade:	0
O&M Grade:	4
Clock Start/From:	
Clock To:	
1st Value:	
2nd Value:	
Value Percent:	
Continuous Index:	
Within 8" of Joint:	NO
Remarks:

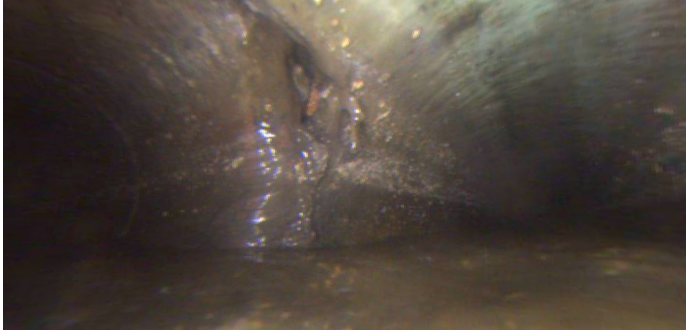
Code: **TB**
Description: **Tap Break-in**

Distance (ft): **27.2**
Structural Grade: **0**
O&M Grade: **0**
Clock Start/From: **3**
Clock To:
1st Value: **6.000**
2nd Value:
Value Percent:
Continuous Index:
Within 8" of Joint:
Remarks:

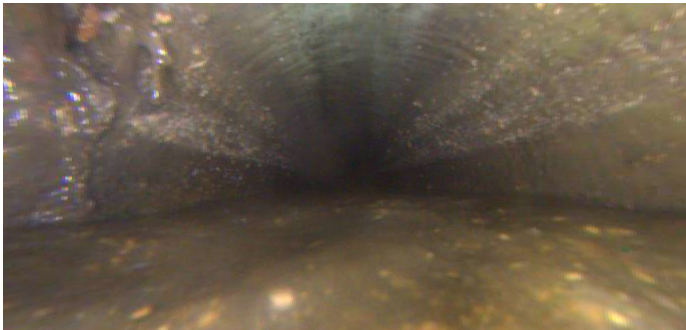
Code: **MGO**
Description: **General Observation**

Distance (ft): **27.2**
Structural Grade: **0**
O&M Grade: **0**
Clock Start/From:
Clock To:
1st Value:
2nd Value:
Value Percent:
Continuous Index:
Within 8" of Joint: **NO**
Remarks: **rear camera/mcu**

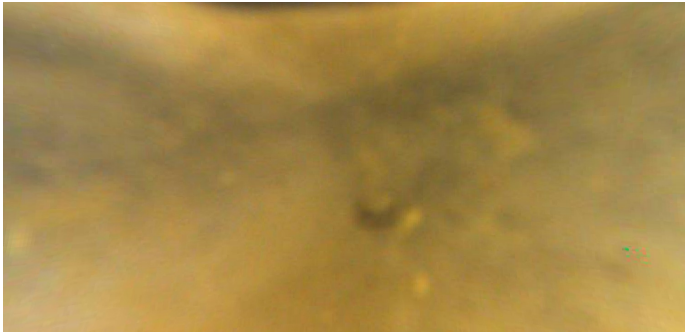
Code: **MCU**
Description: **Camera Underwater**

Distance (ft): **32.5**
Structural Grade: **0**
O&M Grade: **4**
Clock Start/From:
Clock To:
1st Value:
2nd Value:
Value Percent:
Continuous Index: **S01**
Within 8" of Joint: **NO**
Remarks:

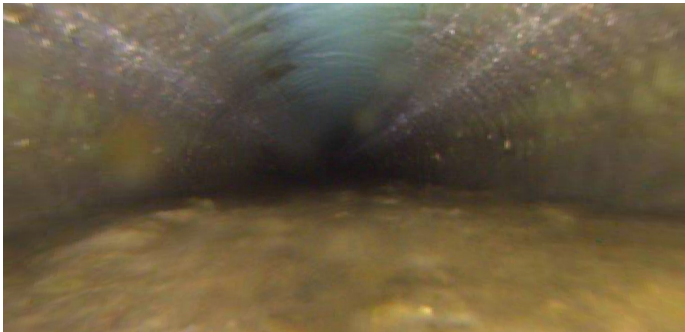
Code: **MCU**
Description: **Camera Underwater**

Distance (ft): **56.0**
Structural Grade: **0**
O&M Grade: **4**
Clock Start/From:
Clock To:
1st Value:
2nd Value:
Value Percent:
Continuous Index: **F01**
Within 8" of Joint: **NO**
Remarks:

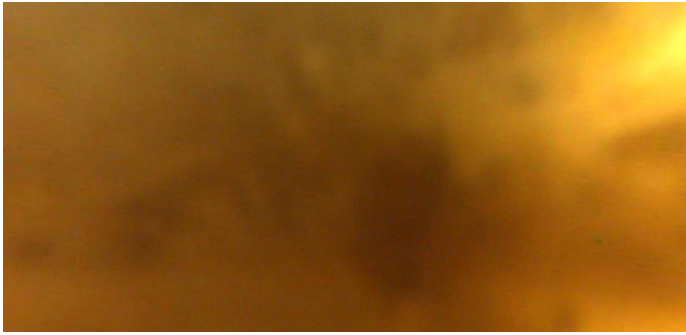
Code: **MCU**
Description: **Camera Underwater**

Distance (ft): **69.0**
Structural Grade: **0**
O&M Grade: **4**
Clock Start/From:
Clock To:
1st Value:
2nd Value:
Value Percent:
Continuous Index: **S02**
Within 8" of Joint: **NO**
Remarks:

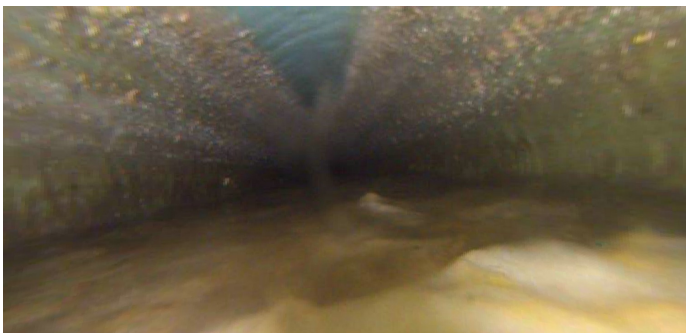
Code: **MCU**
Description: **Camera Underwater**

Distance (ft): **81.9**
Structural Grade: **0**
O&M Grade: **4**
Clock Start/From:
Clock To:
1st Value:
2nd Value:
Value Percent:
Continuous Index: **F02**
Within 8" of Joint: **NO**
Remarks:

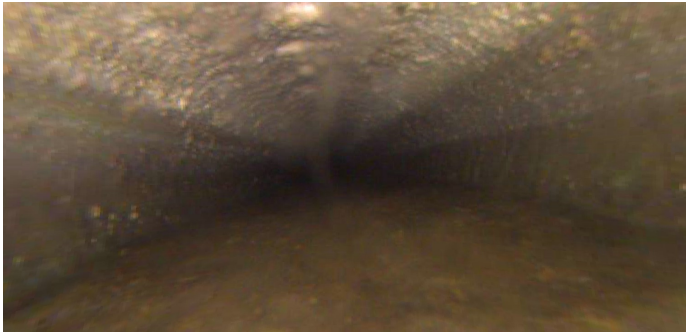
Code: **DAGS**
Description: **Deposits Attached Grease**

Distance (ft): **95.7**
Structural Grade: **0**
O&M Grade: **2**
Clock Start/From: **11**
Clock To: **1**
1st Value:
2nd Value:
Value Percent: **5.000**
Continuous Index: **S03**
Within 8" of Joint: **NO**
Remarks:

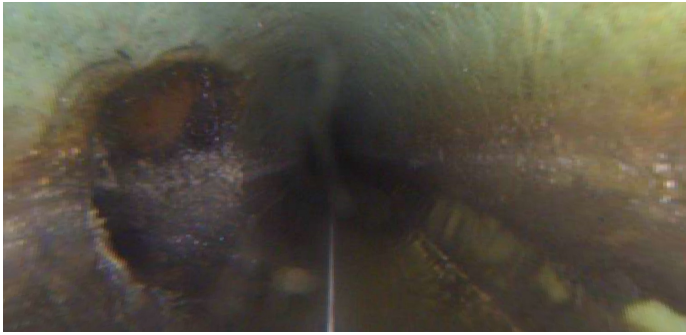
Code: **TB**
Description: **Tap Break-in**

Distance (ft): **190.9**
Structural Grade: **0**
O&M Grade: **0**
Clock Start/From: **3**
Clock To:
1st Value: **4.000**
2nd Value:
Value Percent:
Continuous Index:
Within 8" of Joint:
Remarks:

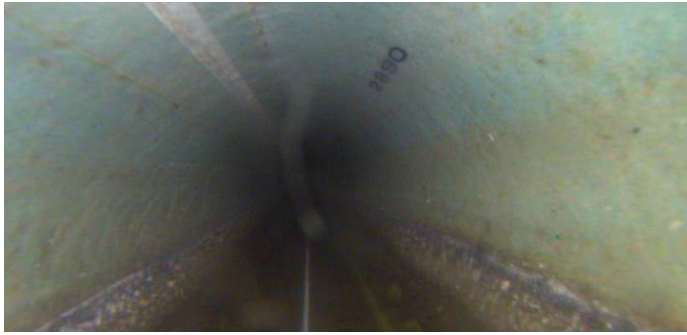
Code:	DAGS
Description:	Deposits Attached Grease
Distance (ft):	281.2
Structural Grade:	0
O&M Grade:	2
Clock Start/From:	11
Clock To:	1
1st Value:	
2nd Value:	
Value Percent:	5.000
Continuous Index:	F03
Within 8" of Joint:	NO
Remarks:

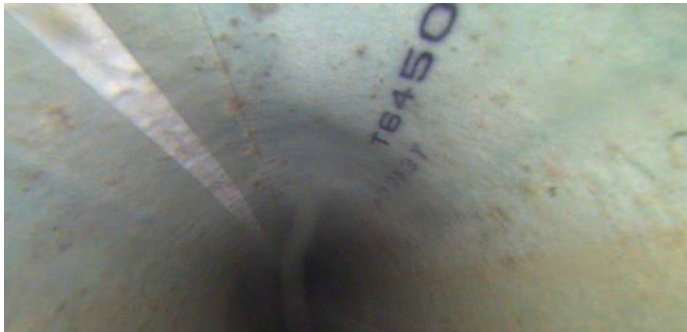
Code:	LFAC
Description:	Lining Failure Abandoned Connection
Distance (ft):	284.0
Structural Grade:	0
O&M Grade:	0
Clock Start/From:	12
Clock To:	
1st Value:	
2nd Value:	
Value Percent:	
Continuous Index:	
Within 8" of Joint:	NO
Remarks:

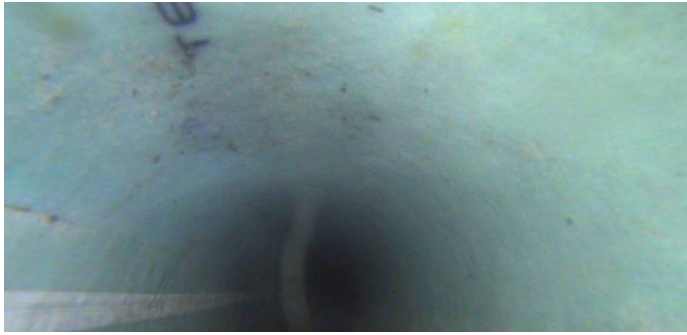
Code:	LFAC
Description:	Lining Failure Abandoned Connection
Distance (ft):	304.6
Structural Grade:	0
O&M Grade:	0
Clock Start/From:	1
Clock To:	
1st Value:	
2nd Value:	
Value Percent:	
Continuous Index:	
Within 8" of Joint:	NO
Remarks:

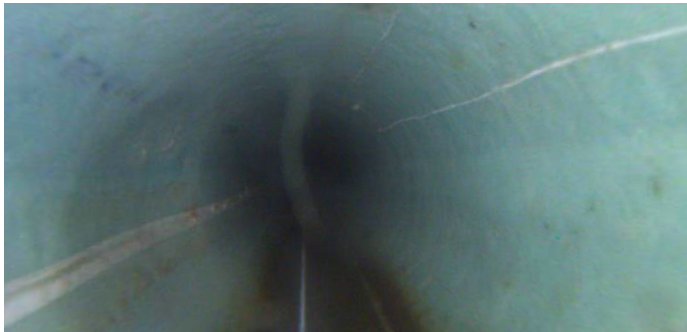
Code:	LFAC
Description:	Lining Failure Abandoned Connection
Distance (ft):	314.9
Structural Grade:	0
O&M Grade:	0
Clock Start/From:	3
Clock To:	
1st Value:	
2nd Value:	
Value Percent:	
Continuous Index:	
Within 8" of Joint:	NO
Remarks:

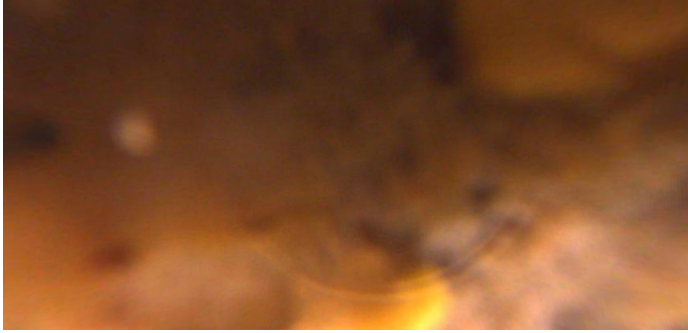
Code:	MSA
Description:	Abandoned Survey
Distance (ft):	320.1
Structural Grade:	0
O&M Grade:	0
Clock Start/From:	
Clock To:	
1st Value:	
2nd Value:	
Value Percent:	
Continuous Index:	
Within 8" of Joint:	NO
Remarks:	mcu
