Profile/Photo Observation Report

Date:	04/18/2018	Weather:		Coding:	PACP 6.0
Pipe Length (ft):	321.1	Owner:	NA	Pre Clean:	No Pre-Cleaning
P.O.#:		Surveyor:	Byrd Fitzgerald	PSR:	P-305-033-034
Customer:		Clean Date:	01/01/1900	Shape:	C

Street:	FOXCROFT STREET	Flow Control:	Not Controlled
City:	Hobart, IN	Year Renewed:	
Location:	Yard	Tape/Media #:	
Purpose:	Routine Assessment	Dia/Height:	8"
Use:	Sanitary	Material:	XXX
Drain Area:	NA	Lining:	Cured in Place
Category:	NA		
Comment:	Flow direction wrong		
Location Details:		Direction of Survey:	Downstream
US MH:	M-305-034	DS MH:	M-305-033
		Total Length Surveyed (ft):	320.1

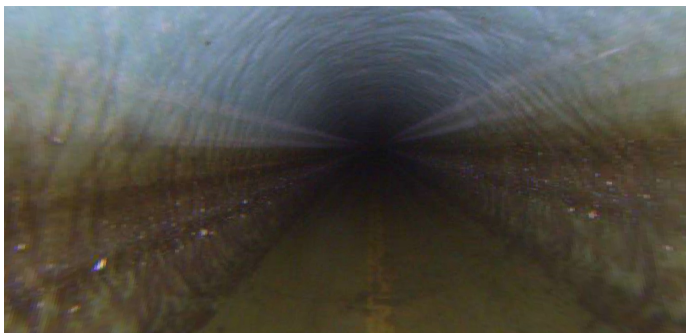
Code: **AMH**
Description: **Manhole**

Distance (ft): **.0**
Structural Grade: **0**
O&M Grade: **0**
Clock Start/From:
Clock To:
1st Value:
2nd Value:
Value Percent:
Continuous Index:
Within 8" of Joint: **NO**
Remarks: **M-305-034**

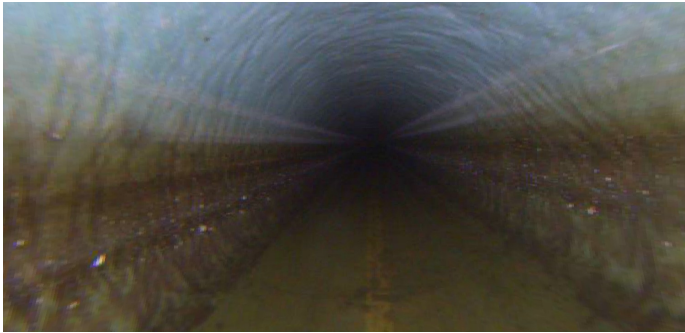
Code:	MWL
Description:	Water Level

Distance (ft):	.0
Structural Grade:	0
O&M Grade:	0
Clock Start/From:	
Clock To:	
1st Value:	
2nd Value:	
Value Percent:	5.000
Continuous Index:	
Within 8" of Joint:	NO
Remarks:

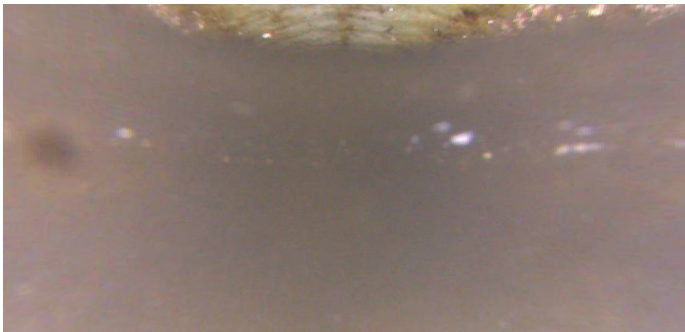
Code:	MCU
Description:	Camera Underwater

Distance (ft):	18.4
Structural Grade:	0
O&M Grade:	4
Clock Start/From:	
Clock To:	
1st Value:	
2nd Value:	
Value Percent:	
Continuous Index:	
Within 8" of Joint:	NO
Remarks:

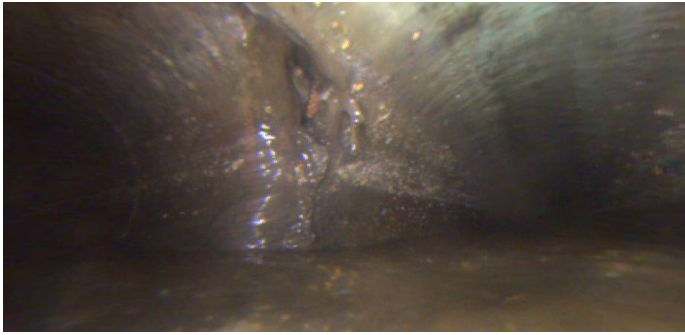
Code: **TB**
Description: **Tap Break-in**

Distance (ft): **27.2**
Structural Grade: **0**
O&M Grade: **0**
Clock Start/From: **3**
Clock To:
1st Value: **6.000**
2nd Value:
Value Percent:
Continuous Index:
Within 8" of Joint:
Remarks:

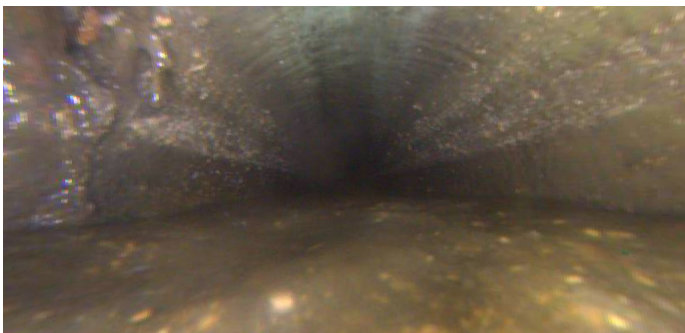
Code: **MGO**
Description: **General Observation**

Distance (ft): **27.2**
Structural Grade: **0**
O&M Grade: **0**
Clock Start/From:
Clock To:
1st Value:
2nd Value:
Value Percent:
Continuous Index:
Within 8" of Joint: **NO**
Remarks: **rear camera/mcu**

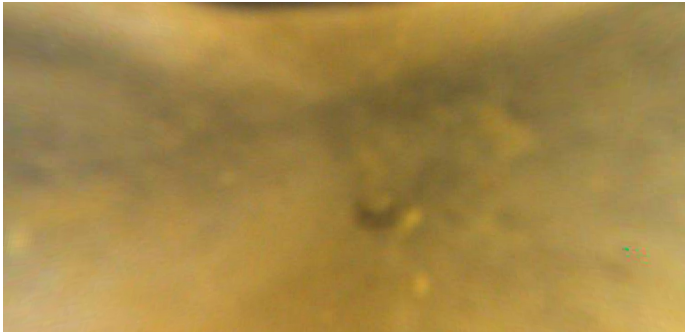
Code: **MCU**
Description: **Camera Underwater**

Distance (ft): **32.5**
Structural Grade: **0**
O&M Grade: **4**
Clock Start/From:
Clock To:
1st Value:
2nd Value:
Value Percent:
Continuous Index: **S01**
Within 8" of Joint: **NO**
Remarks:

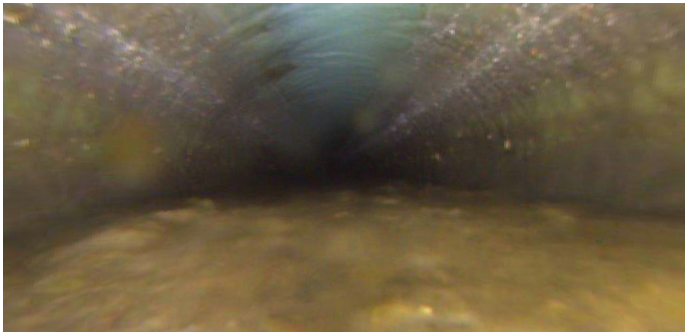
Code: **MCU**
Description: **Camera Underwater**

Distance (ft): **56.0**
Structural Grade: **0**
O&M Grade: **4**
Clock Start/From:
Clock To:
1st Value:
2nd Value:
Value Percent:
Continuous Index: **F01**
Within 8" of Joint: **NO**
Remarks:

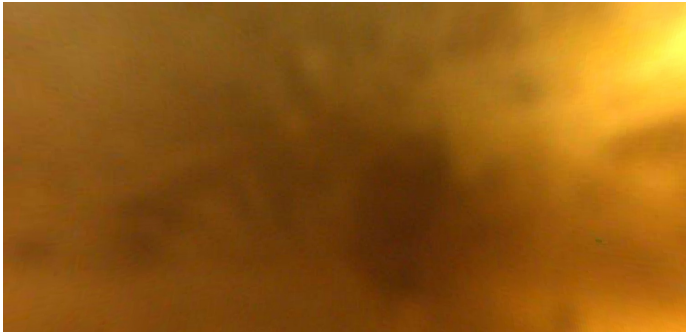
Code: **MCU**
Description: **Camera Underwater**

Distance (ft): **69.0**
Structural Grade: **0**
O&M Grade: **4**
Clock Start/From:
Clock To:
1st Value:
2nd Value:
Value Percent:
Continuous Index: **S02**
Within 8" of Joint: **NO**
Remarks:

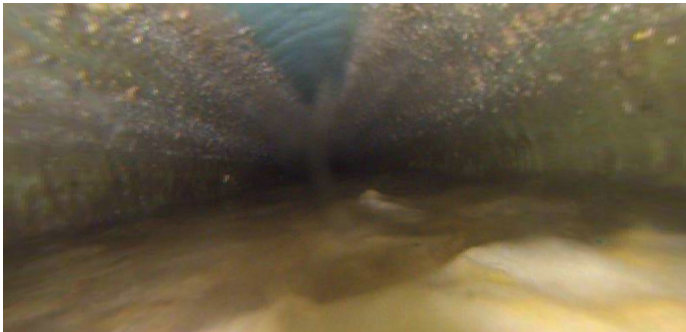
Code: **MCU**
Description: **Camera Underwater**

Distance (ft): **81.9**
Structural Grade: **0**
O&M Grade: **4**
Clock Start/From:
Clock To:
1st Value:
2nd Value:
Value Percent:
Continuous Index: **F02**
Within 8" of Joint: **NO**
Remarks:

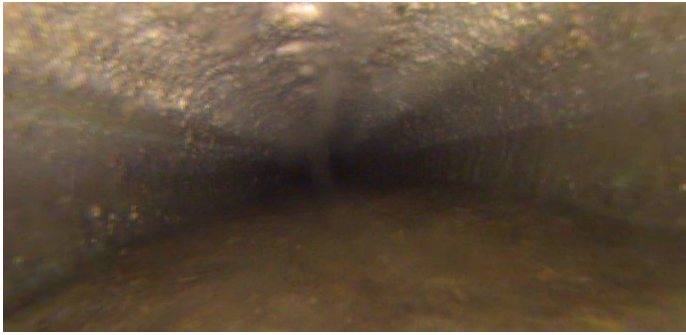
Code: **DAGS**
Description: **Deposits Attached Grease**

Distance (ft): **95.7**
Structural Grade: **0**
O&M Grade: **2**
Clock Start/From: **11**
Clock To: **1**
1st Value:
2nd Value:
Value Percent: **5.000**
Continuous Index: **S03**
Within 8" of Joint: **NO**
Remarks:

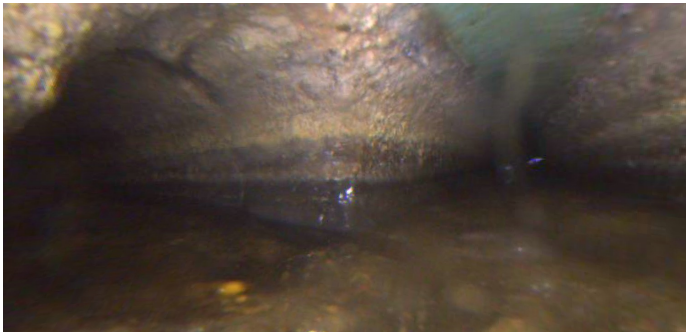
Code: **TFA**
Description: **Tap Factory Active**

Distance (ft): **108.3**
Structural Grade: **0**
O&M Grade: **0**
Clock Start/From: **3**
Clock To:
1st Value: **4.000**
2nd Value:
Value Percent:
Continuous Index:
Within 8" of Joint:
Remarks:

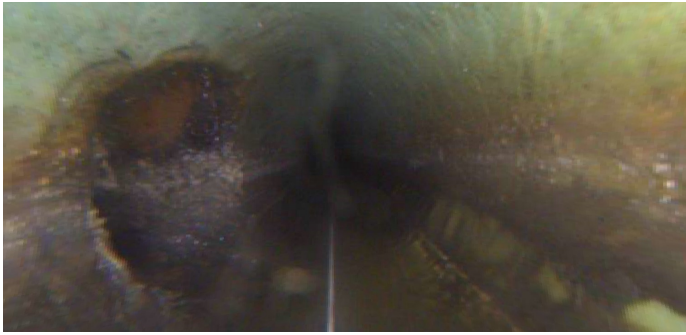
Code: **TB**
Description: **Tap Break-in**

Distance (ft): **190.9**
Structural Grade: **0**
O&M Grade: **0**
Clock Start/From: **3**
Clock To:
1st Value: **4.000**
2nd Value:
Value Percent:
Continuous Index:
Within 8" of Joint:
Remarks:

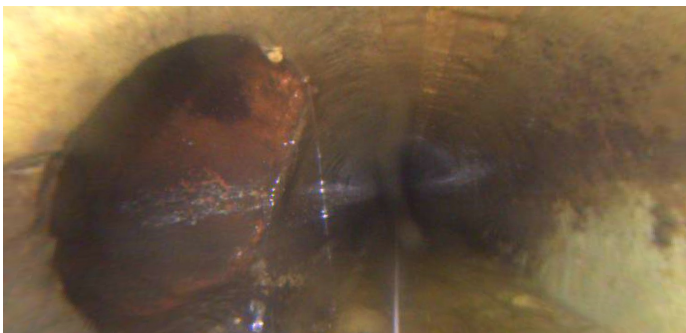
Code: **TFA**
Description: **Tap Factory Active**

Distance (ft): **263.9**
Structural Grade: **0**
O&M Grade: **0**
Clock Start/From: **3**
Clock To:
1st Value: **4.000**
2nd Value:
Value Percent:
Continuous Index:
Within 8" of Joint:
Remarks:

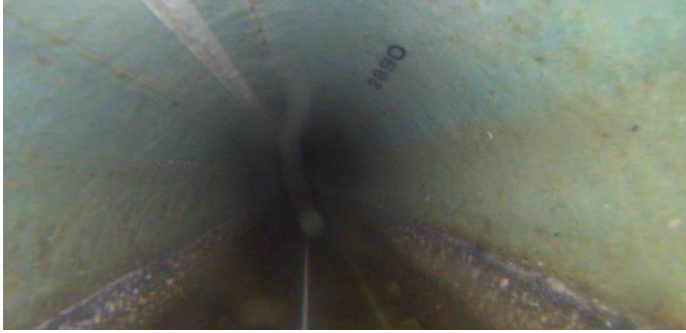
Code:	DAGS
Description:	Deposits Attached Grease
Distance (ft):	281.2
Structural Grade:	0
O&M Grade:	2
Clock Start/From:	11
Clock To:	1
1st Value:	
2nd Value:	
Value Percent:	5.000
Continuous Index:	F03
Within 8" of Joint:	NO
Remarks:

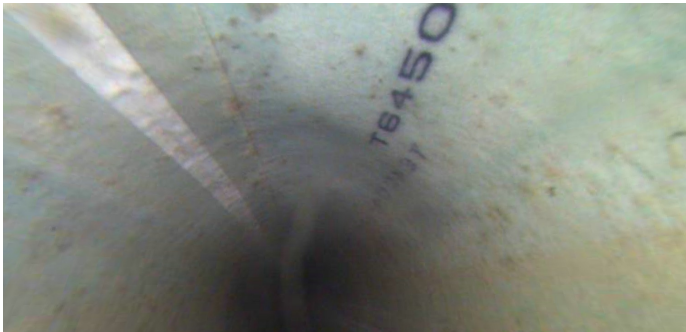
Code:	LFAC
Description:	Lining Failure Abandoned Connection
Distance (ft):	284.0
Structural Grade:	0
O&M Grade:	0
Clock Start/From:	12
Clock To:	
1st Value:	
2nd Value:	
Value Percent:	
Continuous Index:	
Within 8" of Joint:	NO
Remarks:

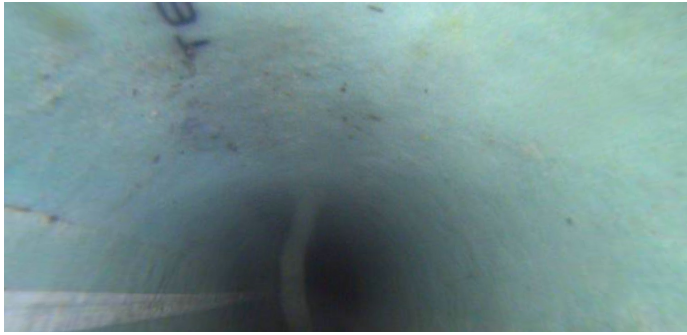
Code:	LFAC
Description:	Lining Failure Abandoned Connection
Distance (ft):	304.6
Structural Grade:	0
O&M Grade:	0
Clock Start/From:	1
Clock To:	
1st Value:	
2nd Value:	
Value Percent:	
Continuous Index:	
Within 8" of Joint:	NO
Remarks:

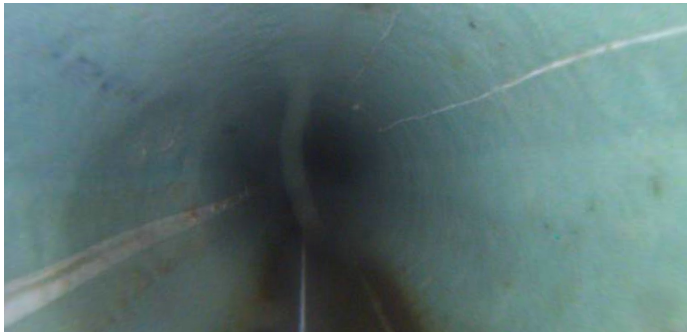
Code:	LFAC
Description:	Lining Failure Abandoned Connection
Distance (ft):	314.9
Structural Grade:	0
O&M Grade:	0
Clock Start/From:	3
Clock To:	
1st Value:	
2nd Value:	
Value Percent:	
Continuous Index:	
Within 8" of Joint:	NO
Remarks:

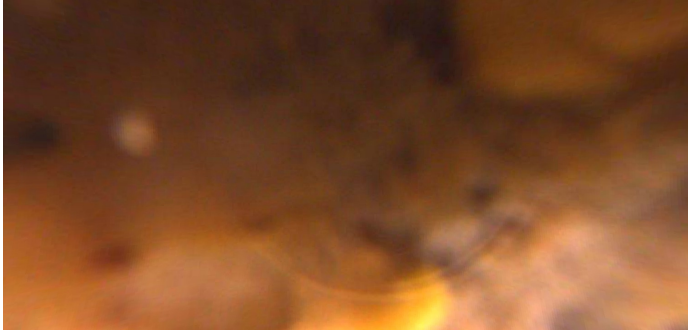
Code:	MSA
Description:	Abandoned Survey
Distance (ft):	320.1
Structural Grade:	0
O&M Grade:	0
Clock Start/From:	
Clock To:	
1st Value:	
2nd Value:	
Value Percent:	
Continuous Index:	
Within 8" of Joint:	NO
Remarks:	mcu
