Profile/Photo Observation Report

Street:	OFF CRABAPPLE LN	Flow Control:	Not Controlled
City:	Hobart, IN	Year Renewed:	
Location:	Yard	Tape/Media #:	
Purpose:	Routine Assessment	Dia/Height:	10"
Use:	Sanitary	Material:	XXX
Drain Area:	NA	Lining:	Cured in Place
Category:	NA		
Comment:	Flow direction wrong		
Location Details:		Direction of Survey:	Upstream
US MH:	M-305-035	DS MH:	M-305-034
		Total Length Surveyed (ft):	243.5

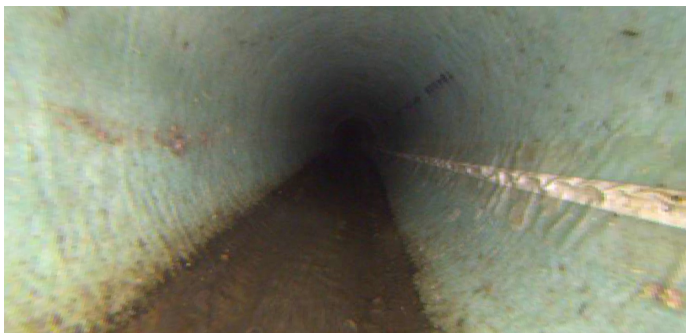
Code: **AMH**
Description: **Manhole**

Distance (ft): **.0**
Structural Grade: **0**
O&M Grade: **0**
Clock Start/From:
Clock To:
1st Value:
2nd Value:
Value Percent:
Continuous Index:
Within 8" of Joint: **NO**
Remarks: **M-305-034**

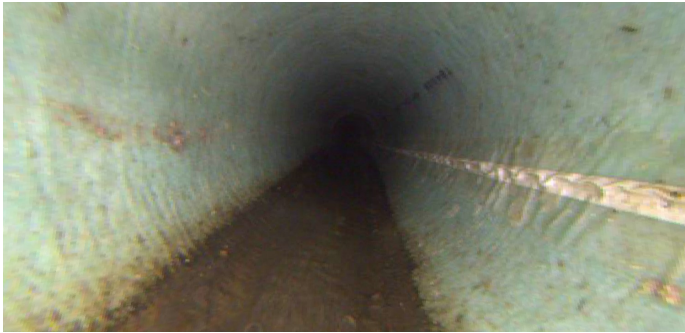
Code:	MWL
Description:	Water Level

Distance (ft):	.0
Structural Grade:	0
O&M Grade:	0
Clock Start/From:	
Clock To:	
1st Value:	
2nd Value:	
Value Percent:	5.000
Continuous Index:	
Within 8" of Joint:	NO
Remarks:

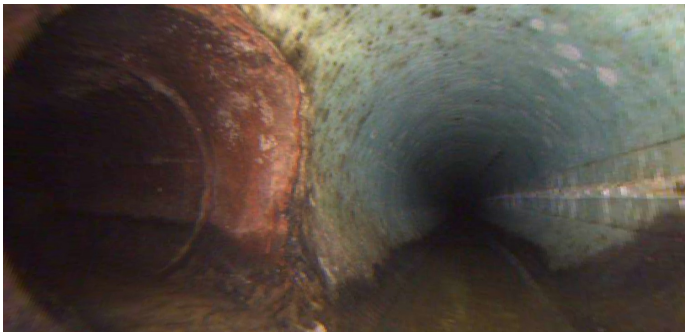
Code:	TB
Description:	Tap Break-in

Distance (ft):	20.0
Structural Grade:	0
O&M Grade:	0
Clock Start/From:	9
Clock To:	
1st Value:	6.000
2nd Value:	
Value Percent:	
Continuous Index:	
Within 8" of Joint:	
Remarks:

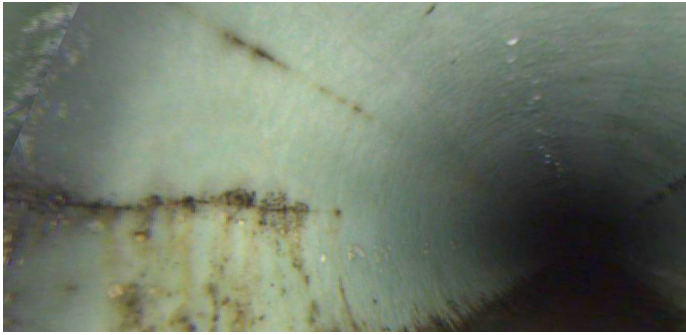
Code: **LFZ**
Description: **Lining Failure Other**

Distance (ft): **131.6**
Structural Grade: **0**
O&M Grade: **0**
Clock Start/From: **9**
Clock To: **10**
1st Value:
2nd Value:
Value Percent:
Continuous Index:
Within 8" of Joint: **NO**
Remarks: **scratch**

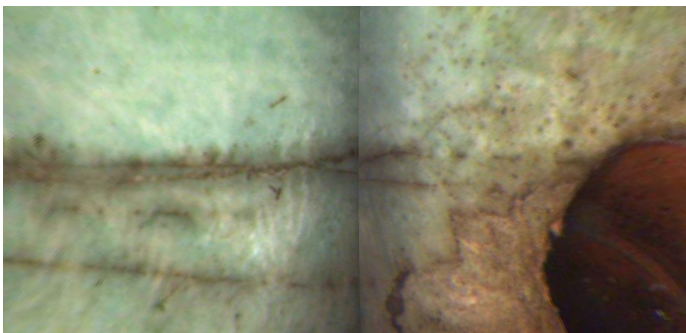
Code: **LFZ**
Description: **Lining Failure Other**

Distance (ft): **177.4**
Structural Grade: **0**
O&M Grade: **0**
Clock Start/From: **9**
Clock To:
1st Value:
2nd Value:
Value Percent:
Continuous Index:
Within 8" of Joint: **NO**
Remarks: **scratches**

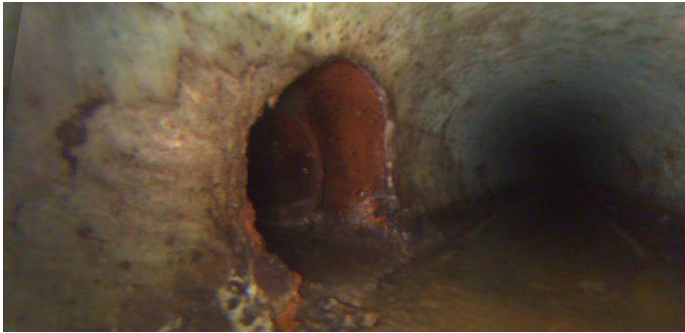
Code: **TB**
Description: **Tap Break-in**

Distance (ft): **177.4**
Structural Grade: **0**
O&M Grade: **0**
Clock Start/From: **9**
Clock To:
1st Value: **6.000**
2nd Value:
Value Percent:
Continuous Index:
Within 8" of Joint:
Remarks:

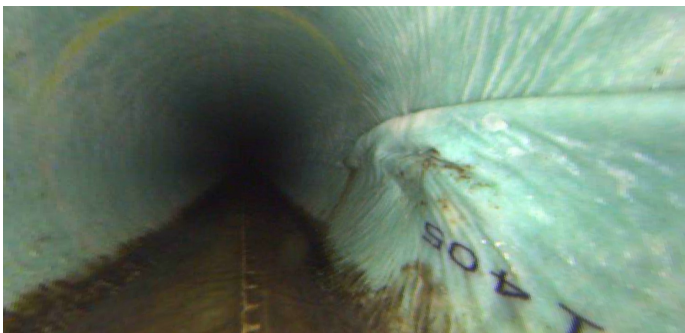
Code: **LFW**
Description: **Lining Failure Wrinkled**

Distance (ft): **195.9**
Structural Grade: **3**
O&M Grade: **0**
Clock Start/From: **3**
Clock To:
1st Value:
2nd Value:
Value Percent:
Continuous Index:
Within 8" of Joint: **NO**
Remarks:

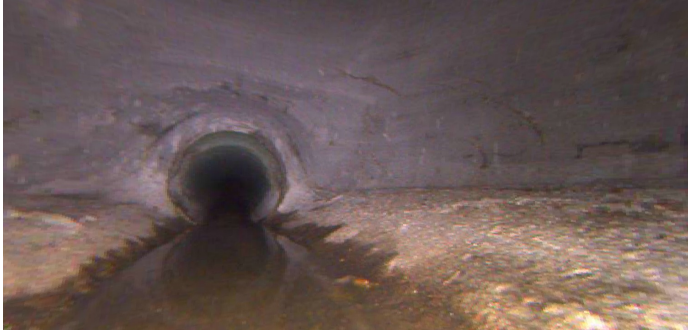
Code:	AMH
Description:	Manhole
Distance (ft):	243.5
Structural Grade:	0
O&M Grade:	0
Clock Start/From:	
Clock To:	
1st Value:	
2nd Value:	
Value Percent:	
Continuous Index:	
Within 8" of Joint:	NO
Remarks:	M-305-035
