Profile/Photo Observation Report

Date:	04/18/2018	Weather:		Coding:	PACP 6.0
Pipe Length (ft):	247.5	Owner:	NA	Pre Clean:	No Pre-Cleaning
P.O.#:		Surveyor:	Byrd Fitzgerald	PSR:	P-305-034-035
Customer:		Clean Date:	01/01/1900	Shape:	C

Street:	FOXCROFT STREET	Flow Control:	Not Controlled
City:	Hobart, IN	Year Renewed:	
Location:	Yard	Tape/Media #:	
Purpose:	Routine Assessment	Dia/Height:	10"
Use:	Sanitary	Material:	XXX
Drain Area:	NA	Lining:	Cured in Place
Category:	NA		
Comment:	Flow direction wrong		
Location Details:		Direction of Survey:	Upstream
US MH:	M-305-035	DS MH:	M-305-034
		Total Length Surveyed (ft):	243.5

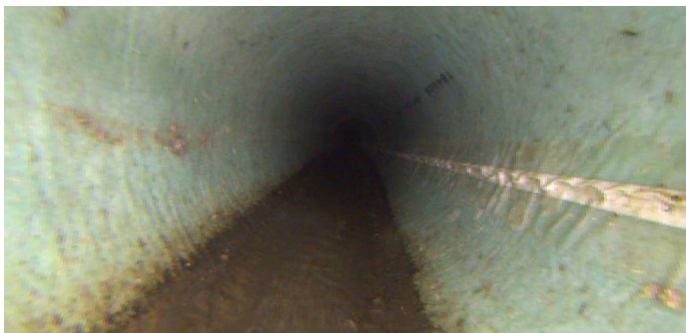
Code: **AMH**
Description: **Manhole**

Distance (ft): **.0**
Structural Grade: **0**
O&M Grade: **0**
Clock Start/From:
Clock To:
1st Value:
2nd Value:
Value Percent:
Continuous Index:
Within 8" of Joint: **NO**
Remarks: **M-305-034**

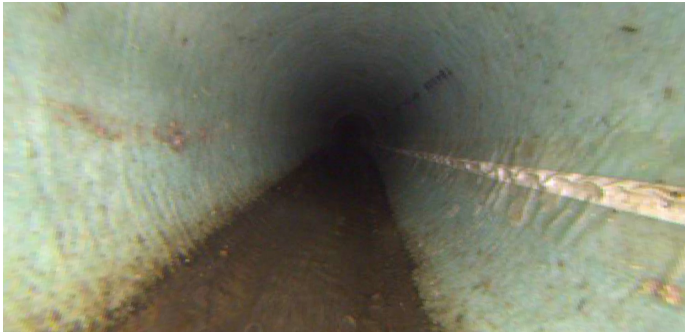
Code:	MWL
Description:	Water Level

Distance (ft):	.0
Structural Grade:	0
O&M Grade:	0
Clock Start/From:	
Clock To:	
1st Value:	
2nd Value:	
Value Percent:	5.000
Continuous Index:	
Within 8" of Joint:	NO
Remarks:

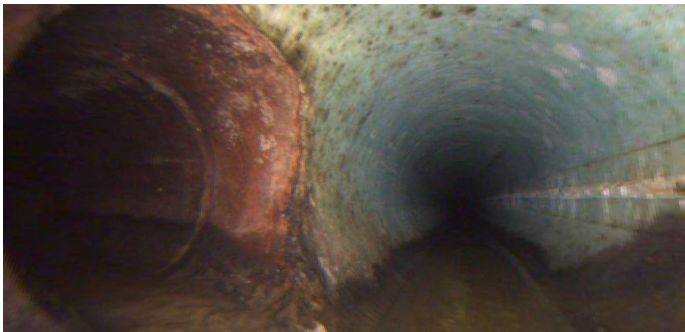
Code:	TB
Description:	Tap Break-in

Distance (ft):	20.0
Structural Grade:	0
O&M Grade:	0
Clock Start/From:	9
Clock To:	
1st Value:	6.000
2nd Value:	
Value Percent:	
Continuous Index:	
Within 8" of Joint:	
Remarks:

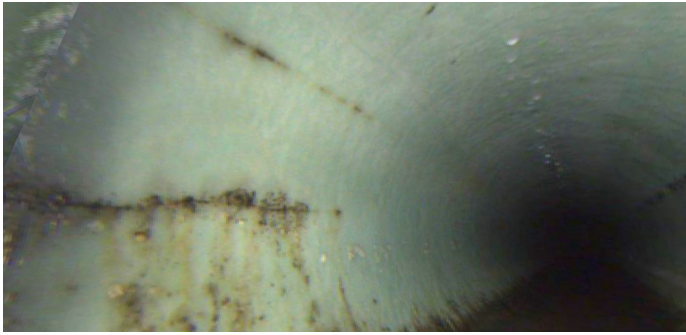
Code: **LFZ**
Description: **Lining Failure Other**

Distance (ft): **131.6**
Structural Grade: **0**
O&M Grade: **0**
Clock Start/From: **9**
Clock To: **10**
1st Value:
2nd Value:
Value Percent:
Continuous Index:
Within 8" of Joint: **NO**
Remarks: **scratch**

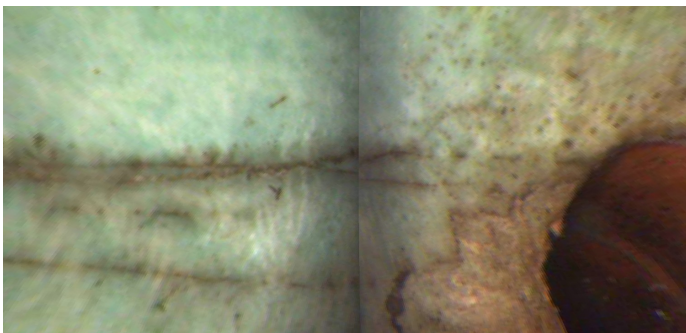
Code: **LFZ**
Description: **Lining Failure Other**

Distance (ft): **177.4**
Structural Grade: **0**
O&M Grade: **0**
Clock Start/From: **9**
Clock To:
1st Value:
2nd Value:
Value Percent:
Continuous Index:
Within 8" of Joint: **NO**
Remarks: **scratches**

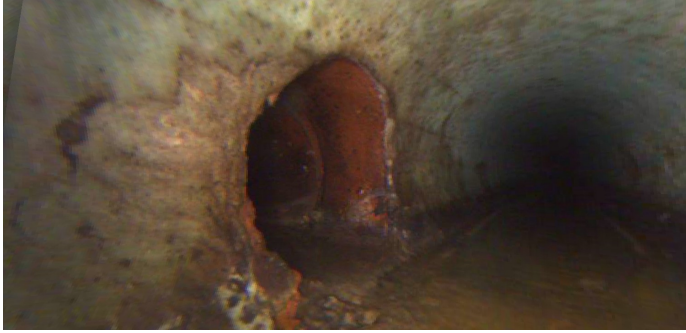
Code: **TB**
Description: **Tap Break-in**

Distance (ft): **177.4**
Structural Grade: **0**
O&M Grade: **0**
Clock Start/From: **9**
Clock To:
1st Value: **6.000**
2nd Value:
Value Percent:
Continuous Index:
Within 8" of Joint:
Remarks:

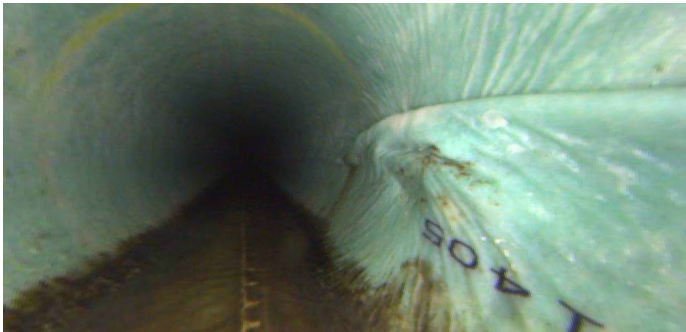
Code: **LFW**
Description: **Lining Failure Wrinkled**

Distance (ft): **195.9**
Structural Grade: **3**
O&M Grade: **0**
Clock Start/From: **3**
Clock To:
1st Value:
2nd Value:
Value Percent:
Continuous Index:
Within 8" of Joint: **NO**
Remarks:

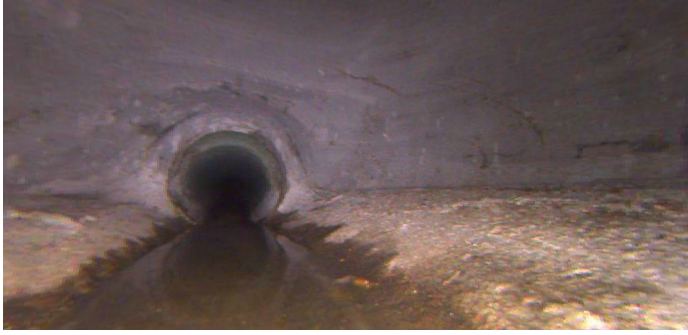
Code:	AMH
Description:	Manhole
Distance (ft):	243.5
Structural Grade:	0
O&M Grade:	0
Clock Start/From:	
Clock To:	
1st Value:	
2nd Value:	
Value Percent:	
Continuous Index:	
Within 8" of Joint:	NO
Remarks:	M-305-035
