Profile/Photo Observation Report

Date:	04/17/2018	Weather:		Coding:	PACP 6.0
Pipe Length (ft):	273.2	Owner:	NA	Pre Clean:	No Pre-Cleaning
P.O.#:		Surveyor:	Justin Gonzales	PSR:	P-305-036-037
Customer:		Clean Date:	01/01/1900	Shape:	C

Street:	OFF CRABAPPLE LN	Flow Control:	Not Controlled
City:	Hobart, IN	Year Renewed:	
Location:	Sidewalk	Tape/Media #:	
Purpose:	Routine Assessment	Dia/Height:	10"
Use:	Sanitary	Material:	PVC
Drain Area:	NA	Lining:	
Category:	NA		
Comment:	Flow direction wrong

Location Details:		Direction of Survey:	Downstream
US MH:	M-305-037	DS MH:	M-305-036
		Total Length Surveyed (ft):	269.3

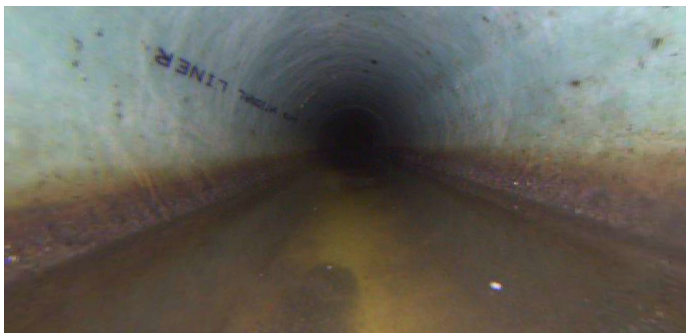
Code: **AMH**
Description: **Manhole**

Distance (ft):	.0
Structural Grade:	0
O&M Grade:	0
Clock Start/From:	
Clock To:	
1st Value:	
2nd Value:	
Value Percent:	
Continuous Index:	
Within 8" of Joint:	NO
Remarks:	M-305-037

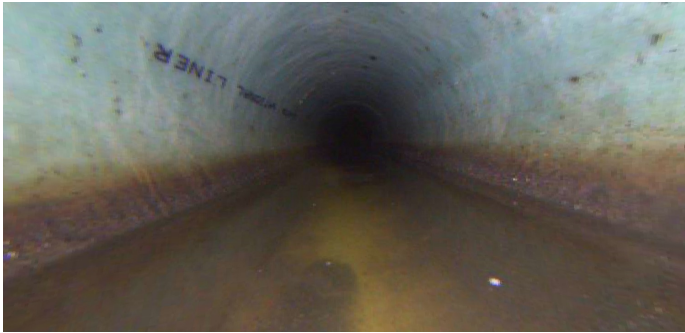
Code:	MWL
Description:	Water Level

Distance (ft):	.0
Structural Grade:	0
O&M Grade:	0
Clock Start/From:	
Clock To:	
1st Value:	
2nd Value:	
Value Percent:	15.000
Continuous Index:	
Within 8" of Joint:	NO
Remarks:

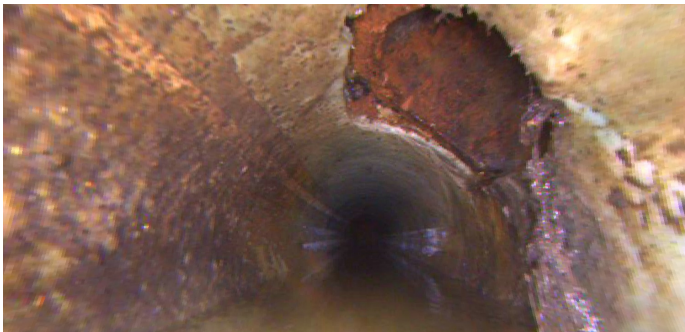
Code:	TB
Description:	Tap Break-in

Distance (ft):	59.0
Structural Grade:	0
O&M Grade:	0
Clock Start/From:	2
Clock To:	
1st Value:	4.000
2nd Value:	
Value Percent:	
Continuous Index:	
Within 8" of Joint:	
Remarks:

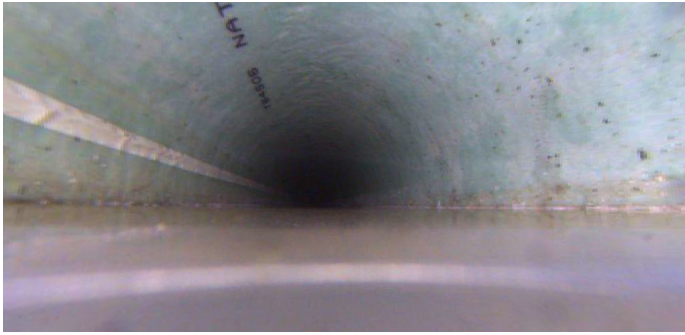
Code: **MWLS**
Description: **Water Level Sag**

Distance (ft): **134.8**
Structural Grade: **3**
O&M Grade: **3**
Clock Start/From:
Clock To:
1st Value:
2nd Value:
Value Percent: **40.000**
Continuous Index:
Within 8" of Joint: **NO**
Remarks:

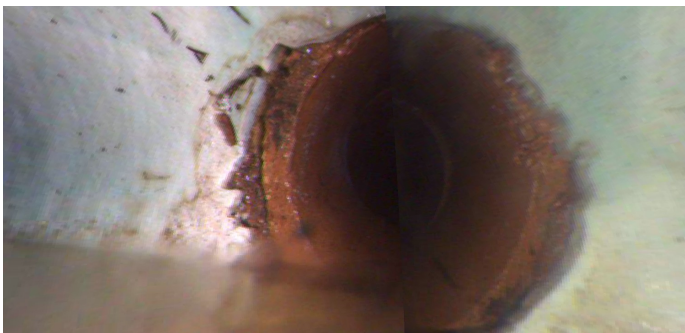
Code: **TB**
Description: **Tap Break-in**

Distance (ft): **150.0**
Structural Grade: **0**
O&M Grade: **0**
Clock Start/From: **3**
Clock To:
1st Value: **4.000**
2nd Value:
Value Percent:
Continuous Index:
Within 8" of Joint:
Remarks:

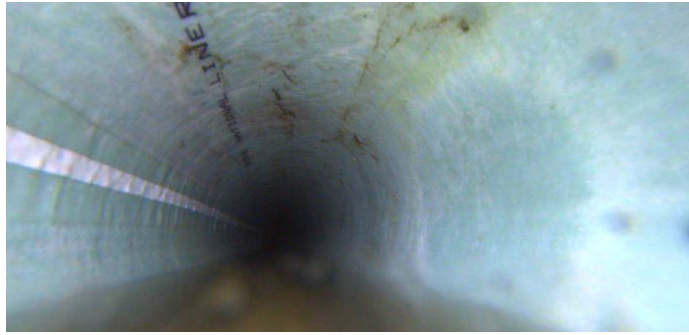
Code:	LFAC
Description:	Lining Failure Abandoned Connection
Distance (ft):	165.0
Structural Grade:	0
O&M Grade:	0
Clock Start/From:	3
Clock To:	
1st Value:	
2nd Value:	
Value Percent:	
Continuous Index:	
Within 8" of Joint:	NO
Remarks:

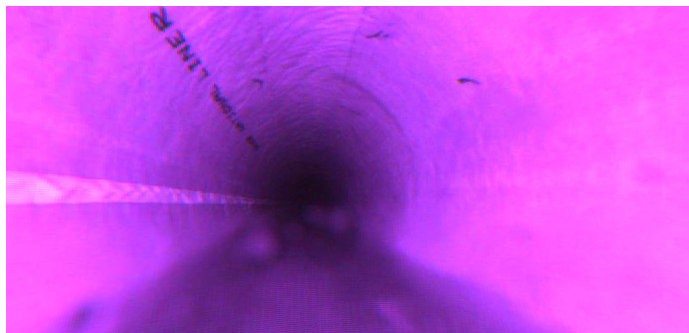
Code:	MGO
Description:	General Observation
Distance (ft):	175.2
Structural Grade:	0
O&M Grade:	0
Clock Start/From:	
Clock To:	
1st Value:	
2nd Value:	
Value Percent:	
Continuous Index:	
Within 8" of Joint:	NO
Remarks:	CAMERA PINK HUE

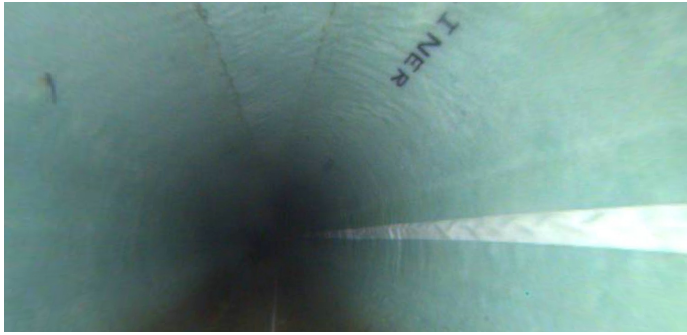
Code:	MGO
Description:	General Observation
Distance (ft):	176.2
Structural Grade:	0
O&M Grade:	0
Clock Start/From:	
Clock To:	
1st Value:	
2nd Value:	
Value Percent:	
Continuous Index:	
Within 8" of Joint:	NO
Remarks:	rear camera

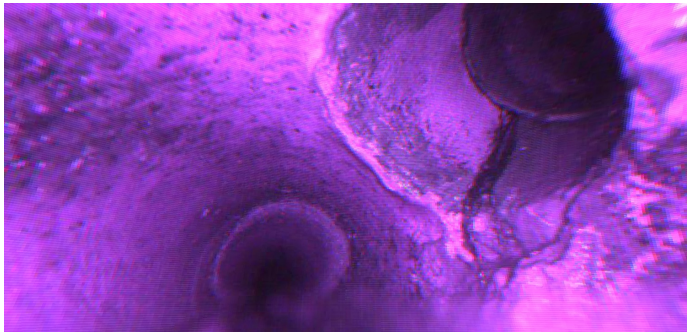
Code:	TF
Description:	Tap Factory
Distance (ft):	214.6
Structural Grade:	0
O&M Grade:	0
Clock Start/From:	2
Clock To:	
1st Value:	4.000
2nd Value:	
Value Percent:	
Continuous Index:	
Within 8" of Joint:	
Remarks:

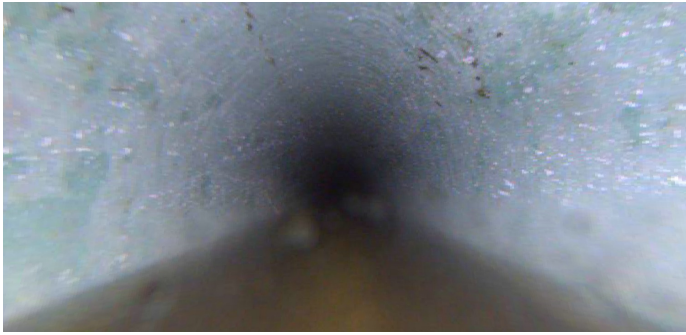
Code: **MGO**
Description: **General Observation**

Distance (ft): **243.8**
Structural Grade: **0**
O&M Grade: **0**
Clock Start/From:
Clock To:
1st Value:
2nd Value:
Value Percent:
Continuous Index:
Within 8" of Joint: **NO**
Remarks: **CAMERA RESUME NORMAL VIEW;
ISSUE WITH CAMERA**

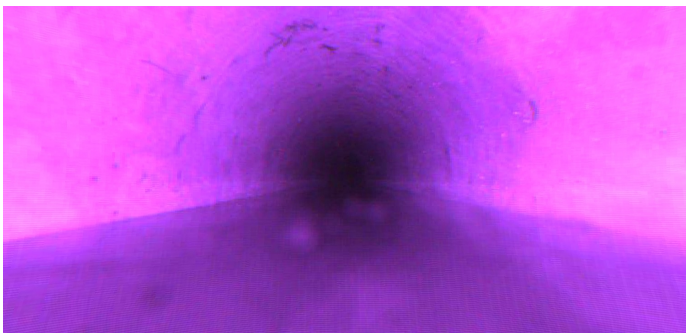
Code: **MGO**
Description: **General Observation**

Distance (ft): **247.5**
Structural Grade: **0**
O&M Grade: **0**
Clock Start/From:
Clock To:
1st Value:
2nd Value:
Value Percent:
Continuous Index:
Within 8" of Joint: **NO**
Remarks: **CAMERA ISSUE INTERMITTENT**

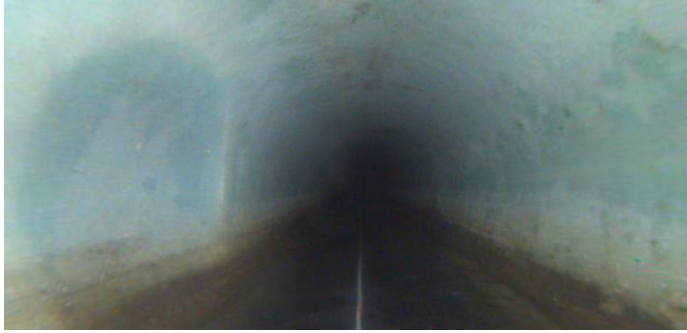
Code:	LFAC
Description:	Lining Failure Abandoned Connection
Distance (ft):	253.2
Structural Grade:	0
O&M Grade:	0
Clock Start/From:	3
Clock To:	
1st Value:	
2nd Value:	
Value Percent:	
Continuous Index:	
Within 8" of Joint:	NO
Remarks:

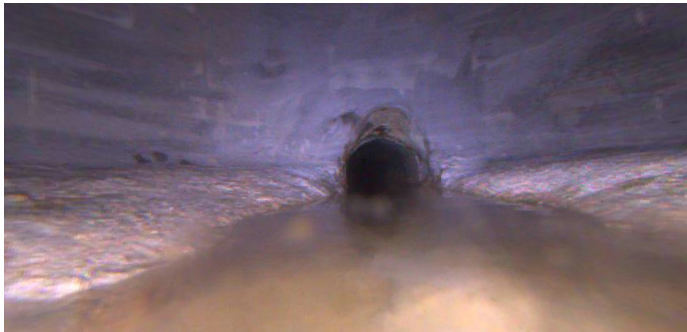
Code:	AMH
Description:	Manhole
Distance (ft):	269.3
Structural Grade:	0
O&M Grade:	0
Clock Start/From:	
Clock To:	
1st Value:	
2nd Value:	
Value Percent:	
Continuous Index:	
Within 8" of Joint:	NO
Remarks:	M-305-036
