Profile/Photo Observation Report

Date:	04/17/2018	Weather:		Coding:	PACP 6.0
Pipe Length (ft):	273.2	Owner:	NA	Pre Clean:	No Pre-Cleaning
P.O.#:		Surveyor:	Justin Gonzales	PSR:	P-305-036-037
Customer:		Clean Date:	01/01/1900	Shape:	C

Street:	FOXCROFT STREET	Flow Control:	Not Controlled
City:	Hobart, IN	Year Renewed:	
Location:	Sidewalk	Tape/Media #:	
Purpose:	Routine Assessment	Dia/Height:	10"
Use:	Sanitary	Material:	PVC
Drain Area:	NA	Lining:	
Category:	NA		
Comment:	Flow direction wrong

Location Details:		Direction of Survey:	Downstream
US MH:	M-305-037	DS MH:	M-305-036
		Total Length Surveyed (ft):	269.3

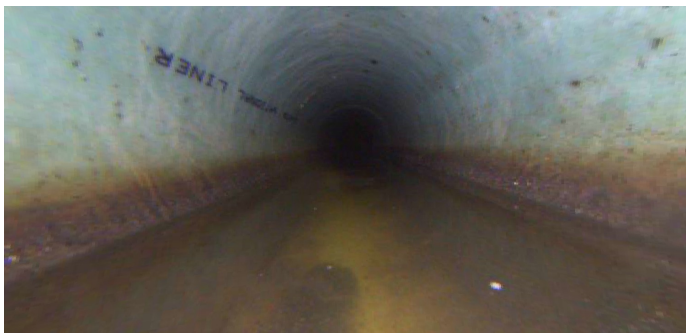
Code: **AMH**
Description: **Manhole**

Distance (ft): **.0**
Structural Grade: **0**
O&M Grade: **0**
Clock Start/From:
Clock To:
1st Value:
2nd Value:
Value Percent:
Continuous Index:
Within 8" of Joint: **NO**
Remarks: **M-305-037**

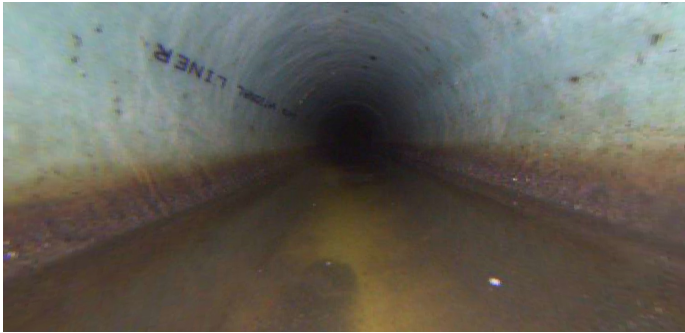
Code:	MWL
Description:	Water Level

Distance (ft):	.0
Structural Grade:	0
O&M Grade:	0
Clock Start/From:	
Clock To:	
1st Value:	
2nd Value:	
Value Percent:	15.000
Continuous Index:	
Within 8" of Joint:	NO
Remarks:

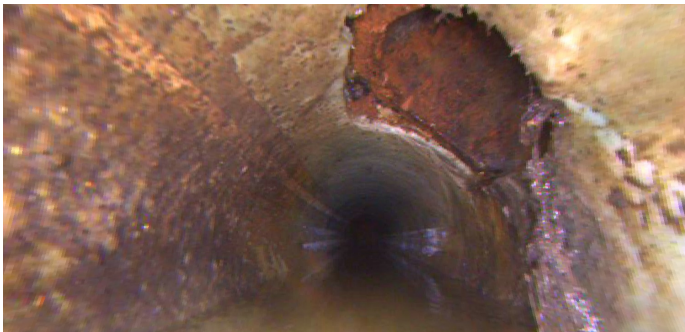
Code:	TB
Description:	Tap Break-in

Distance (ft):	59.0
Structural Grade:	0
O&M Grade:	0
Clock Start/From:	2
Clock To:	
1st Value:	4.000
2nd Value:	
Value Percent:	
Continuous Index:	
Within 8" of Joint:	
Remarks:

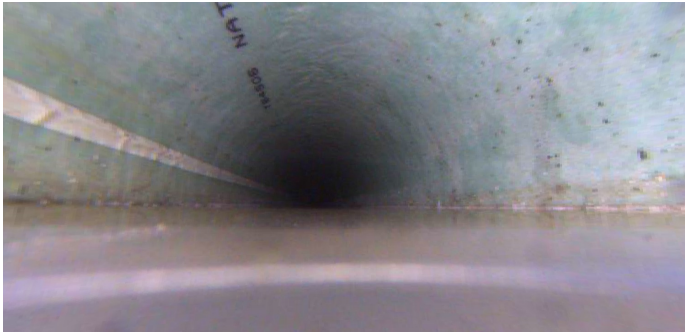
Code: **MWLS**
Description: **Water Level Sag**

Distance (ft): **134.8**
Structural Grade: **3**
O&M Grade: **3**
Clock Start/From:
Clock To:
1st Value:
2nd Value:
Value Percent: **40.000**
Continuous Index:
Within 8" of Joint: **NO**
Remarks:

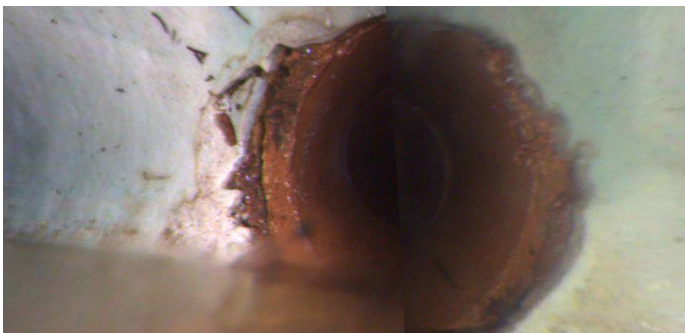
Code: **TB**
Description: **Tap Break-in**

Distance (ft): **150.0**
Structural Grade: **0**
O&M Grade: **0**
Clock Start/From: **3**
Clock To:
1st Value: **4.000**
2nd Value:
Value Percent:
Continuous Index:
Within 8" of Joint:
Remarks:

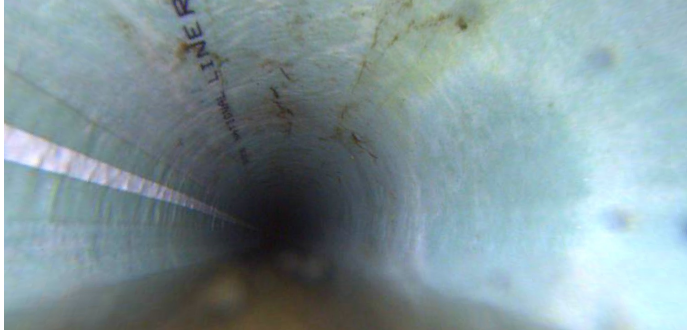
Code: **LFAC**
Description: **Lining Failure Abandoned Connection**

Distance (ft): **165.0**
Structural Grade: **0**
O&M Grade: **0**
Clock Start/From: **3**
Clock To:
1st Value:
2nd Value:
Value Percent:
Continuous Index:
Within 8" of Joint: **NO**
Remarks:

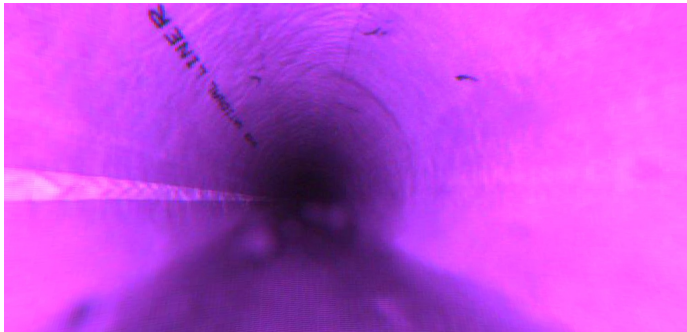
Code: **MGO**
Description: **General Observation**

Distance (ft): **175.2**
Structural Grade: **0**
O&M Grade: **0**
Clock Start/From:
Clock To:
1st Value:
2nd Value:
Value Percent:
Continuous Index:
Within 8" of Joint: **NO**
Remarks: **CAMERA PINK HUE**

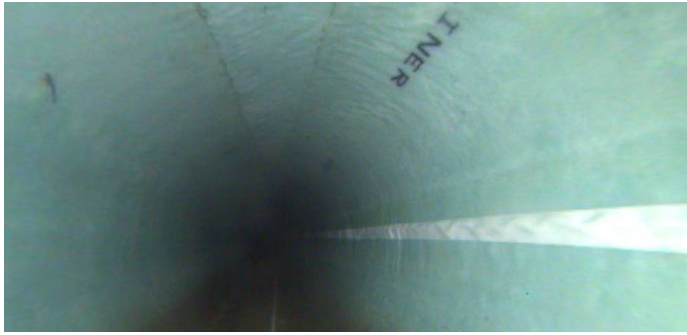
Code:	MGO
Description:	General Observation
Distance (ft):	176.2
Structural Grade:	0
O&M Grade:	0
Clock Start/From:	
Clock To:	
1st Value:	
2nd Value:	
Value Percent:	
Continuous Index:	
Within 8" of Joint:	NO
Remarks:	rear camera

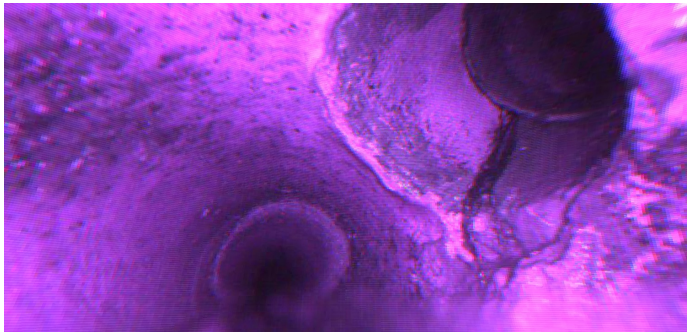
Code:	TF
Description:	Tap Factory
Distance (ft):	214.6
Structural Grade:	0
O&M Grade:	0
Clock Start/From:	2
Clock To:	
1st Value:	4.000
2nd Value:	
Value Percent:	
Continuous Index:	
Within 8" of Joint:	
Remarks:

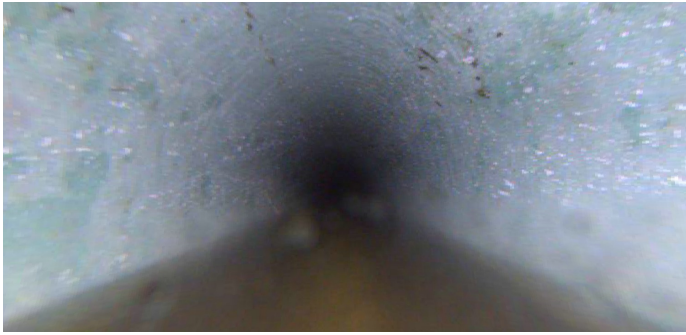
Code: **MGO**
Description: **General Observation**

Distance (ft): **243.8**
Structural Grade: **0**
O&M Grade: **0**
Clock Start/From:
Clock To:
1st Value:
2nd Value:
Value Percent:
Continuous Index:
Within 8" of Joint: **NO**
Remarks: **CAMERA RESUME NORMAL VIEW;
ISSUE WITH CAMERA**

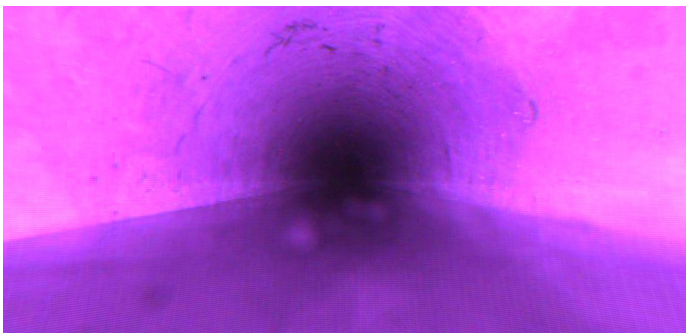
Code: **MGO**
Description: **General Observation**

Distance (ft): **247.5**
Structural Grade: **0**
O&M Grade: **0**
Clock Start/From:
Clock To:
1st Value:
2nd Value:
Value Percent:
Continuous Index:
Within 8" of Joint: **NO**
Remarks: **CAMERA ISSUE INTERMITTENT**

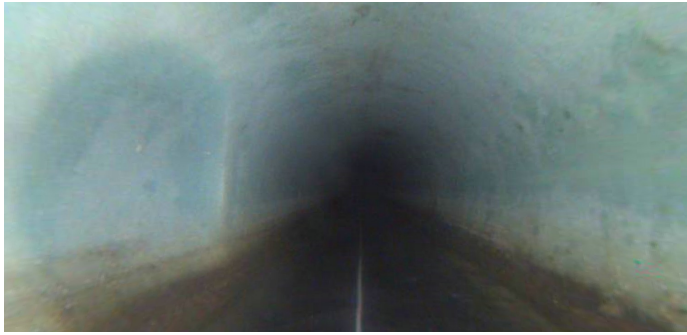
Code:	LFAC
Description:	Lining Failure Abandoned Connection
Distance (ft):	253.2
Structural Grade:	0
O&M Grade:	0
Clock Start/From:	3
Clock To:	
1st Value:	
2nd Value:	
Value Percent:	
Continuous Index:	
Within 8" of Joint:	NO
Remarks:

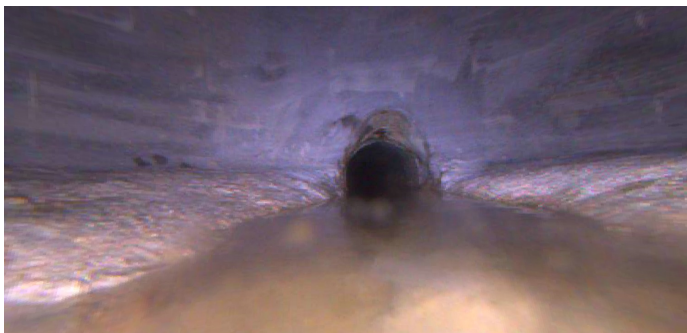
Code:	AMH
Description:	Manhole
Distance (ft):	269.3
Structural Grade:	0
O&M Grade:	0
Clock Start/From:	
Clock To:	
1st Value:	
2nd Value:	
Value Percent:	
Continuous Index:	
Within 8" of Joint:	NO
Remarks:	M-305-036
