## Profile/Photo Observation Report

Street:	<b>OFF CRABAPPLE LN</b>	Flow Control:	<b>Not Controlled</b>
City:	<b>Hobart, IN</b>	Year Renewed:	
Location:	<b>Yard</b>	Tape/Media #:	
Purpose:	<b>Routine Assessment</b>	Dia/Height:	<b>10"</b>
Use:	<b>Sanitary</b>	Material:	<b>VCP</b>
Drain Area:	<b>NA</b>	Lining:	<b>Cured in Place</b>
Category:	<b>NA</b>		
Comment:

Location Details:		Direction of Survey:	<b>Downstream</b>
US MH:	<b>M-305-039</b>	DS MH:	<b>M-305-038</b>
		Total Length Surveyed (ft):	<b>292.4</b>

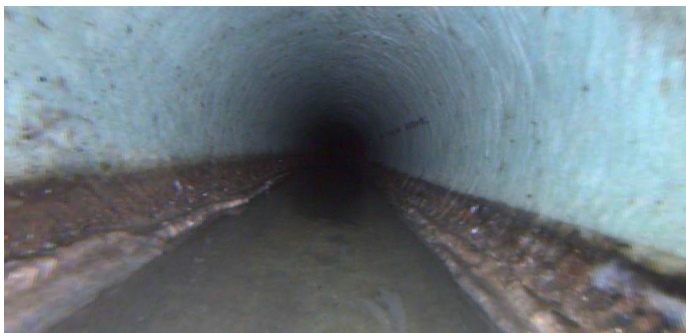
Code: **AMH**  
Description: **Manhole**

Distance (ft): **.0**  
Structural Grade: **0**  
O&M Grade: **0**  
Clock Start/From:  
Clock To:  
1st Value:  
2nd Value:  
Value Percent:  
Continuous Index:  
Within 8" of Joint: **NO**  
Remarks: **M-305-039**

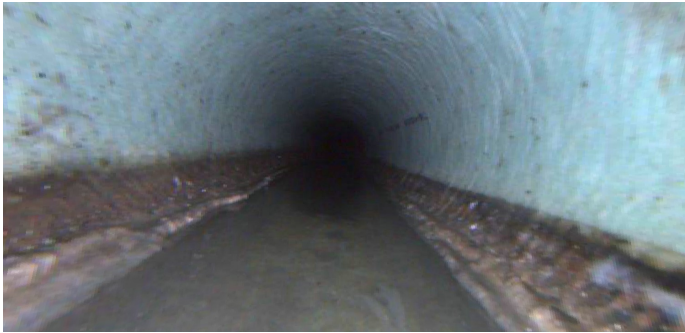
Code:	<b>MWL</b>
Description:	<b>Water Level</b>

Distance (ft):	<b>.0</b>
Structural Grade:	<b>0</b>
O&M Grade:	<b>0</b>
Clock Start/From:	
Clock To:	
1st Value:	
2nd Value:	
Value Percent:	<b>5.000</b>
Continuous Index:	
Within 8" of Joint:	<b>NO</b>
Remarks:

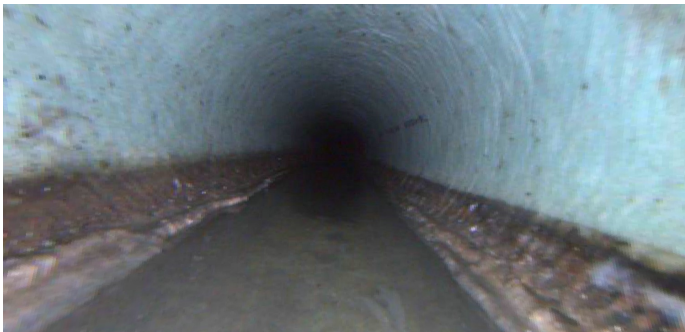
Code:	<b>DAZ</b>
Description:	<b>Deposits Attached Other</b>

Distance (ft):	<b>.0</b>
Structural Grade:	<b>0</b>
O&M Grade:	<b>2</b>
Clock Start/From:	<b>7</b>
Clock To:	<b>5</b>
1st Value:	
2nd Value:	
Value Percent:	<b>5.000</b>
Continuous Index:	<b>S01</b>
Within 8" of Joint:	<b>YES</b>
Remarks:	<b>WANDER</b>

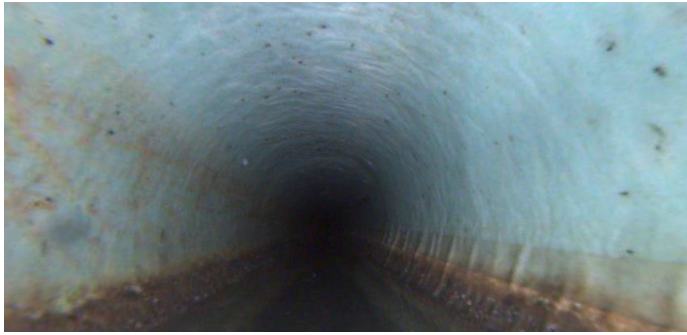
Code:	<b>LFAC</b>
Description:	<b>Lining Failure Abandoned Connection</b>
Distance (ft):	<b>9.8</b>
Structural Grade:	<b>0</b>
O&M Grade:	<b>0</b>
Clock Start/From:	<b>3</b>
Clock To:	
1st Value:	
2nd Value:	
Value Percent:	
Continuous Index:	
Within 8" of Joint:	<b>NO</b>
Remarks:

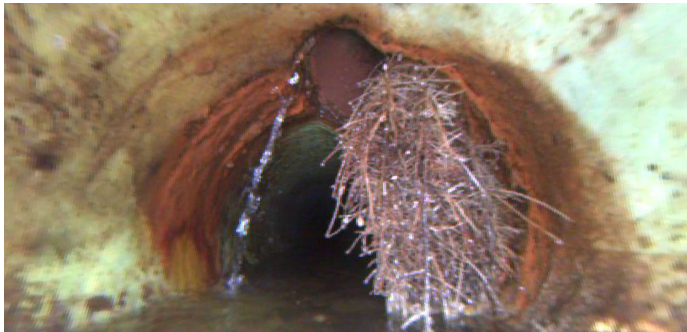
Code:	<b>RML</b>
Description:	<b>Roots Medium Lateral</b>
Distance (ft):	<b>21.0</b>
Structural Grade:	<b>0</b>
O&M Grade:	<b>3</b>
Clock Start/From:	<b>1</b>
Clock To:	<b>5</b>
1st Value:	
2nd Value:	
Value Percent:	<b>40.000</b>
Continuous Index:	
Within 8" of Joint:	<b>NO</b>
Remarks:

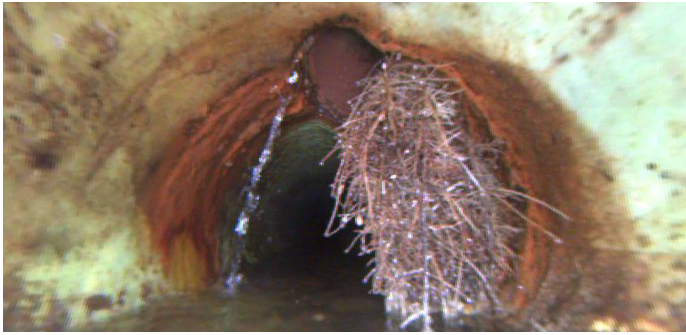
Code: **TFD**  
Description: **Tap Factory Defective**

Distance (ft): **21.0**  
Structural Grade: **0**  
O&M Grade: **2**  
Clock Start/From: **1**  
Clock To:  
1st Value: **4.000**  
2nd Value:  
Value Percent:  
Continuous Index:  
Within 8" of Joint:  
Remarks: **ROOTS COMING FROM TAP**

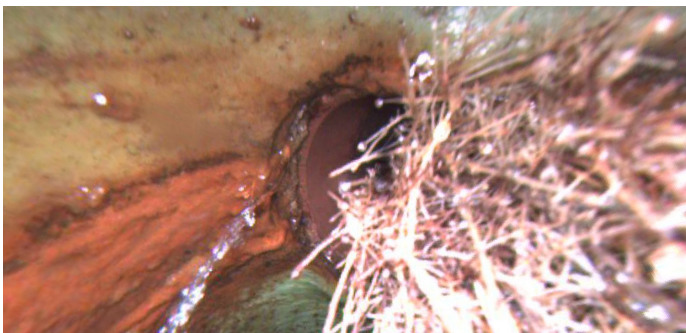
Code: **IR**  
Description: **Infil Runner**

Distance (ft): **21.4**  
Structural Grade: **0**  
O&M Grade: **4**  
Clock Start/From: **12**  
Clock To:  
1st Value:  
2nd Value:  
Value Percent:  
Continuous Index:  
Within 8" of Joint:  
Remarks:

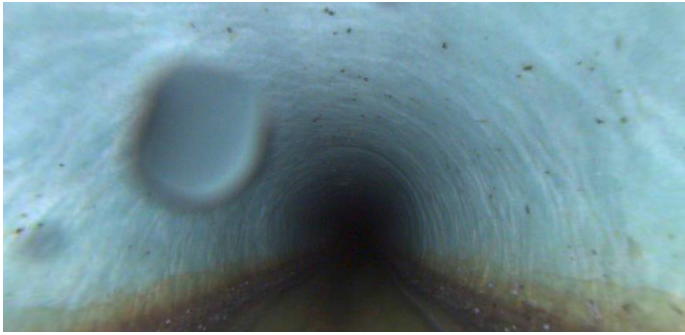
Code: **LR**  
Description: **Alignment Right**

Distance (ft): **54.8**  
Structural Grade: **0**  
O&M Grade: **1**  
Clock Start/From:  
Clock To:  
1st Value:  
2nd Value:  
Value Percent: **5.000**  
Continuous Index:  
Within 8" of Joint: **NO**  
Remarks:

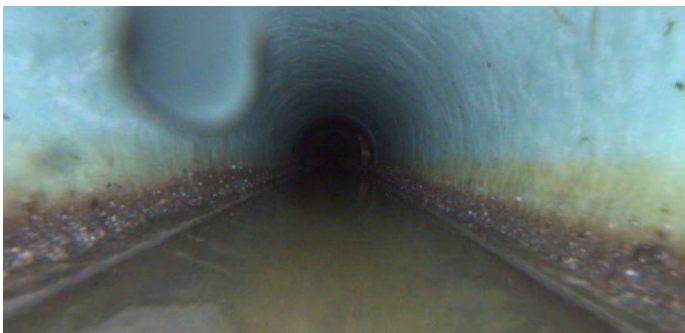
Code: **MWL**  
Description: **Water Level**

Distance (ft): **88.1**  
Structural Grade: **0**  
O&M Grade: **0**  
Clock Start/From:  
Clock To:  
1st Value:  
2nd Value:  
Value Percent: **20.000**  
Continuous Index:  
Within 8" of Joint: **NO**  
Remarks:

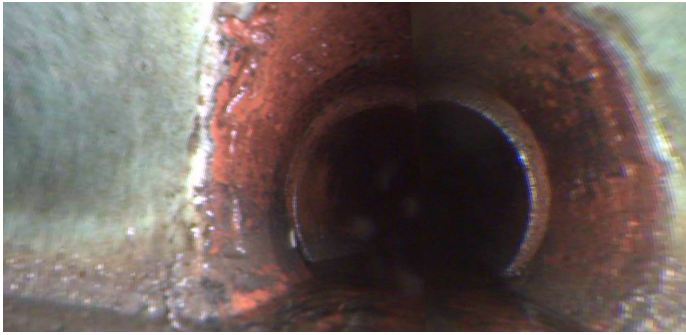
Code: **TFA**  
Description: **Tap Factory Active**

Distance (ft): **91.5**  
Structural Grade: **0**  
O&M Grade: **0**  
Clock Start/From: **3**  
Clock To:  
1st Value: **4.000**  
2nd Value:  
Value Percent:  
Continuous Index:  
Within 8" of Joint:  
Remarks:

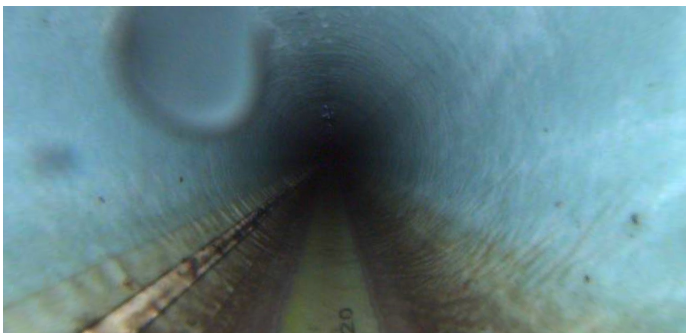
Code: **MWL**  
Description: **Water Level**

Distance (ft): **103.6**  
Structural Grade: **0**  
O&M Grade: **0**  
Clock Start/From:  
Clock To:  
1st Value:  
2nd Value:  
Value Percent: **5.000**  
Continuous Index:  
Within 8" of Joint: **NO**  
Remarks:

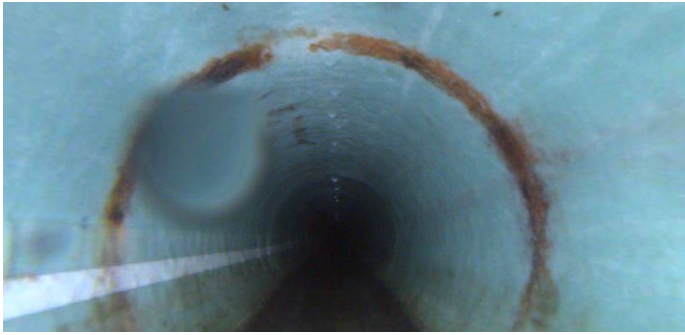
Code: **IS**  
Description: **Infil Stain**

Distance (ft): **135.7**  
Structural Grade: **0**  
O&M Grade: **0**  
Clock Start/From: **8**  
Clock To: **4**  
1st Value:  
2nd Value:  
Value Percent:  
Continuous Index:  
Within 8" of Joint:  
Remarks:

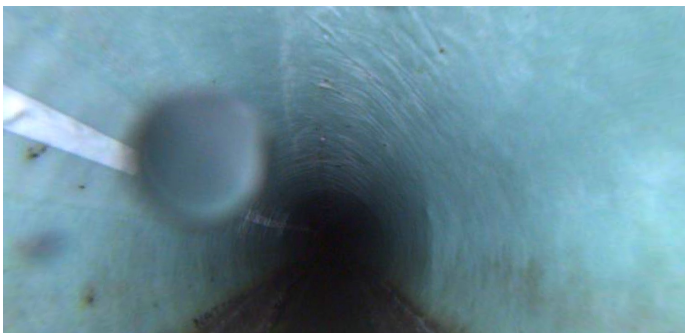
Code: **LFAC**  
Description: **Lining Failure Abandoned Connection**

Distance (ft): **167.2**  
Structural Grade: **0**  
O&M Grade: **0**  
Clock Start/From: **3**  
Clock To:  
1st Value:  
2nd Value:  
Value Percent:  
Continuous Index:  
Within 8" of Joint: **NO**  
Remarks:

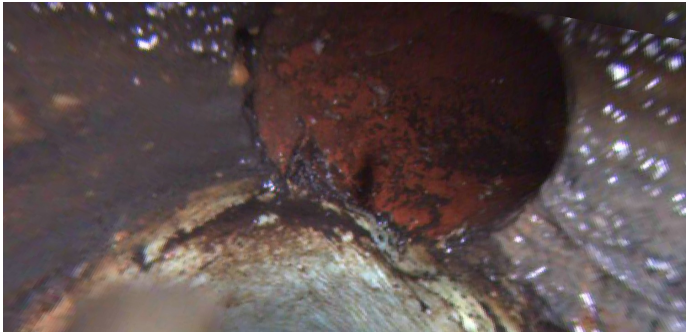
Code: **TBA**  
Description: **Tap Break-in Active**

Distance (ft): **180.0**  
Structural Grade: **0**  
O&M Grade: **0**  
Clock Start/From: **1**  
Clock To:  
1st Value: **4.000**  
2nd Value:  
Value Percent:  
Continuous Index:  
Within 8" of Joint:  
Remarks:

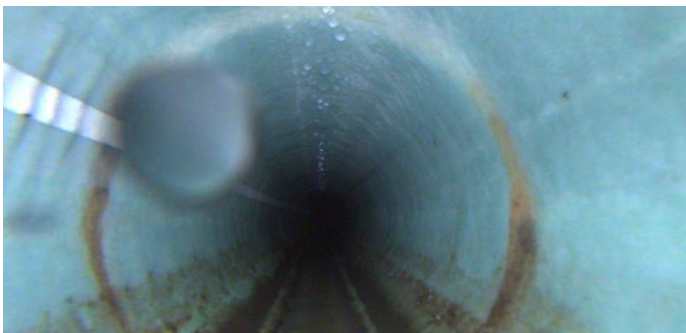
Code: **IS**  
Description: **Infil Stain**

Distance (ft): **206.1**  
Structural Grade: **0**  
O&M Grade: **0**  
Clock Start/From: **8**  
Clock To: **4**  
1st Value:  
2nd Value:  
Value Percent:  
Continuous Index:  
Within 8" of Joint:  
Remarks:

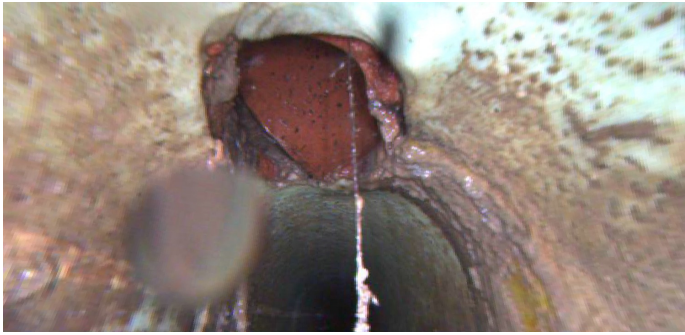
Code: **TBD**  
Description: **Tap Break-in Defective**

Distance (ft): **252.7**  
Structural Grade: **0**  
O&M Grade: **3**  
Clock Start/From: **12**  
Clock To:  
1st Value: **4.000**  
2nd Value:  
Value Percent:  
Continuous Index:  
Within 8" of Joint:  
Remarks: **roots**

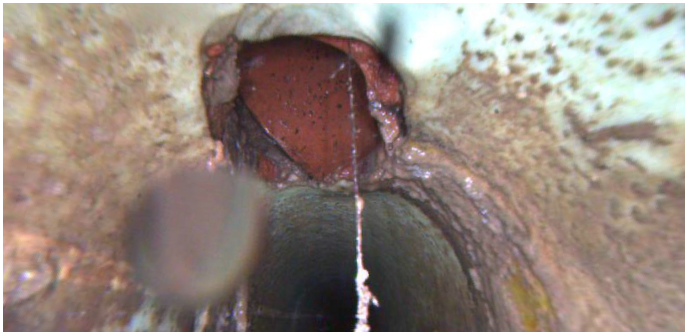
Code: **RFL**  
Description: **Roots Fine Lateral**

Distance (ft): **252.7**  
Structural Grade: **0**  
O&M Grade: **1**  
Clock Start/From: **12**  
Clock To:  
1st Value:  
2nd Value:  
Value Percent:  
Continuous Index:  
Within 8" of Joint: **NO**  
Remarks:

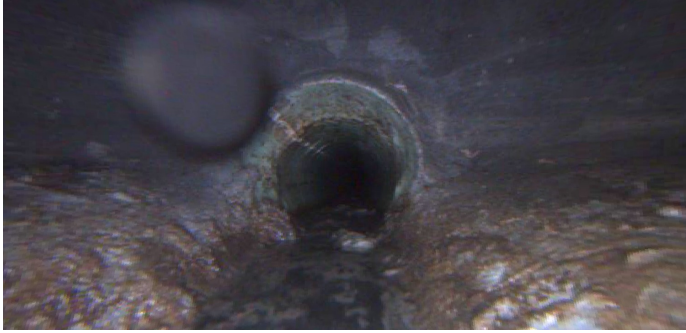
Code: **AMH**  
Description: **Manhole**

Distance (ft): **292.4**  
Structural Grade: **0**  
O&M Grade: **0**  
Clock Start/From:  
Clock To:  
1st Value:  
2nd Value:  
Value Percent:  
Continuous Index:  
Within 8" of Joint: **NO**  
Remarks: **M-305-038**

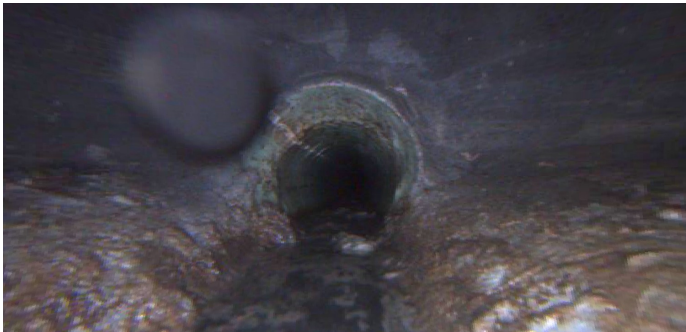
Code: **DAZ**  
Description: **Deposits Attached Other**

Distance (ft): **292.4**  
Structural Grade: **0**  
O&M Grade: **2**  
Clock Start/From: **7**  
Clock To: **5**  
1st Value:  
2nd Value:  
Value Percent: **5.000**  
Continuous Index: **F01**  
Within 8" of Joint: **YES**  
Remarks: **WANDER**
