Profile/Photo Observation Report

Street:	FOXCROFT STREET	Flow Control:	Not Controlled
City:	Hobart, IN	Year Renewed:	
Location:	Yard	Tape/Media #:	
Purpose:	Routine Assessment	Dia/Height:	10"
Use:	Sanitary	Material:	VCP
Drain Area:	NA	Lining:	Cured in Place
Category:	NA		
Comment:

Location Details:		Direction of Survey:	Downstream
US MH:	M-305-039	DS MH:	M-305-038
		Total Length Surveyed (ft):	292.4

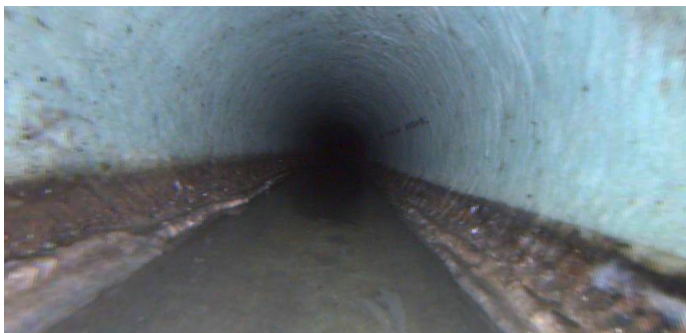
Code: **AMH**
Description: **Manhole**

Distance (ft): **.0**
Structural Grade: **0**
O&M Grade: **0**
Clock Start/From:
Clock To:
1st Value:
2nd Value:
Value Percent:
Continuous Index:
Within 8" of Joint: **NO**
Remarks: **M-305-039**

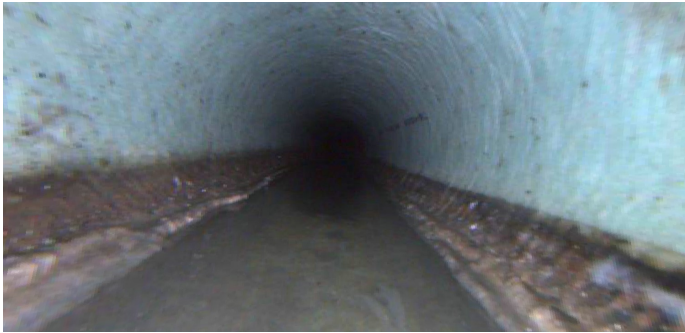
Code:	MWL
Description:	Water Level

Distance (ft):	.0
Structural Grade:	0
O&M Grade:	0
Clock Start/From:	
Clock To:	
1st Value:	
2nd Value:	
Value Percent:	5.000
Continuous Index:	
Within 8" of Joint:	NO
Remarks:

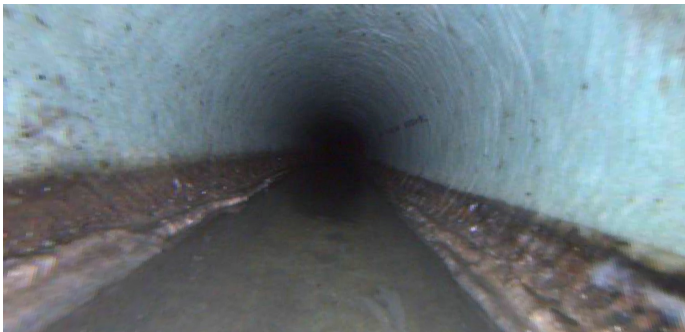
Code:	DAZ
Description:	Deposits Attached Other

Distance (ft):	.0
Structural Grade:	0
O&M Grade:	2
Clock Start/From:	7
Clock To:	5
1st Value:	
2nd Value:	
Value Percent:	5.000
Continuous Index:	S01
Within 8" of Joint:	YES
Remarks:	WANDER

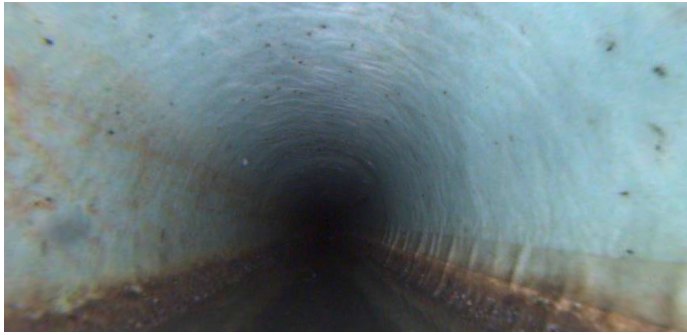
Code:	LFAC
Description:	Lining Failure Abandoned Connection
Distance (ft):	9.8
Structural Grade:	0
O&M Grade:	0
Clock Start/From:	3
Clock To:	
1st Value:	
2nd Value:	
Value Percent:	
Continuous Index:	
Within 8" of Joint:	NO
Remarks:

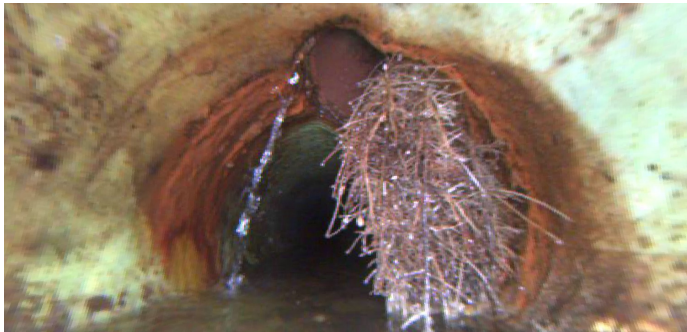
Code:	RML
Description:	Roots Medium Lateral
Distance (ft):	21.0
Structural Grade:	0
O&M Grade:	3
Clock Start/From:	1
Clock To:	5
1st Value:	
2nd Value:	
Value Percent:	40.000
Continuous Index:	
Within 8" of Joint:	NO
Remarks:

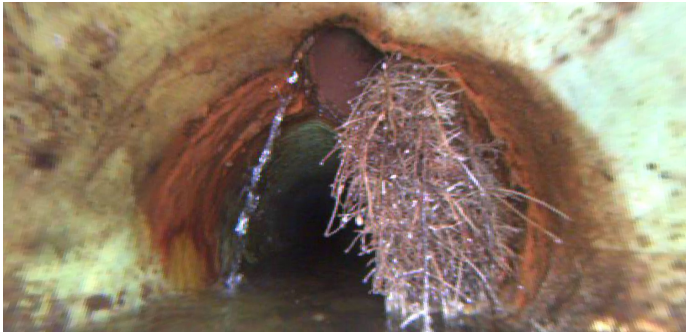
Code: **TFD**
Description: **Tap Factory Defective**

Distance (ft): **21.0**
Structural Grade: **0**
O&M Grade: **2**
Clock Start/From: **1**
Clock To:
1st Value: **4.000**
2nd Value:
Value Percent:
Continuous Index:
Within 8" of Joint:

Remarks: **ROOTS COMING FROM TAP**

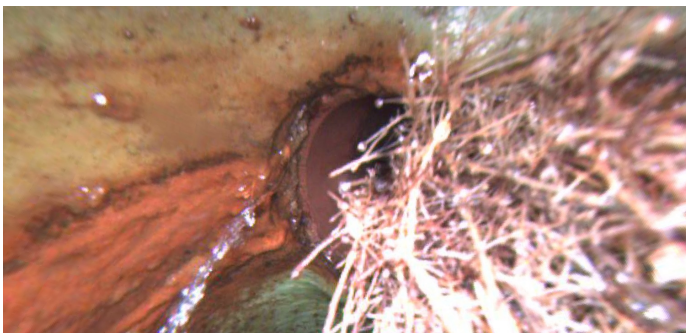
Code: **IR**
Description: **Infil Runner**

Distance (ft): **21.4**
Structural Grade: **0**
O&M Grade: **4**
Clock Start/From: **12**
Clock To:
1st Value:
2nd Value:
Value Percent:
Continuous Index:
Within 8" of Joint:
Remarks:

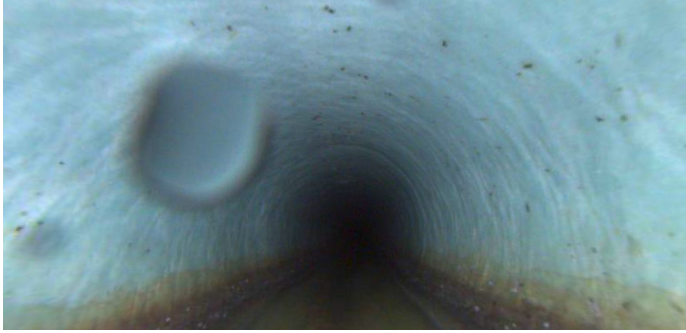
Code: **LR**
Description: **Alignment Right**

Distance (ft): **54.8**
Structural Grade: **0**
O&M Grade: **1**
Clock Start/From:
Clock To:
1st Value:
2nd Value:
Value Percent: **5.000**
Continuous Index:
Within 8" of Joint: **NO**
Remarks:

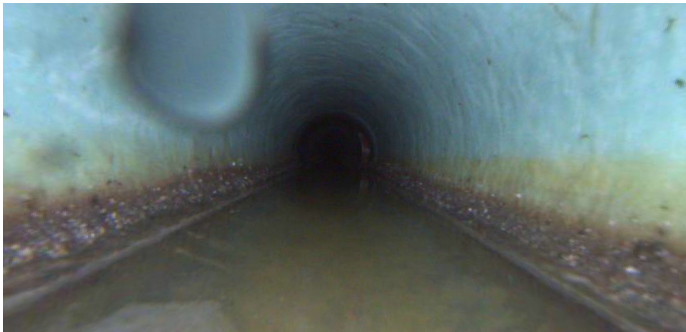
Code: **MWL**
Description: **Water Level**

Distance (ft): **88.1**
Structural Grade: **0**
O&M Grade: **0**
Clock Start/From:
Clock To:
1st Value:
2nd Value:
Value Percent: **20.000**
Continuous Index:
Within 8" of Joint: **NO**
Remarks:

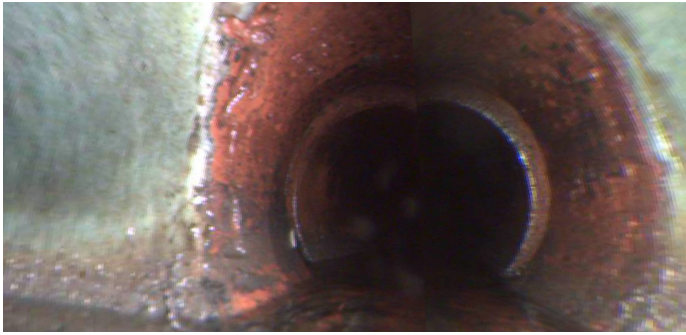
Code: **TFA**
Description: **Tap Factory Active**

Distance (ft): **91.5**
Structural Grade: **0**
O&M Grade: **0**
Clock Start/From: **3**
Clock To:
1st Value: **4.000**
2nd Value:
Value Percent:
Continuous Index:
Within 8" of Joint:
Remarks:

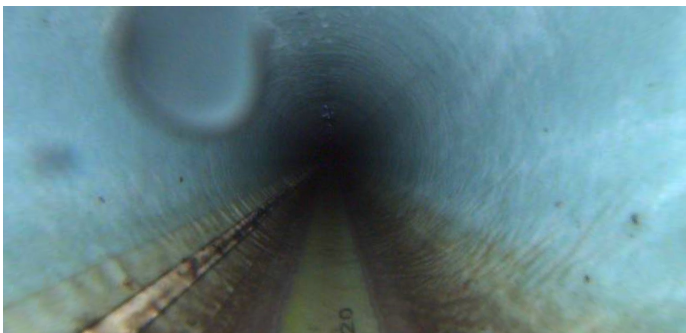
Code: **MWL**
Description: **Water Level**

Distance (ft): **103.6**
Structural Grade: **0**
O&M Grade: **0**
Clock Start/From:
Clock To:
1st Value:
2nd Value:
Value Percent: **5.000**
Continuous Index:
Within 8" of Joint: **NO**
Remarks:

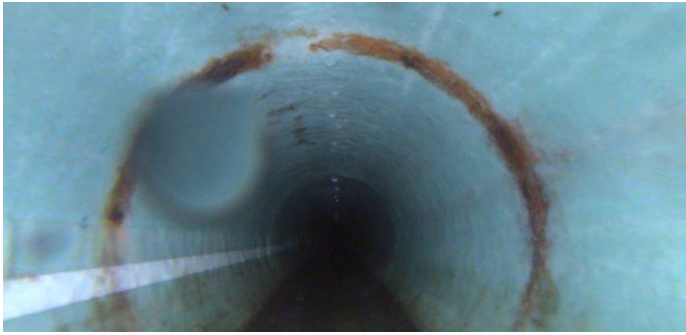
Code: **IS**
Description: **Infil Stain**

Distance (ft): **135.7**
Structural Grade: **0**
O&M Grade: **0**
Clock Start/From: **8**
Clock To: **4**
1st Value:
2nd Value:
Value Percent:
Continuous Index:
Within 8" of Joint:
Remarks:

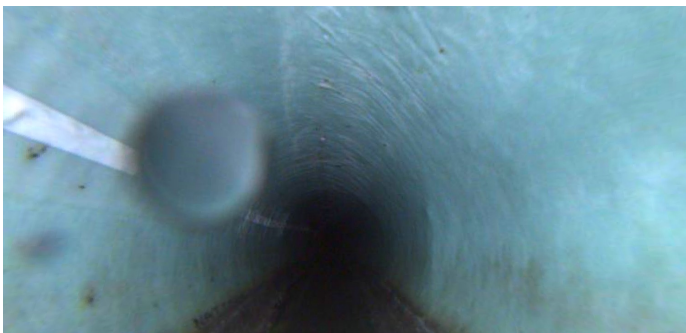
Code: **LFAC**
Description: **Lining Failure Abandoned Connection**

Distance (ft): **167.2**
Structural Grade: **0**
O&M Grade: **0**
Clock Start/From: **3**
Clock To:
1st Value:
2nd Value:
Value Percent:
Continuous Index:
Within 8" of Joint: **NO**
Remarks:

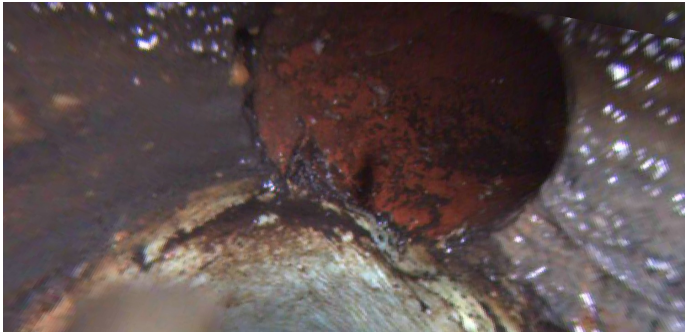
Code: **TBA**
Description: **Tap Break-in Active**

Distance (ft): **180.0**
Structural Grade: **0**
O&M Grade: **0**
Clock Start/From: **1**
Clock To:
1st Value: **4.000**
2nd Value:
Value Percent:
Continuous Index:
Within 8" of Joint:
Remarks:

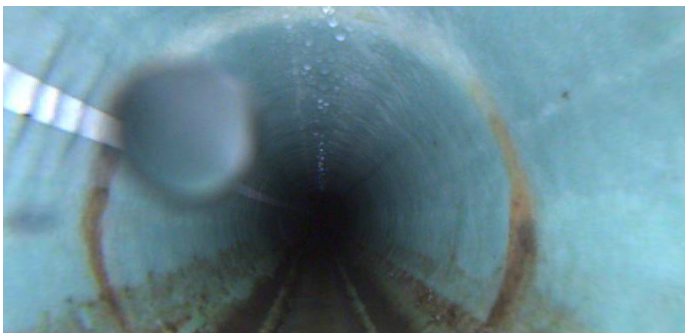
Code: **IS**
Description: **Infil Stain**

Distance (ft): **206.1**
Structural Grade: **0**
O&M Grade: **0**
Clock Start/From: **8**
Clock To: **4**
1st Value:
2nd Value:
Value Percent:
Continuous Index:
Within 8" of Joint:
Remarks:

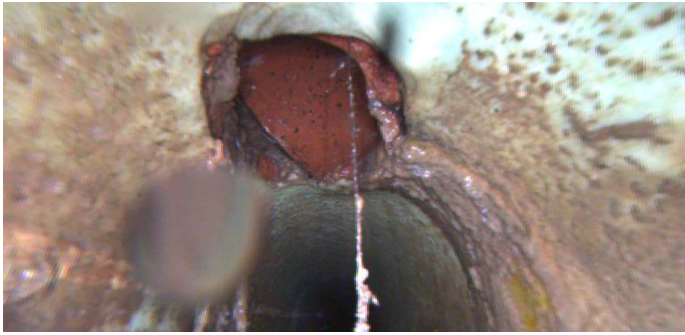
Code: **TBD**
Description: **Tap Break-in Defective**

Distance (ft): **252.7**
Structural Grade: **0**
O&M Grade: **3**
Clock Start/From: **12**
Clock To:
1st Value: **4.000**
2nd Value:
Value Percent:
Continuous Index:
Within 8" of Joint:
Remarks: **roots**

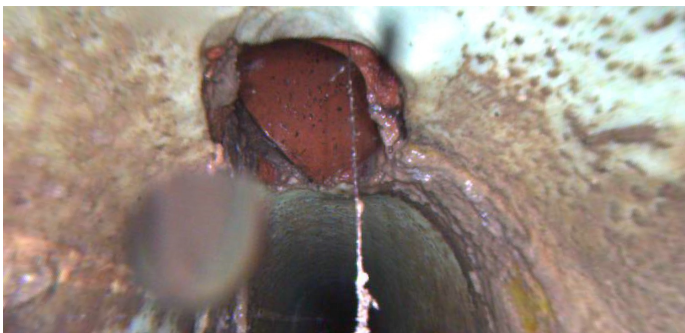
Code: **RFL**
Description: **Roots Fine Lateral**

Distance (ft): **252.7**
Structural Grade: **0**
O&M Grade: **1**
Clock Start/From: **12**
Clock To:
1st Value:
2nd Value:
Value Percent:
Continuous Index:
Within 8" of Joint: **NO**
Remarks:

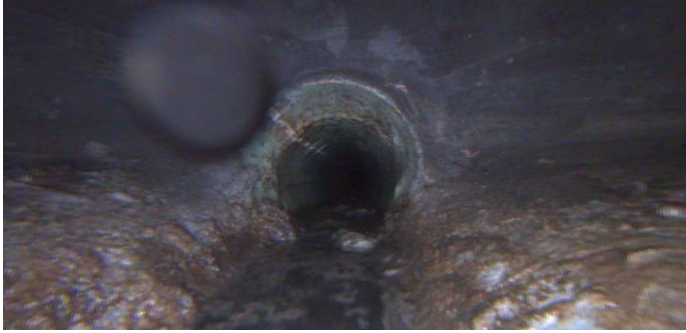
Code: **AMH**
Description: **Manhole**

Distance (ft): **292.4**
Structural Grade: **0**
O&M Grade: **0**
Clock Start/From:
Clock To:
1st Value:
2nd Value:
Value Percent:
Continuous Index:
Within 8" of Joint: **NO**
Remarks: **M-305-038**

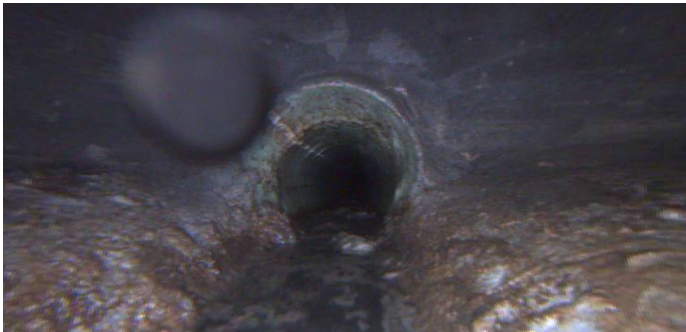
Code: **DAZ**
Description: **Deposits Attached Other**

Distance (ft): **292.4**
Structural Grade: **0**
O&M Grade: **2**
Clock Start/From: **7**
Clock To: **5**
1st Value:
2nd Value:
Value Percent: **5.000**
Continuous Index: **F01**
Within 8" of Joint: **YES**
Remarks: **WANDER**
