## Profile/Photo Observation Report

Street:	<b>CRABAPPLE LN</b>	Flow Control:	<b>Not Controlled</b>
City:	<b>Hobart, IN</b>	Year Renewed:	
Location:	<b>Yard</b>	Tape/Media #:	
Purpose:	<b>Routine Assessment</b>	Dia/Height:	<b>10"</b>
Use:	<b>Sanitary</b>	Material:	<b>PVC</b>
Drain Area:	<b>NA</b>	Lining:	<b>Cured in Place</b>
Category:	<b>NA</b>		
Comment:

Location Details:		Direction of Survey:	<b>Upstream</b>
US MH:	<b>M-305-040</b>	DS MH:	<b>M-305-039</b>
		Total Length Surveyed (ft):	<b>293.1</b>

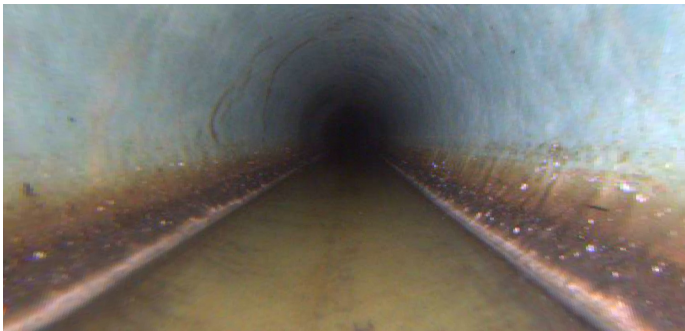
Code: **AMH**  
Description: **Manhole**

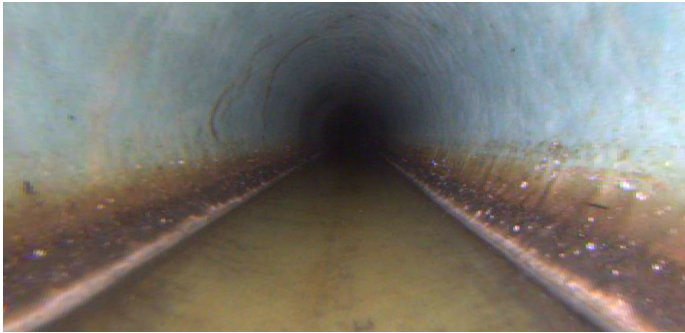
Code:	<b>MWL</b>
Description:	<b>Water Level</b>

Distance (ft):	<b>.0</b>
Structural Grade:	<b>0</b>
O&M Grade:	<b>0</b>
Clock Start/From:	
Clock To:	
1st Value:	
2nd Value:	
Value Percent:	<b>5.000</b>
Continuous Index:	
Within 8" of Joint:	<b>NO</b>
Remarks:

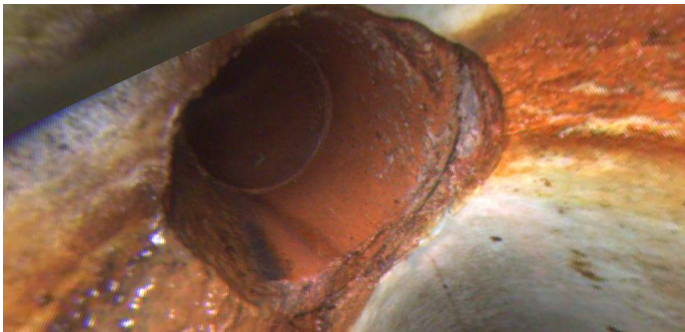
Code:	<b>TF</b>
Description:	<b>Tap Factory</b>

Distance (ft):	<b>65.5</b>
Structural Grade:	<b>0</b>
O&M Grade:	<b>0</b>
Clock Start/From:	<b>11</b>
Clock To:	
1st Value:	<b>4.000</b>
2nd Value:	
Value Percent:	
Continuous Index:	
Within 8" of Joint:	
Remarks:

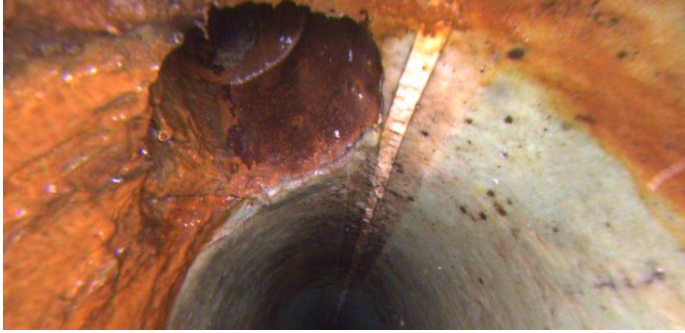
Code: **TF**  
Description: **Tap Factory**

Distance (ft): **117.6**  
Structural Grade: **0**  
O&M Grade: **0**  
Clock Start/From: **11**  
Clock To:  
1st Value: **4.000**  
2nd Value:  
Value Percent:  
Continuous Index:  
Within 8" of Joint:  
Remarks:

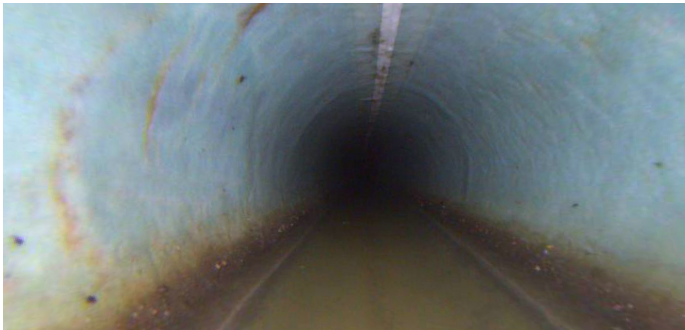
Code: **LFAC**  
Description: **Lining Failure Abandoned Connection**

Distance (ft): **137.8**  
Structural Grade: **0**  
O&M Grade: **0**  
Clock Start/From: **9**  
Clock To:  
1st Value:  
2nd Value:  
Value Percent:  
Continuous Index:  
Within 8" of Joint: **NO**  
Remarks:

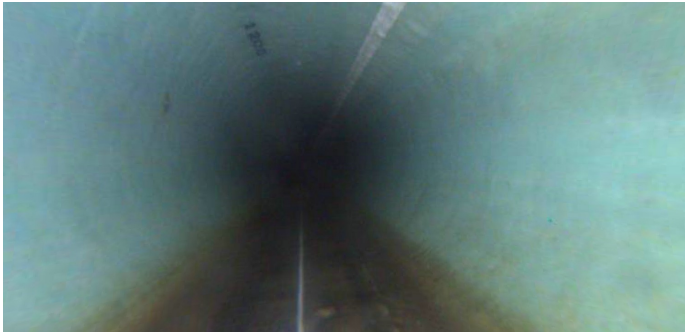
Code: **MGO**  
Description: **General Observation**

Distance (ft): **182.8**  
Structural Grade: **0**  
O&M Grade: **0**  
Clock Start/From:  
Clock To:  
1st Value:  
2nd Value:  
Value Percent:  
Continuous Index:  
Within 8" of Joint: **NO**  
Remarks: **rear camera**

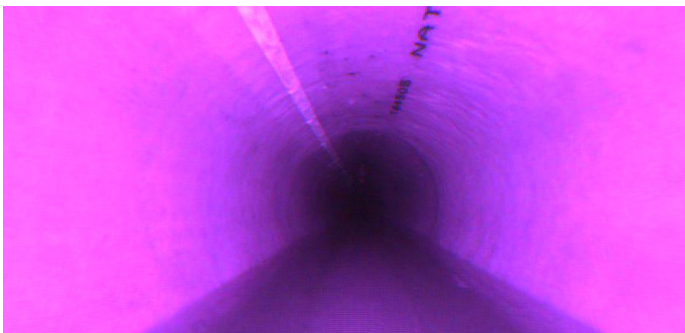
Code: **MGO**  
Description: **General Observation**

Distance (ft): **182.8**  
Structural Grade: **0**  
O&M Grade: **0**  
Clock Start/From:  
Clock To:  
1st Value:  
2nd Value:  
Value Percent:  
Continuous Index:  
Within 8" of Joint: **NO**  
Remarks: **CAMERA HUE PINK**

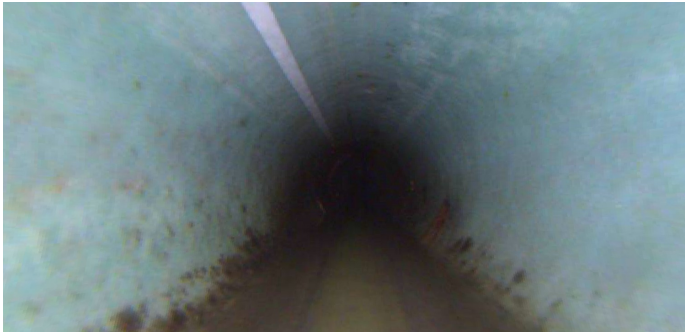
Code: **MGO**  
Description: **General Observation**

Distance (ft): **206.6**  
Structural Grade: **0**  
O&M Grade: **0**  
Clock Start/From:  
Clock To:  
1st Value:  
2nd Value:  
Value Percent:  
Continuous Index:  
Within 8" of Joint: **NO**  
Remarks: **CAMERA STATUS NORMAL**

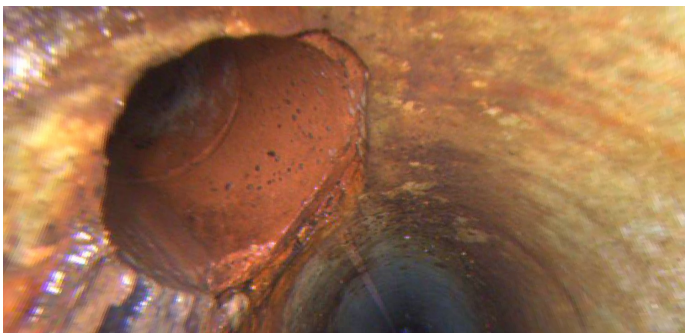
Code: **TB**  
Description: **Tap Break-in**

Distance (ft): **210.1**  
Structural Grade: **0**  
O&M Grade: **0**  
Clock Start/From: **10**  
Clock To:  
1st Value: **4.000**  
2nd Value:  
Value Percent:  
Continuous Index:  
Within 8" of Joint:  
Remarks:

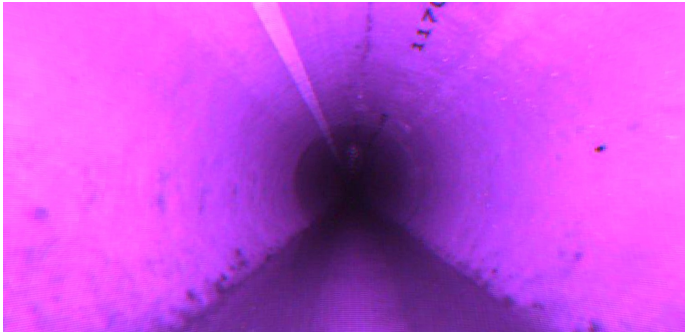
Code: **MGO**  
Description: **General Observation**

Distance (ft): **212.5**  
Structural Grade: **0**  
O&M Grade: **0**  
Clock Start/From:  
Clock To:  
1st Value:  
2nd Value:  
Value Percent:  
Continuous Index:  
Within 8" of Joint: **NO**  
Remarks: **CAMERA PINK HUE**

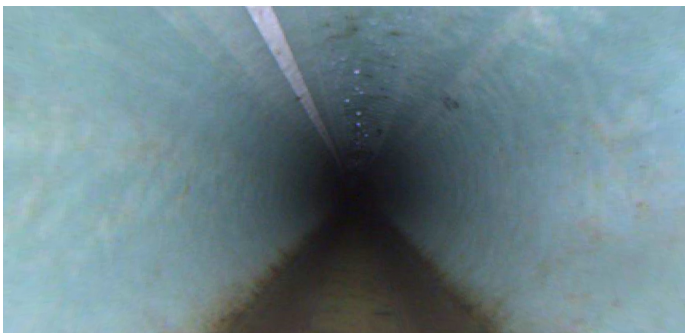
Code: **MGO**  
Description: **General Observation**

Distance (ft): **216.6**  
Structural Grade: **0**  
O&M Grade: **0**  
Clock Start/From:  
Clock To:  
1st Value:  
2nd Value:  
Value Percent:  
Continuous Index:  
Within 8" of Joint: **NO**  
Remarks: **CAMERA NORMAL**

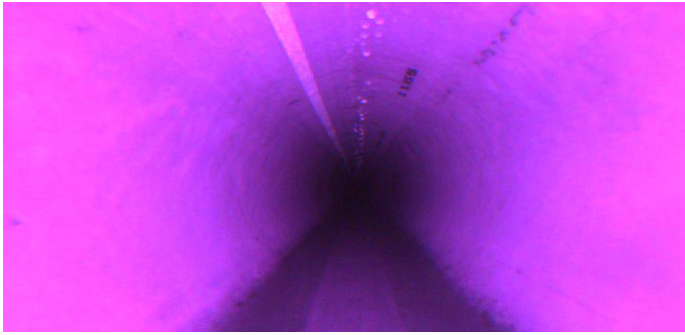
Code: **MGO**  
Description: **General Observation**

Distance (ft): **228.1**  
Structural Grade: **0**  
O&M Grade: **0**  
Clock Start/From:  
Clock To:  
1st Value:  
2nd Value:  
Value Percent:  
Continuous Index:  
Within 8" of Joint: **NO**  
Remarks: **PINK HUE INTERMITENT**

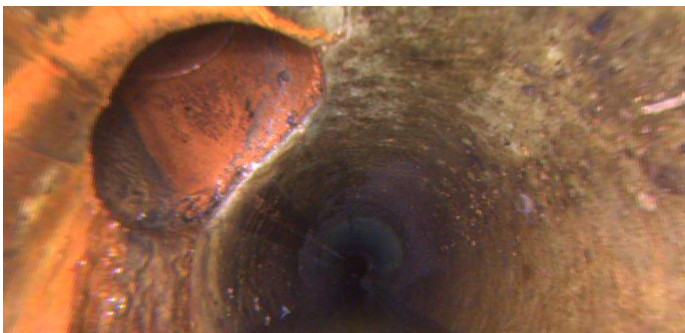
Code: **TF**  
Description: **Tap Factory**

Distance (ft): **285.2**  
Structural Grade: **0**  
O&M Grade: **0**  
Clock Start/From: **1**  
Clock To:  
1st Value: **4.000**  
2nd Value:  
Value Percent:  
Continuous Index:  
Within 8" of Joint:  
Remarks:

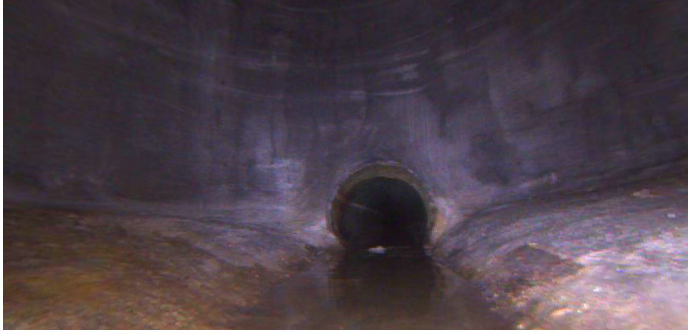
Code:	AMH
Description:	Manhole
Distance (ft):	293.1
Structural Grade:	0
O&M Grade:	0
Clock Start/From:	
Clock To:	
1st Value:	
2nd Value:	
Value Percent:	
Continuous Index:	
Within 8" of Joint:	NO
Remarks:	M-305-040
