Profile/Photo Observation Report

Date:	04/17/2018	Weather:		Coding:	PACP 6.0
Pipe Length (ft):	230.3	Owner:	NA	Pre Clean:	No Pre-Cleaning
P.O.#:		Surveyor:	Justin Gonzales	PSR:	P-305-041-040
Customer:		Clean Date:	01/01/1900	Shape:	C

Street:	CRABAPPLE LN	Flow Control:	Not Controlled
City:	Hobart, IN	Year Renewed:	
Location:	Yard	Tape/Media #:	
Purpose:	Routine Assessment	Dia/Height:	10"
Use:	Sanitary	Material:	VCP
Drain Area:	NA	Lining:	Cured in Place
Category:	NA		
Comment:	P_C at 105 ft debris		
Location Details:		Direction of Survey:	Upstream
US MH:	M-305-041	DS MH:	M-305-040
		Total Length Surveyed (ft):	107.0

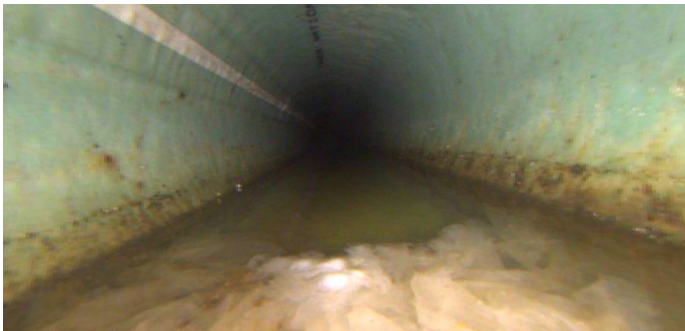
Code: **AMH**
Description: **Manhole**

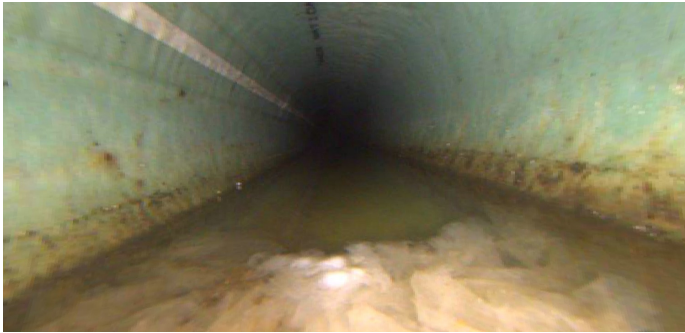
Code:	MWL
Description:	Water Level

Distance (ft):	.0
Structural Grade:	0
O&M Grade:	0
Clock Start/From:	
Clock To:	
1st Value:	
2nd Value:	
Value Percent:	10.000
Continuous Index:	
Within 8" of Joint:	NO
Remarks:

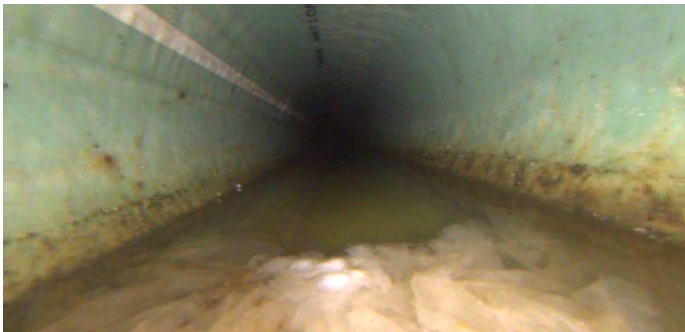
Code:	MGO
Description:	General Observation

Distance (ft):	.0
Structural Grade:	0
O&M Grade:	0
Clock Start/From:	
Clock To:	
1st Value:	
2nd Value:	
Value Percent:	
Continuous Index:	
Within 8" of Joint:	NO
Remarks:	TOILET TISSUE

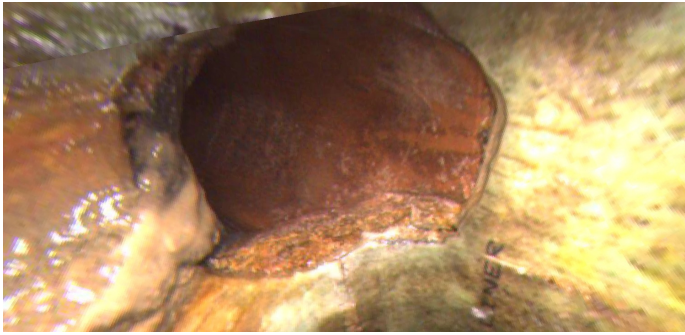
Code: **TB**
Description: **Tap Break-in**

Distance (ft): **66.7**
Structural Grade: **0**
O&M Grade: **0**
Clock Start/From: **11**
Clock To:
1st Value: **4.000**
2nd Value:
Value Percent:
Continuous Index:
Within 8" of Joint:
Remarks:

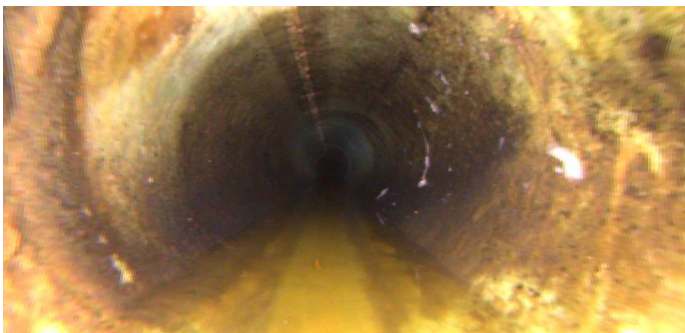
Code: **DAZ**
Description: **Deposits Attached Other**

Distance (ft): **66.7**
Structural Grade: **0**
O&M Grade: **2**
Clock Start/From: **7**
Clock To: **5**
1st Value:
2nd Value:
Value Percent: **5.000**
Continuous Index:
Within 8" of Joint: **NO**
Remarks:

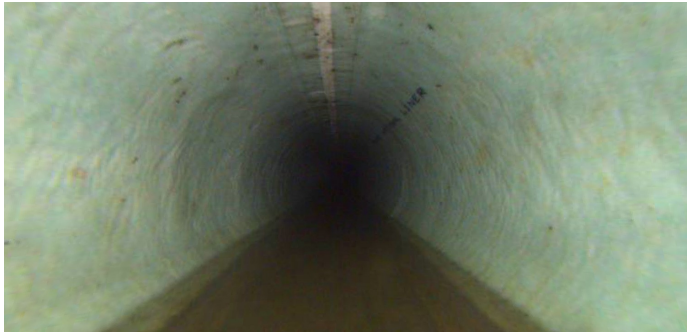
Code:	LFAC
Description:	Lining Failure Abandoned Connection
Distance (ft):	81.5
Structural Grade:	0
O&M Grade:	0
Clock Start/From:	9
Clock To:	
1st Value:	
2nd Value:	
Value Percent:	
Continuous Index:	
Within 8" of Joint:	NO
Remarks:

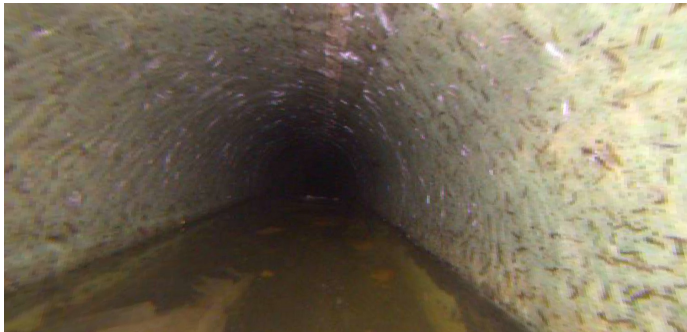
Code:	DAZ
Description:	Deposits Attached Other
Distance (ft):	95.3
Structural Grade:	0
O&M Grade:	2
Clock Start/From:	7
Clock To:	5
1st Value:	
2nd Value:	
Value Percent:	5.000
Continuous Index:	S01
Within 8" of Joint:	YES
Remarks:

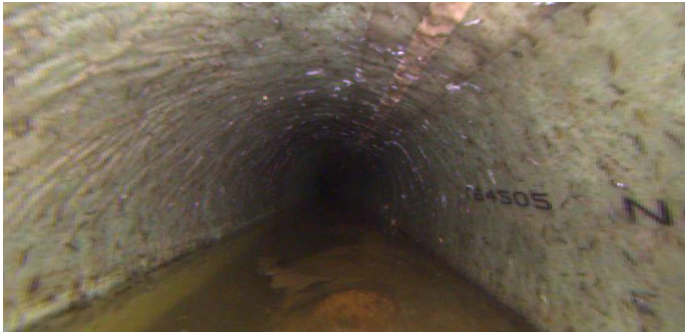
Code: **MGO**
Description: **General Observation**

Distance (ft): **98.0**
Structural Grade: **0**
O&M Grade: **0**
Clock Start/From:
Clock To:
1st Value:
2nd Value:
Value Percent:
Continuous Index:
Within 8" of Joint: **NO**
Remarks: **TOILET TISSUE**

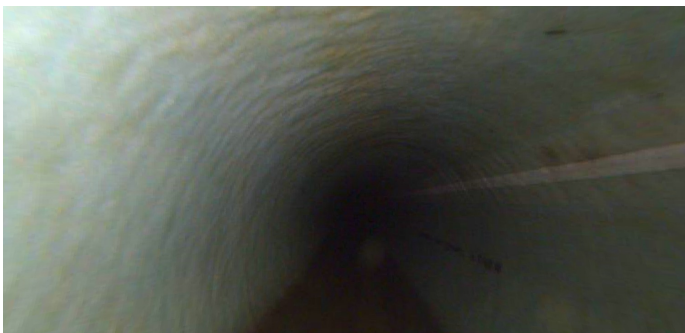
Code: **MSA**
Description: **Abandoned Survey**

Distance (ft): **107.0**
Structural Grade: **0**
O&M Grade: **0**
Clock Start/From:
Clock To:
1st Value:
2nd Value:
Value Percent:
Continuous Index:
Within 8" of Joint: **NO**
Remarks: **ROBOT HAS STOPPED**

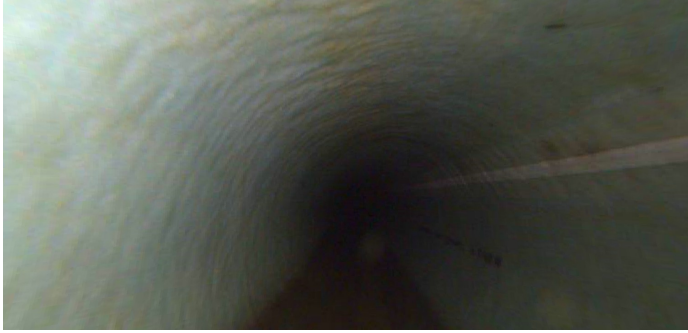
Code:	DAZ
Description:	Deposits Attached Other
Distance (ft):	107.0
Structural Grade:	0
O&M Grade:	2
Clock Start/From:	7
Clock To:	5
1st Value:	
2nd Value:	
Value Percent:	5.000
Continuous Index:	F01
Within 8" of Joint:	YES
Remarks:
