Profile/Photo Observation Report

Date:	04/17/2018	Weather:		Coding:	PACP 6.0
Pipe Length (ft):	230.3	Owner:	NA	Pre Clean:	No Pre-Cleaning
P.O.#:		Surveyor:	Justin Gonzales	PSR:	P-305-041-040
Customer:		Clean Date:	01/01/1900	Shape:	C

Street:	FOXCROFT STREET	Flow Control:	Not Controlled
City:	Hobart, IN	Year Renewed:	
Location:	Yard	Tape/Media #:	
Purpose:	Routine Assessment	Dia/Height:	10"
Use:	Sanitary	Material:	VCP
Drain Area:	NA	Lining:	Cured in Place
Category:	NA		
Comment:	P_C at 105 ft debris		
Location Details:		Direction of Survey:	Upstream
US MH:	M-305-041	DS MH:	M-305-040
		Total Length Surveyed (ft):	107.0

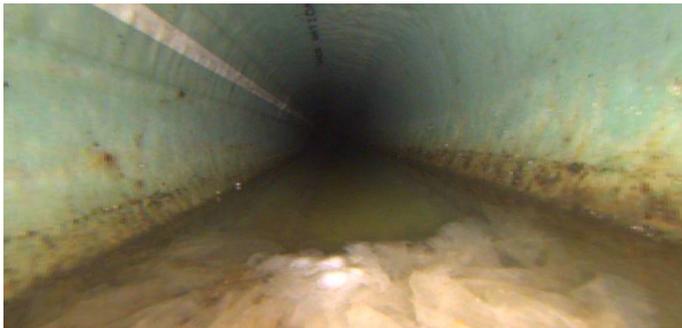
Code: **AMH**
Description: **Manhole**

Distance (ft): **.0**
Structural Grade: **0**
O&M Grade: **0**
Clock Start/From:
Clock To:
1st Value:
2nd Value:
Value Percent:
Continuous Index:
Within 8" of Joint: **NO**
Remarks: **M-305-040**

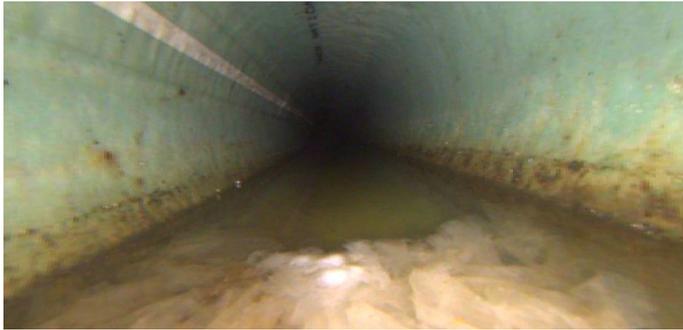
Code: **MWL**
Description: **Water Level**

Distance (ft): **.0**
Structural Grade: **0**
O&M Grade: **0**
Clock Start/From:
Clock To:
1st Value:
2nd Value:
Value Percent: **10.000**
Continuous Index:
Within 8" of Joint: **NO**
Remarks:

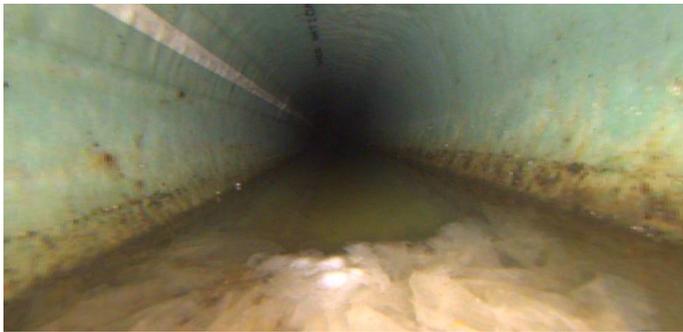
Code: **MGO**
Description: **General Observation**

Distance (ft): **.0**
Structural Grade: **0**
O&M Grade: **0**
Clock Start/From:
Clock To:
1st Value:
2nd Value:
Value Percent:
Continuous Index:
Within 8" of Joint: **NO**
Remarks: **TOILET TISSUE**

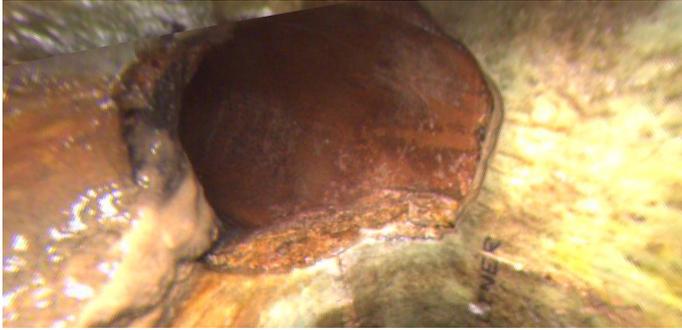
Code: **TB**
Description: **Tap Break-in**

Distance (ft): **66.7**
Structural Grade: **0**
O&M Grade: **0**
Clock Start/From: **11**
Clock To:
1st Value: **4.000**
2nd Value:
Value Percent:
Continuous Index:
Within 8" of Joint:
Remarks:

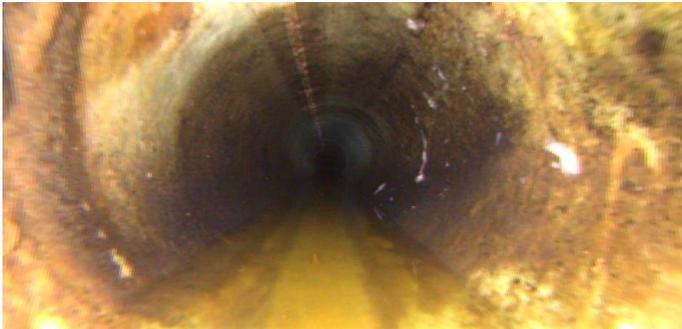
Code: **DAZ**
Description: **Deposits Attached Other**

Distance (ft): **66.7**
Structural Grade: **0**
O&M Grade: **2**
Clock Start/From: **7**
Clock To: **5**
1st Value:
2nd Value:
Value Percent: **5.000**
Continuous Index:
Within 8" of Joint: **NO**
Remarks:

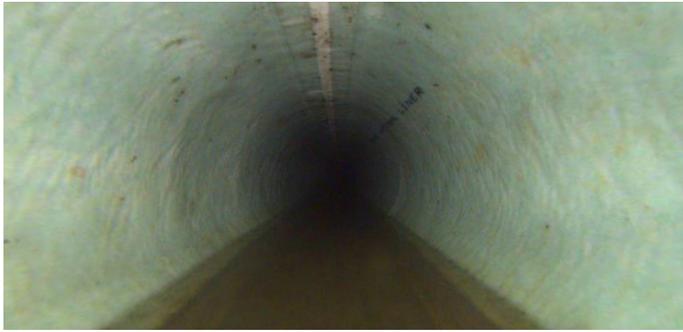
Code: **LFAC**
Description: **Lining Failure Abandoned Connection**

Distance (ft): **81.5**
Structural Grade: **0**
O&M Grade: **0**
Clock Start/From: **9**
Clock To:
1st Value:
2nd Value:
Value Percent:
Continuous Index:
Within 8" of Joint: **NO**
Remarks:

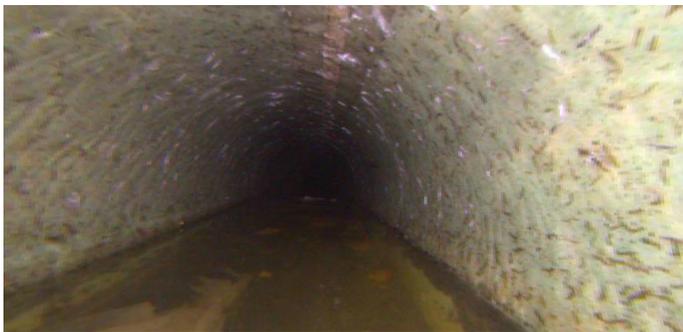
Code: **DAZ**
Description: **Deposits Attached Other**

Distance (ft): **95.3**
Structural Grade: **0**
O&M Grade: **2**
Clock Start/From: **7**
Clock To: **5**
1st Value:
2nd Value:
Value Percent: **5.000**
Continuous Index: **S01**
Within 8" of Joint: **YES**
Remarks:

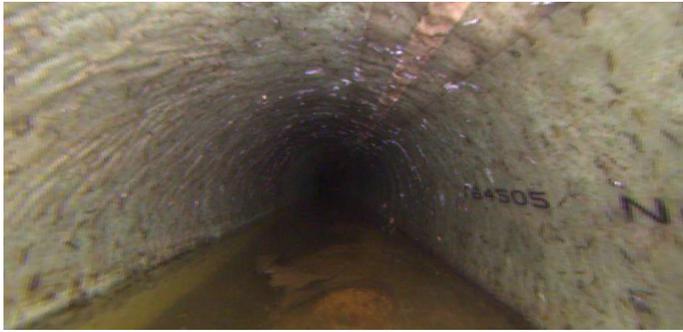
Code: **MGO**
Description: **General Observation**

Distance (ft): **98.0**
Structural Grade: **0**
O&M Grade: **0**
Clock Start/From:
Clock To:
1st Value:
2nd Value:
Value Percent:
Continuous Index:
Within 8" of Joint: **NO**
Remarks: **TOILET TISSUE**

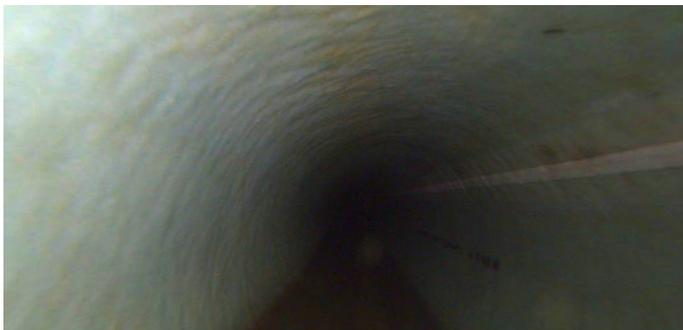
Code: **MSA**
Description: **Abandoned Survey**

Distance (ft): **107.0**
Structural Grade: **0**
O&M Grade: **0**
Clock Start/From:
Clock To:
1st Value:
2nd Value:
Value Percent:
Continuous Index:
Within 8" of Joint: **NO**
Remarks: **ROBOT HAS STOPPED**

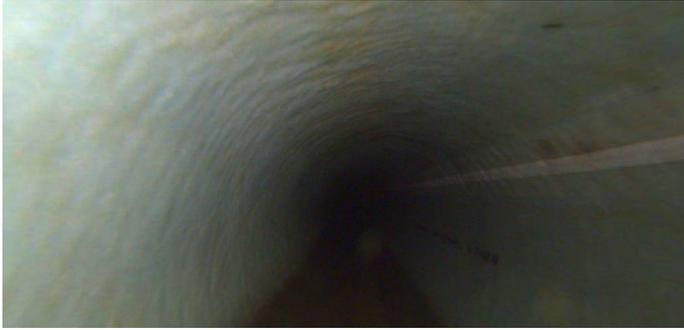
Code:	DAZ
Description:	Deposits Attached Other
Distance (ft):	107.0
Structural Grade:	0
O&M Grade:	2
Clock Start/From:	7
Clock To:	5
1st Value:	
2nd Value:	
Value Percent:	5.000
Continuous Index:	F01
Within 8" of Joint:	YES
Remarks:
