Profile/Photo Observation Report

Date:	04/24/2018	Weather:		Coding:	PACP 6.0
Pipe Length (ft):	211.8	Owner:	NA	Pre Clean:	No Pre-Cleaning
P.O.#:		Surveyor:	Jen Costello	PSR:	P-305-042-043
Customer:		Clean Date:	01/01/1900	Shape:	C

Street:	CRESTWOOD DR	Flow Control:	Not Controlled
City:	Hobart, IN	Year Renewed:	
Location:	Yard	Tape/Media #:	
Purpose:	Routine Assessment	Dia/Height:	8"
Use:	Sanitary	Material:	PVC
Drain Area:	NA	Lining:	
Category:	NA		
Comment:

Location Details:		Direction of Survey:	Upstream
US MH:	M-305-042	DS MH:	M-305-043
		Total Length Surveyed (ft):	200.5

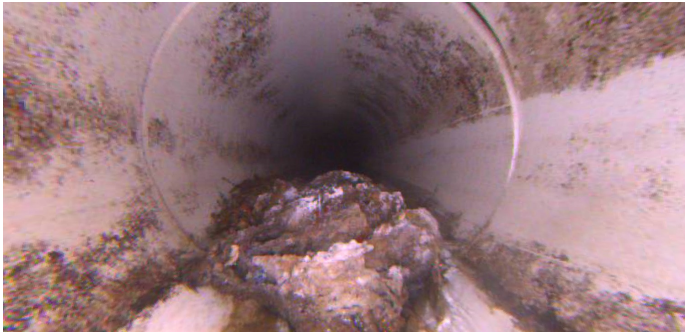
Code: **DSC**
Description: **Deposits Settled Compacted**

Distance (ft): **.9**
Structural Grade: **0**
O&M Grade: **2**
Clock Start/From: **5**
Clock To: **7**
1st Value:
2nd Value:
Value Percent: **10.000**
Continuous Index:
Within 8" of Joint: **NO**
Remarks:

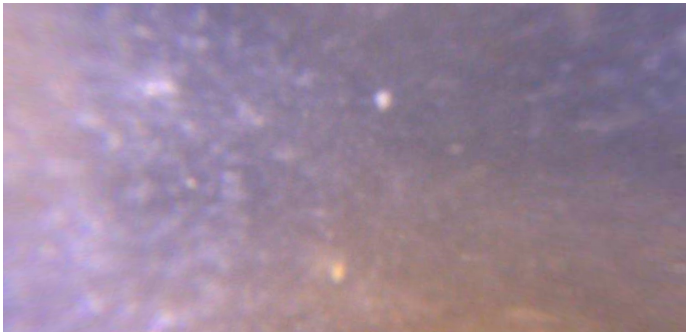
Code: **MCU**
Description: **Camera Underwater**

Distance (ft): **13.0**
Structural Grade: **0**
O&M Grade: **4**
Clock Start/From:
Clock To:
1st Value:
2nd Value:
Value Percent:
Continuous Index:
Within 8" of Joint: **NO**
Remarks:

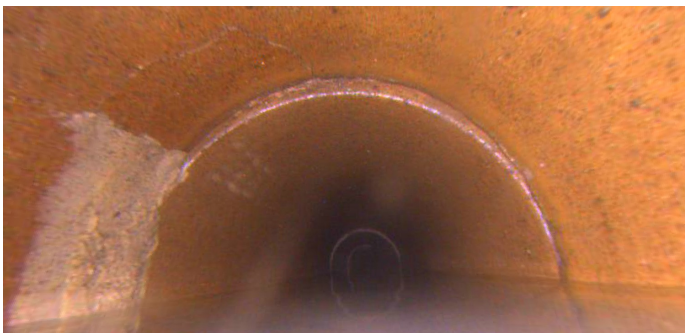
Code: **FS**
Description: **Fracture Spiral**

Distance (ft): **17.8**
Structural Grade: **3**
O&M Grade: **0**
Clock Start/From: **10**
Clock To: **12**
1st Value:
2nd Value:
Value Percent:
Continuous Index:
Within 8" of Joint: **YES**
Remarks:

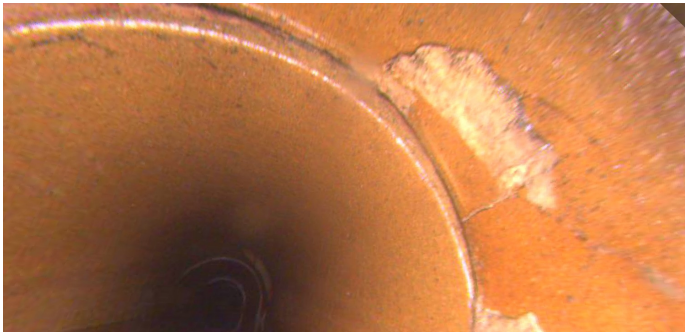
Code: **FM**
Description: **Fracture Multiple**

Distance (ft): **26.7**
Structural Grade: **4**
O&M Grade: **0**
Clock Start/From: **1**
Clock To: **3**
1st Value:
2nd Value:
Value Percent:
Continuous Index:
Within 8" of Joint: **YES**
Remarks:

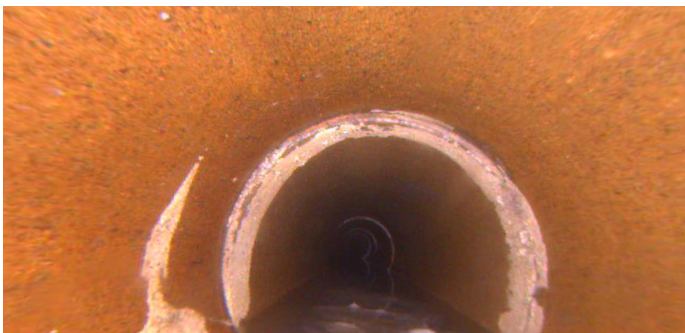
Code: **FS**
Description: **Fracture Spiral**

Distance (ft): **38.2**
Structural Grade: **3**
O&M Grade: **0**
Clock Start/From: **8**
Clock To: **12**
1st Value:
2nd Value:
Value Percent:
Continuous Index:
Within 8" of Joint: **YES**
Remarks:

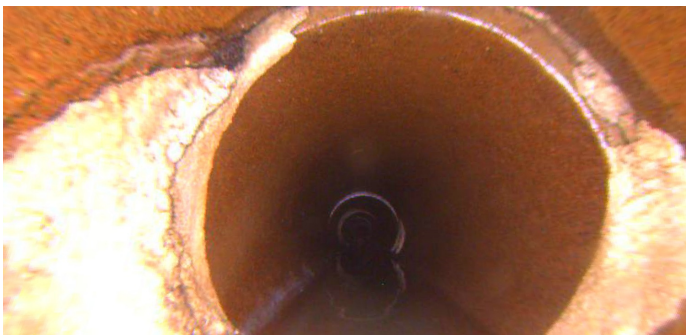
Code: **DAE**
Description: **Deposits Attached Encrustation**

Distance (ft): **106.4**
Structural Grade: **0**
O&M Grade: **2**
Clock Start/From: **8**
Clock To: **4**
1st Value:
2nd Value:
Value Percent: **5.000**
Continuous Index:
Within 8" of Joint: **YES**
Remarks:

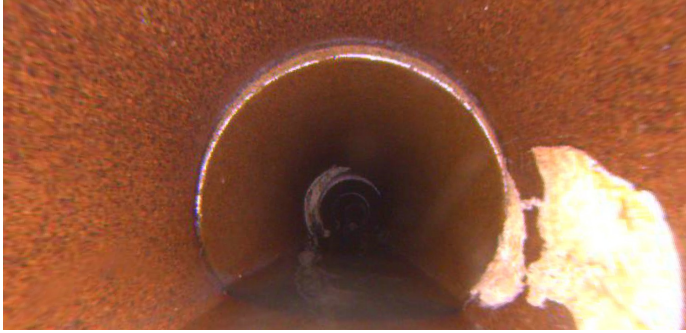
Code: **DAE**
Description: **Deposits Attached Encrustation**

Distance (ft): **109.1**
Structural Grade: **0**
O&M Grade: **2**
Clock Start/From: **3**
Clock To: **4**
1st Value:
2nd Value:
Value Percent: **5.000**
Continuous Index:
Within 8" of Joint: **YES**
Remarks:

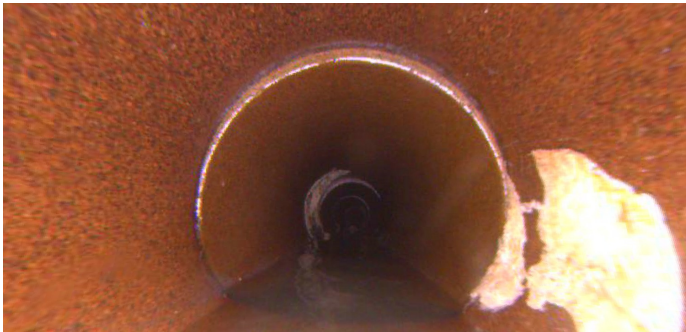
Code: **FM**
Description: **Fracture Multiple**

Distance (ft): **109.1**
Structural Grade: **4**
O&M Grade: **0**
Clock Start/From: **3**
Clock To: **5**
1st Value:
2nd Value:
Value Percent:
Continuous Index:
Within 8" of Joint: **YES**
Remarks:

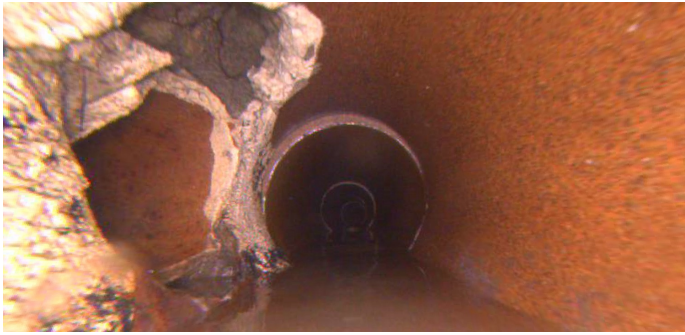
Code: **TBD**
Description: **Tap Break-in Defective**

Distance (ft): **111.4**
Structural Grade: **0**
O&M Grade: **3**
Clock Start/From: **9**
Clock To:
1st Value: **4.000**
2nd Value:
Value Percent:
Continuous Index:
Within 8" of Joint:
Remarks: **DAE,HSV**

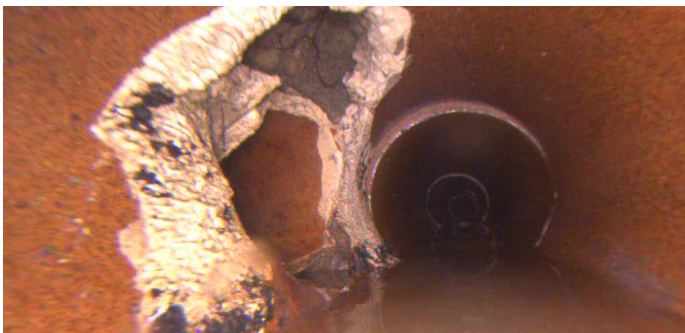
Code: **DAE**
Description: **Deposits Attached Encrustation**

Distance (ft): **111.4**
Structural Grade: **0**
O&M Grade: **2**
Clock Start/From: **8**
Clock To: **10**
1st Value:
2nd Value:
Value Percent: **5.000**
Continuous Index:
Within 8" of Joint: **NO**
Remarks:

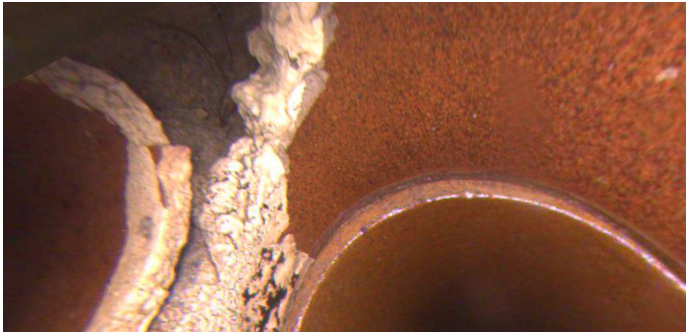
Code: **HSV**
Description: **Hole Soil Visible**

Distance (ft): **112.0**
Structural Grade: **5**
O&M Grade: **0**
Clock Start/From: **10**
Clock To: **11**
1st Value:
2nd Value:
Value Percent:
Continuous Index:
Within 8" of Joint:
Remarks:

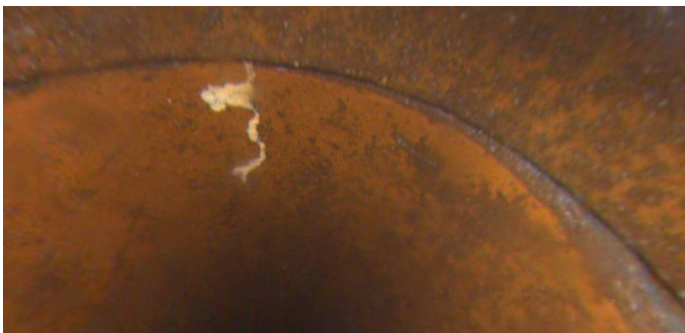
Code: **CL**
Description: **Crack Longitudinal**

Distance (ft): **161.0**
Structural Grade: **2**
O&M Grade: **0**
Clock Start/From: **12**
Clock To:
1st Value:
2nd Value:
Value Percent:
Continuous Index:
Within 8" of Joint: **YES**
Remarks:

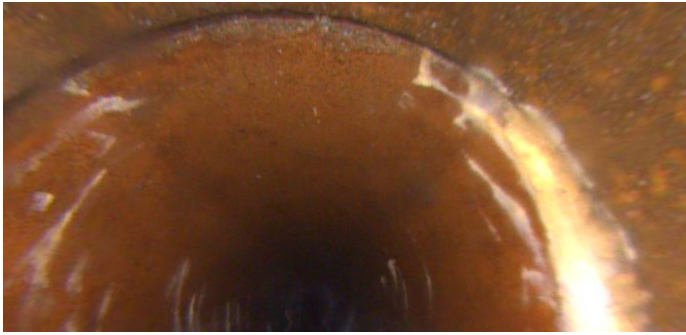
Code: **FM**
Description: **Fracture Multiple**

Distance (ft): **164.0**
Structural Grade: **4**
O&M Grade: **0**
Clock Start/From: **8**
Clock To: **4**
1st Value:
2nd Value:
Value Percent:
Continuous Index: **S01**
Within 8" of Joint: **YES**
Remarks:

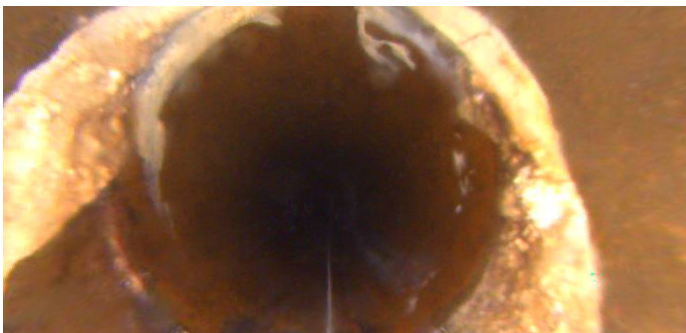
Code: **DAE**
Description: **Deposits Attached Encrustation**

Distance (ft): **167.4**
Structural Grade: **0**
O&M Grade: **2**
Clock Start/From: **8**
Clock To: **4**
1st Value:
2nd Value:
Value Percent: **5.000**
Continuous Index: **S02**
Within 8" of Joint: **YES**
Remarks:

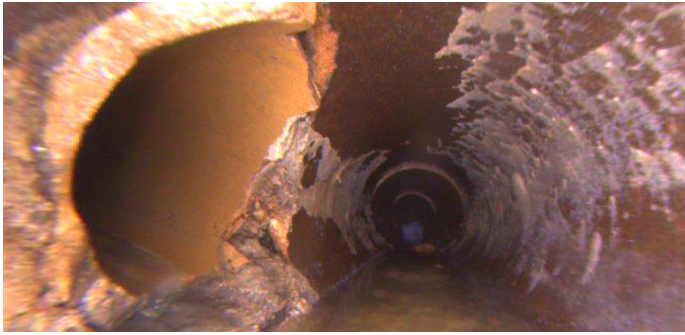
Code: **TBI**
Description: **Tap Break-in Intruding**

Distance (ft): **191.1**
Structural Grade: **0**
O&M Grade: **2**
Clock Start/From: **9**
Clock To:
1st Value: **4.000**
2nd Value: **1.000**
Value Percent:
Continuous Index:
Within 8" of Joint:
Remarks:

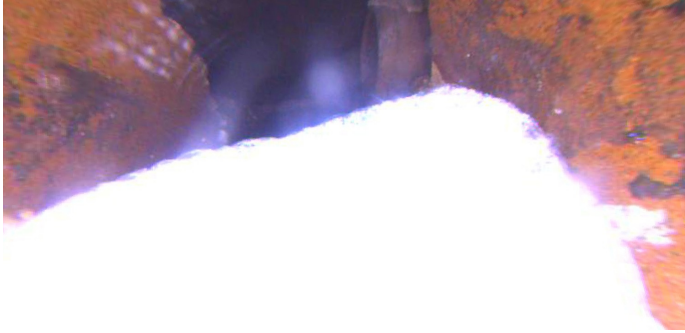
Code: **FM**
Description: **Fracture Multiple**

Distance (ft): **198.4**
Structural Grade: **4**
O&M Grade: **0**
Clock Start/From: **8**
Clock To: **4**
1st Value:
2nd Value:
Value Percent:
Continuous Index: **F01**
Within 8" of Joint: **YES**
Remarks:

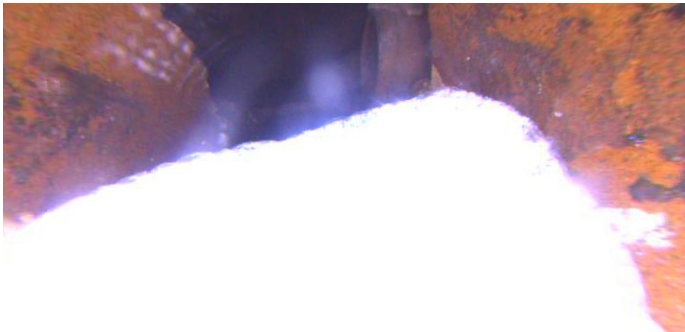
Code: **DAE**
Description: **Deposits Attached Encrustation**

Distance (ft): **198.4**
Structural Grade: **0**
O&M Grade: **2**
Clock Start/From: **8**
Clock To: **4**
1st Value:
2nd Value:
Value Percent: **5.000**
Continuous Index: **F02**
Within 8" of Joint: **YES**
Remarks:
