## Profile/Photo Observation Report

Street:	<b>FOXCROFT STREET</b>	Flow Control:	<b>Not Controlled</b>
City:	<b>Hobart, IN</b>	Year Renewed:	
Location:	<b>Yard</b>	Tape/Media #:	
Purpose:	<b>Routine Assessment</b>	Dia/Height:	<b>8"</b>
Use:	<b>Sanitary</b>	Material:	<b>PVC</b>
Drain Area:	<b>NA</b>	Lining:	
Category:	<b>NA</b>		
Comment:

Location Details:		Direction of Survey:	<b>Upstream</b>
US MH:	<b>M-305-042</b>	DS MH:	<b>M-305-043</b>
		Total Length Surveyed (ft):	<b>200.5</b>

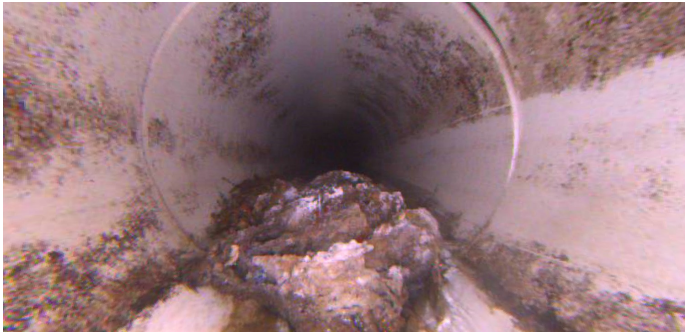
Code: **DSC**  
Description: **Deposits Settled Compacted**

Distance (ft): **.9**  
Structural Grade: **0**  
O&M Grade: **2**  
Clock Start/From: **5**  
Clock To: **7**  
1st Value:  
2nd Value:  
Value Percent: **10.000**  
Continuous Index:  
Within 8" of Joint: **NO**  
Remarks:

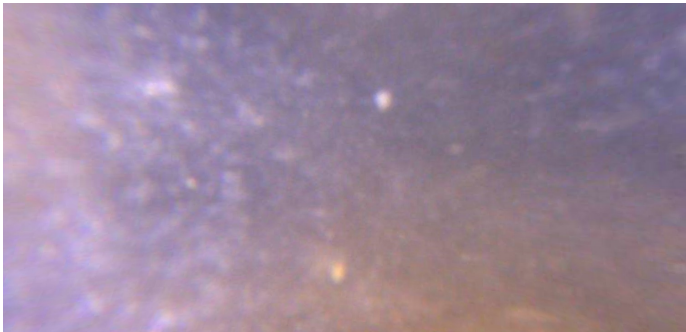
Code: **MCU**  
Description: **Camera Underwater**

Distance (ft): **13.0**  
Structural Grade: **0**  
O&M Grade: **4**  
Clock Start/From:  
Clock To:  
1st Value:  
2nd Value:  
Value Percent:  
Continuous Index:  
Within 8" of Joint: **NO**  
Remarks:

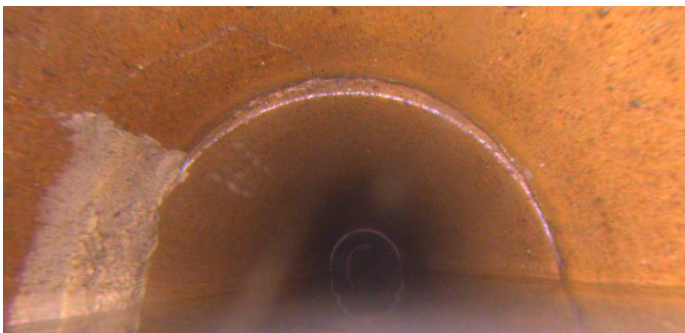
Code: **FS**  
Description: **Fracture Spiral**

Distance (ft): **17.8**  
Structural Grade: **3**  
O&M Grade: **0**  
Clock Start/From: **10**  
Clock To: **12**  
1st Value:  
2nd Value:  
Value Percent:  
Continuous Index:  
Within 8" of Joint: **YES**  
Remarks:

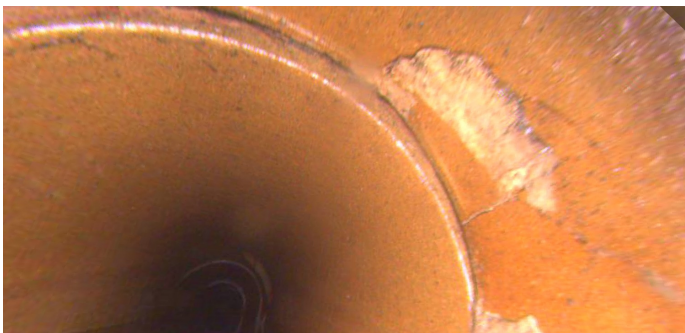
Code: **FM**  
Description: **Fracture Multiple**

Distance (ft): **26.7**  
Structural Grade: **4**  
O&M Grade: **0**  
Clock Start/From: **1**  
Clock To: **3**  
1st Value:  
2nd Value:  
Value Percent:  
Continuous Index:  
Within 8" of Joint: **YES**  
Remarks:

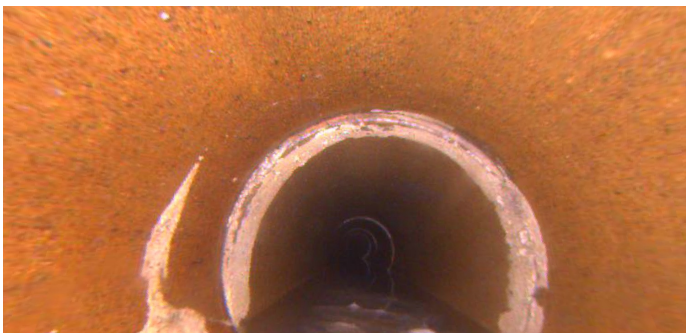
Code: **FS**  
Description: **Fracture Spiral**

Distance (ft): **38.2**  
Structural Grade: **3**  
O&M Grade: **0**  
Clock Start/From: **8**  
Clock To: **12**  
1st Value:  
2nd Value:  
Value Percent:  
Continuous Index:  
Within 8" of Joint: **YES**  
Remarks:

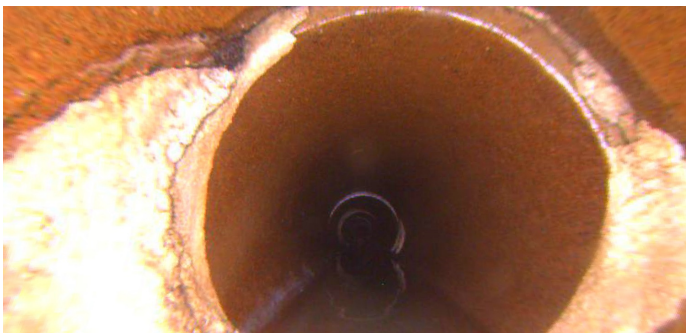
Code: **DAE**  
Description: **Deposits Attached Encrustation**

Distance (ft): **106.4**  
Structural Grade: **0**  
O&M Grade: **2**  
Clock Start/From: **8**  
Clock To: **4**  
1st Value:  
2nd Value:  
Value Percent: **5.000**  
Continuous Index:  
Within 8" of Joint: **YES**  
Remarks:

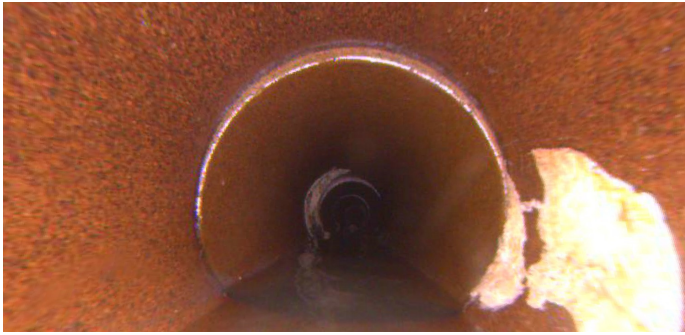
Code: **DAE**  
Description: **Deposits Attached Encrustation**

Distance (ft): **109.1**  
Structural Grade: **0**  
O&M Grade: **2**  
Clock Start/From: **3**  
Clock To: **4**  
1st Value:  
2nd Value:  
Value Percent: **5.000**  
Continuous Index:  
Within 8" of Joint: **YES**  
Remarks:

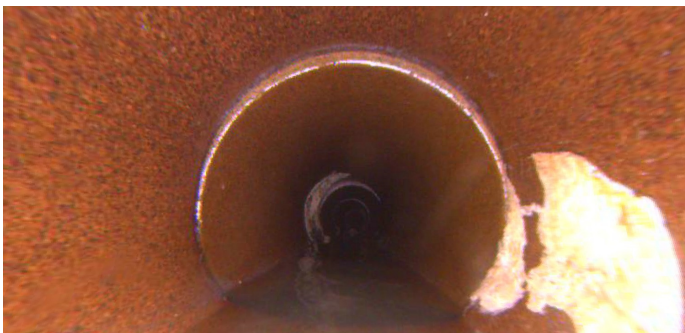
Code: **FM**  
Description: **Fracture Multiple**

Distance (ft): **109.1**  
Structural Grade: **4**  
O&M Grade: **0**  
Clock Start/From: **3**  
Clock To: **5**  
1st Value:  
2nd Value:  
Value Percent:  
Continuous Index:  
Within 8" of Joint: **YES**  
Remarks:

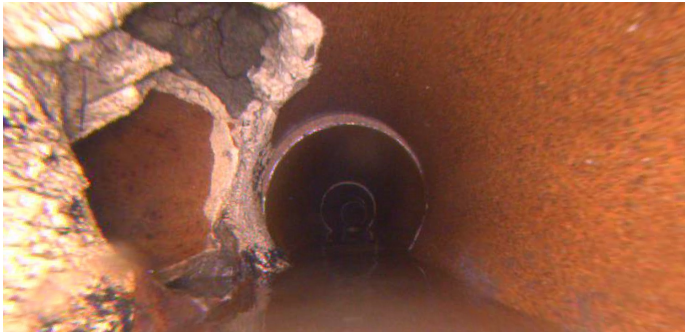
Code: **TBD**  
Description: **Tap Break-in Defective**

Distance (ft): **111.4**  
Structural Grade: **0**  
O&M Grade: **3**  
Clock Start/From: **9**  
Clock To:  
1st Value: **4.000**  
2nd Value:  
Value Percent:  
Continuous Index:  
Within 8" of Joint:  
Remarks: **DAE,HSV**

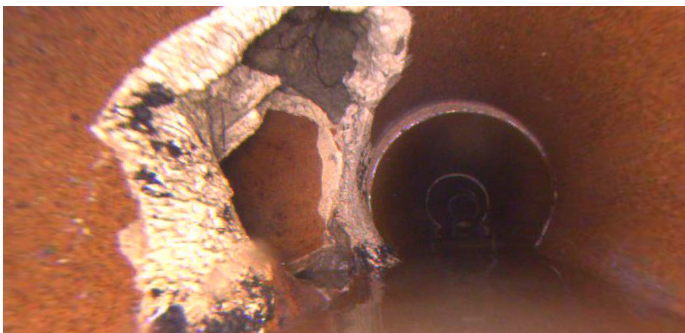
Code: **DAE**  
Description: **Deposits Attached Encrustation**

Distance (ft): **111.4**  
Structural Grade: **0**  
O&M Grade: **2**  
Clock Start/From: **8**  
Clock To: **10**  
1st Value:  
2nd Value:  
Value Percent: **5.000**  
Continuous Index:  
Within 8" of Joint: **NO**  
Remarks:

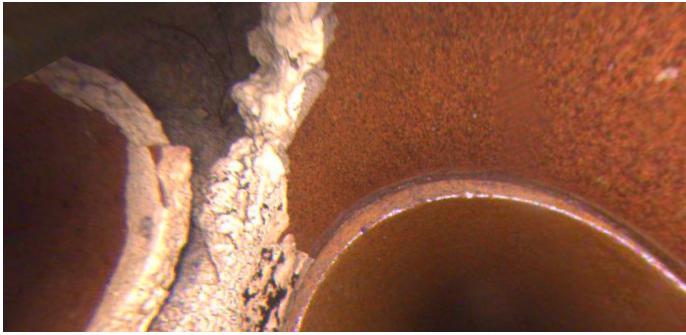
Code: **HSV**  
Description: **Hole Soil Visible**

Distance (ft): **112.0**  
Structural Grade: **5**  
O&M Grade: **0**  
Clock Start/From: **10**  
Clock To: **11**  
1st Value:  
2nd Value:  
Value Percent:  
Continuous Index:  
Within 8" of Joint:  
Remarks:

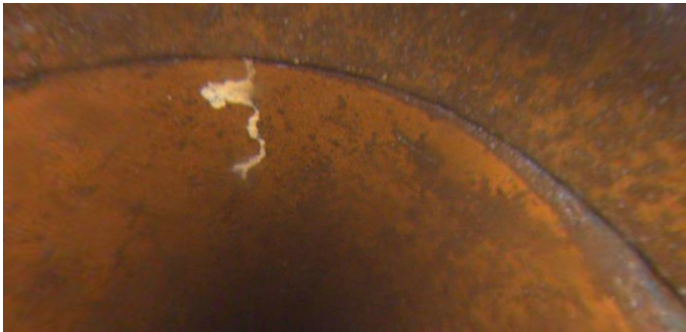
Code: **CL**  
Description: **Crack Longitudinal**

Distance (ft): **161.0**  
Structural Grade: **2**  
O&M Grade: **0**  
Clock Start/From: **12**  
Clock To:  
1st Value:  
2nd Value:  
Value Percent:  
Continuous Index:  
Within 8" of Joint: **YES**  
Remarks:

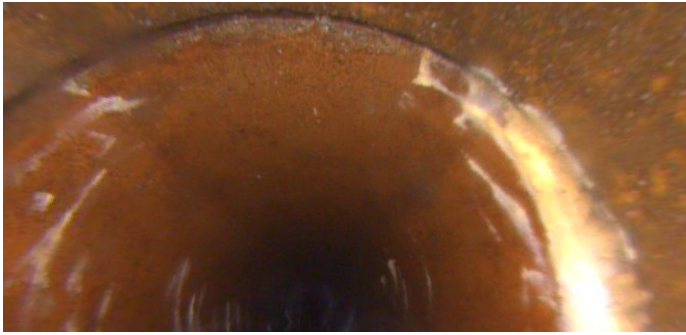
Code: **FM**  
Description: **Fracture Multiple**

Distance (ft): **164.0**  
Structural Grade: **4**  
O&M Grade: **0**  
Clock Start/From: **8**  
Clock To: **4**  
1st Value:  
2nd Value:  
Value Percent:  
Continuous Index: **S01**  
Within 8" of Joint: **YES**  
Remarks:

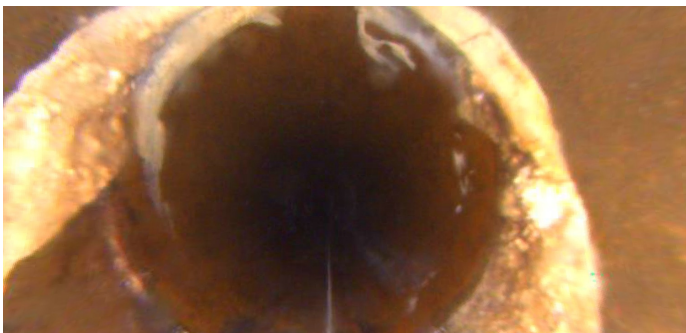
Code: **DAE**  
Description: **Deposits Attached Encrustation**

Distance (ft): **167.4**  
Structural Grade: **0**  
O&M Grade: **2**  
Clock Start/From: **8**  
Clock To: **4**  
1st Value:  
2nd Value:  
Value Percent: **5.000**  
Continuous Index: **S02**  
Within 8" of Joint: **YES**  
Remarks:

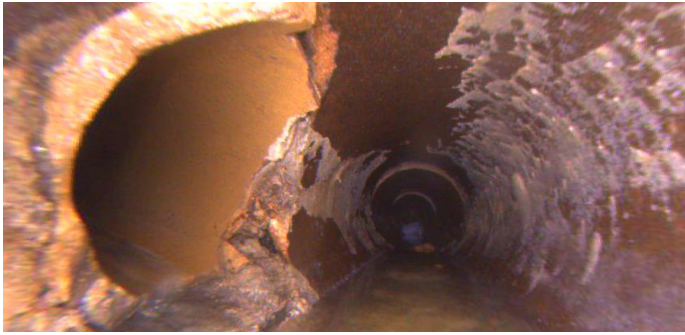
Code: **TBI**  
Description: **Tap Break-in Intruding**

Distance (ft): **191.1**  
Structural Grade: **0**  
O&M Grade: **2**  
Clock Start/From: **9**  
Clock To:  
1st Value: **4.000**  
2nd Value: **1.000**  
Value Percent:  
Continuous Index:  
Within 8" of Joint:  
Remarks:

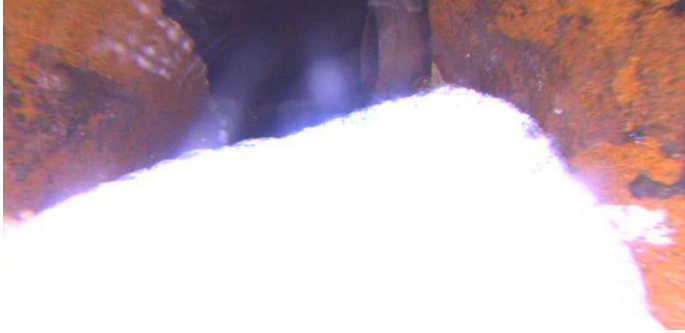
Code: **FM**  
Description: **Fracture Multiple**

Distance (ft): **198.4**  
Structural Grade: **4**  
O&M Grade: **0**  
Clock Start/From: **8**  
Clock To: **4**  
1st Value:  
2nd Value:  
Value Percent:  
Continuous Index: **F01**  
Within 8" of Joint: **YES**  
Remarks:

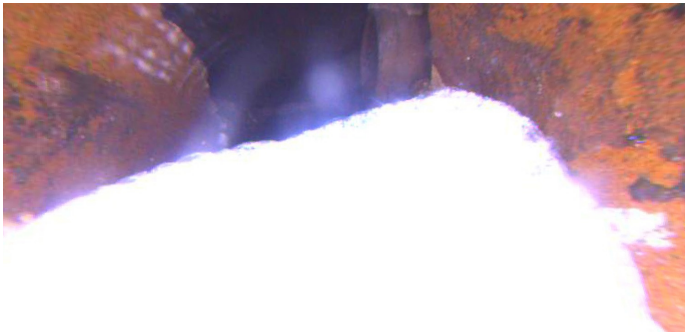
Code: **DAE**  
Description: **Deposits Attached Encrustation**

Distance (ft): **198.4**  
Structural Grade: **0**  
O&M Grade: **2**  
Clock Start/From: **8**  
Clock To: **4**  
1st Value:  
2nd Value:  
Value Percent: **5.000**  
Continuous Index: **F02**  
Within 8" of Joint: **YES**  
Remarks:
