Profile/Photo Observation Report

Date:	04/20/2018	Weather:		Coding:	PACP 6.0
Pipe Length (ft):	205.4	Owner:	NA	Pre Clean:	No Pre-Cleaning
P.O.#:		Surveyor:	Byrd Fitzgerald	PSR:	P-305-043-057
Customer:		Clean Date:	01/01/1900	Shape:	C

Street:	CRESTWOOD DR	Flow Control:	Not Controlled
City:	Hobart, IN	Year Renewed:	
Location:	Yard	Tape/Media #:	
Purpose:	Routine Assessment	Dia/Height:	10"
Use:	Sanitary	Material:	VCP
Drain Area:	NA	Lining:	
Category:	NA		
Comment:	P_C at 176 ft debris		
Location Details:		Direction of Survey:	Upstream
US MH:	M-305-043	DS MH:	M-305-057
		Total Length Surveyed (ft):	177.7

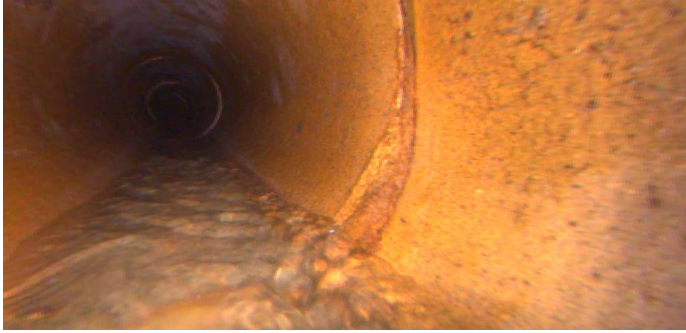
Code: **DAE**
Description: **Deposits Attached Encrustation**

Distance (ft): **10.7**
Structural Grade: **0**
O&M Grade: **2**
Clock Start/From: **3**
Clock To: **5**
1st Value:
2nd Value:
Value Percent: **5.000**
Continuous Index:
Within 8" of Joint: **YES**
Remarks:

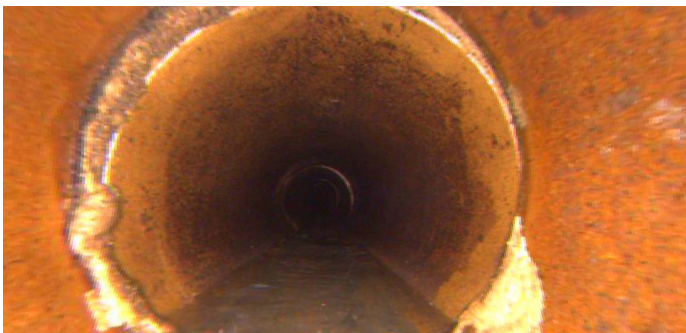
Code: **DAZ**
Description: **Deposits Attached Other**

Distance (ft): **16.4**
Structural Grade: **0**
O&M Grade: **2**
Clock Start/From: **7**
Clock To: **5**
1st Value:
2nd Value:
Value Percent: **5.000**
Continuous Index: **S01**
Within 8" of Joint: **YES**
Remarks:

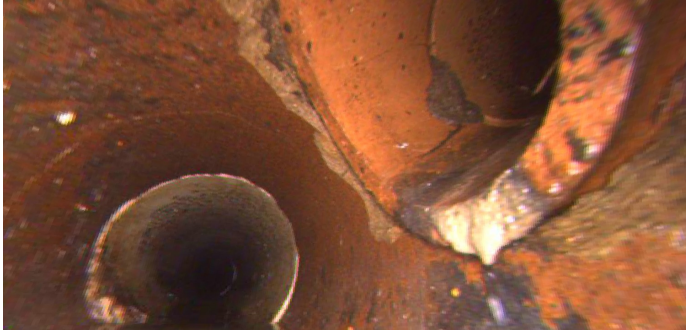
Code: **TB**
Description: **Tap Break-in**

Distance (ft): **32.9**
Structural Grade: **0**
O&M Grade: **0**
Clock Start/From: **2**
Clock To:
1st Value: **6.000**
2nd Value:
Value Percent:
Continuous Index:
Within 8" of Joint:
Remarks:

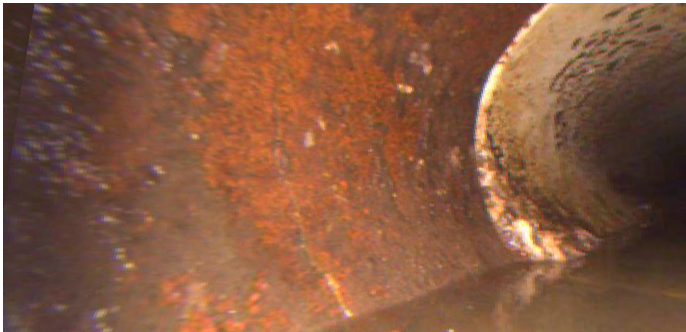
Code: **CC**
Description: **Crack Circumferential**

Distance (ft): **33.5**
Structural Grade: **1**
O&M Grade: **0**
Clock Start/From: **7**
Clock To: **5**
1st Value:
2nd Value:
Value Percent:
Continuous Index:
Within 8" of Joint:
Remarks:

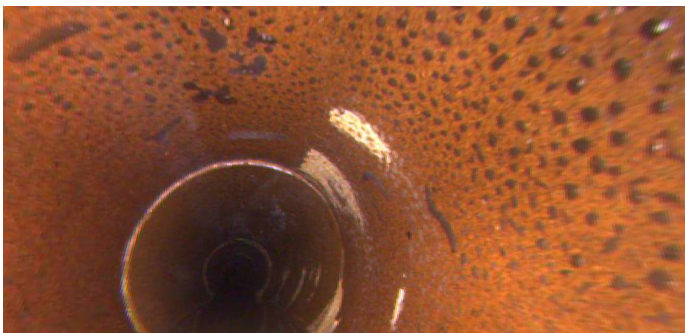
Code: **DAZ**
Description: **Deposits Attached Other**

Distance (ft): **89.3**
Structural Grade: **0**
O&M Grade: **2**
Clock Start/From: **2**
Clock To:
1st Value:
2nd Value:
Value Percent: **5.000**
Continuous Index: **S02**
Within 8" of Joint: **NO**
Remarks: **wandering in barrel**

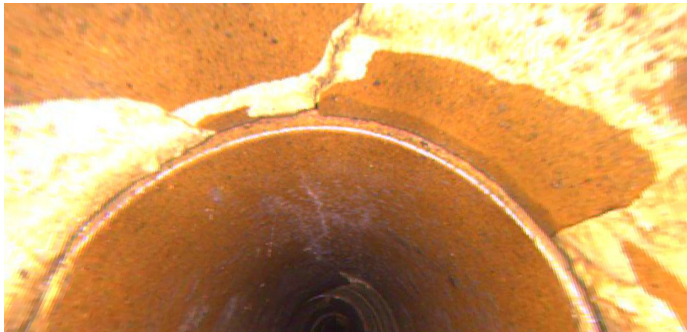
Code:	CM
Description:	Crack Multiple
Distance (ft):	166.8
Structural Grade:	3
O&M Grade:	0
Clock Start/From:	7
Clock To:	5
1st Value:	
2nd Value:	
Value Percent:	
Continuous Index:	S03
Within 8" of Joint:	YES
Remarks:	wandering

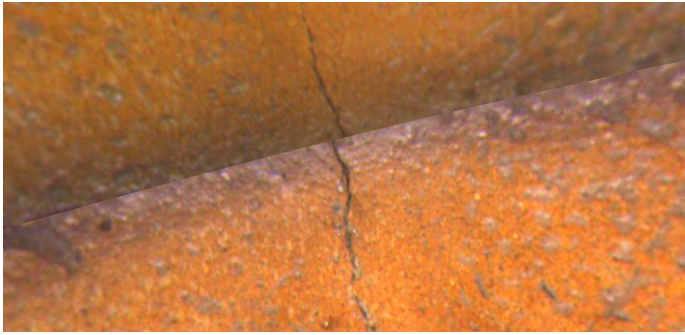
Code: **CL**
Description: **Crack Longitudinal**

Distance (ft): **172.3**
Structural Grade: **2**
O&M Grade: **0**
Clock Start/From: **12**
Clock To:
1st Value:
2nd Value:
Value Percent:
Continuous Index:
Within 8" of Joint: **YES**
Remarks:

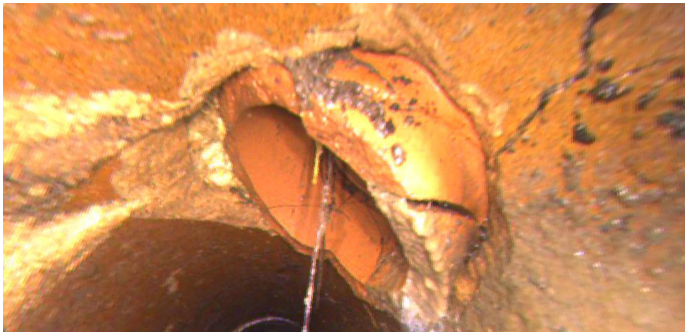
Code: **TBI**
Description: **Tap Break-in Intruding**

Distance (ft): **173.5**
Structural Grade: **0**
O&M Grade: **2**
Clock Start/From: **1**
Clock To:
1st Value: **4.000**
2nd Value: **1.500**
Value Percent:
Continuous Index:
Within 8" of Joint:
Remarks:

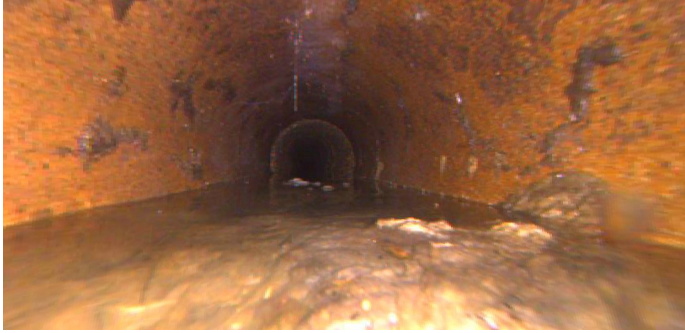
Code: **DSC**
Description: **Deposits Settled Compacted**

Distance (ft): **176.2**
Structural Grade: **0**
O&M Grade: **4**
Clock Start/From: **6**
Clock To:
1st Value:
2nd Value:
Value Percent: **25.000**
Continuous Index:
Within 8" of Joint: **NO**
Remarks:

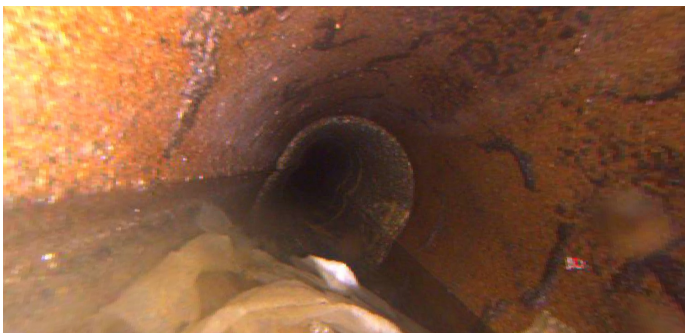
Code: **MSA**
Description: **Abandoned Survey**

Distance (ft): **177.7**
Structural Grade: **0**
O&M Grade: **0**
Clock Start/From:
Clock To:
1st Value:
2nd Value:
Value Percent:
Continuous Index:
Within 8" of Joint: **NO**
Remarks: **camera flipped**

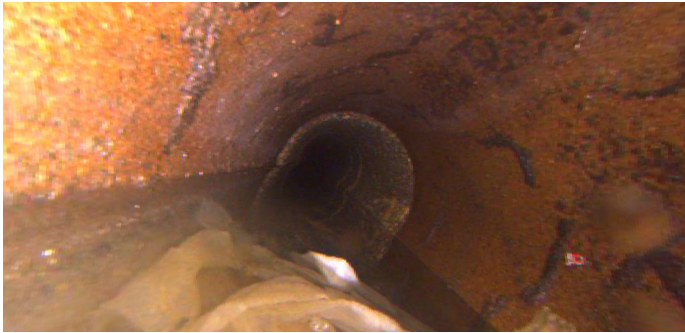
Code: **CM**
Description: **Crack Multiple**

Distance (ft): **177.7**
Structural Grade: **3**
O&M Grade: **0**
Clock Start/From: **7**
Clock To: **5**
1st Value:
2nd Value:
Value Percent:
Continuous Index: **F03**
Within 8" of Joint: **YES**
Remarks: **wandering**

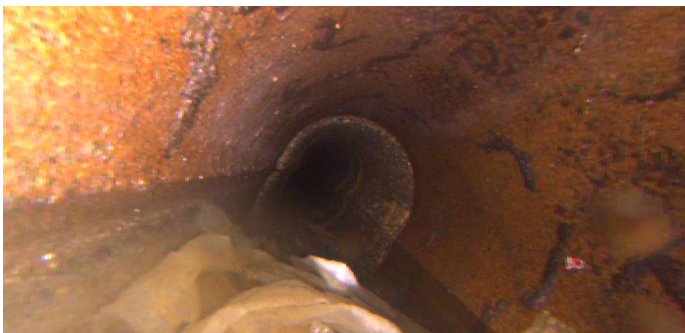
Code: **DAZ**
Description: **Deposits Attached Other**

Distance (ft): **177.7**
Structural Grade: **0**
O&M Grade: **2**
Clock Start/From: **2**
Clock To:
1st Value:
2nd Value:
Value Percent: **5.000**
Continuous Index: **F02**
Within 8" of Joint: **NO**
Remarks: **wandering in barrel**

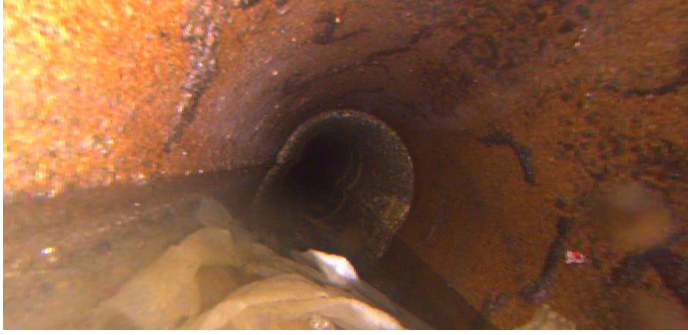
Code:	DAZ
Description:	Deposits Attached Other
Distance (ft):	177.7
Structural Grade:	0
O&M Grade:	2
Clock Start/From:	7
Clock To:	5
1st Value:	
2nd Value:	
Value Percent:	5.000
Continuous Index:	F01
Within 8" of Joint:	YES
Remarks:
