## Profile/Photo Observation Report

Date:	<b>04/20/2018</b>	Weather:		Coding:	<b>PACP 6.0</b>
Pipe Length (ft):	<b>205.4</b>	Owner:	<b>NA</b>	Pre Clean:	<b>No Pre-Cleaning</b>
P.O.#:		Surveyor:	<b>Byrd Fitzgerald</b>	PSR:	<b>P-305-043-057</b>
Customer:		Clean Date:	<b>01/01/1900</b>	Shape:	<b>C</b>

Street:	<b>FOXCROFT STREET</b>	Flow Control:	<b>Not Controlled</b>
City:	<b>Hobart, IN</b>	Year Renewed:	
Location:	<b>Yard</b>	Tape/Media #:	
Purpose:	<b>Routine Assessment</b>	Dia/Height:	<b>10"</b>
Use:	<b>Sanitary</b>	Material:	<b>VCP</b>
Drain Area:	<b>NA</b>	Lining:	
Category:	<b>NA</b>		
Comment:	<b>P_C at 176 ft debris</b>		
Location Details:		Direction of Survey:	<b>Upstream</b>
US MH:	<b>M-305-043</b>	DS MH:	<b>M-305-057</b>
		Total Length Surveyed (ft):	<b>177.7</b>

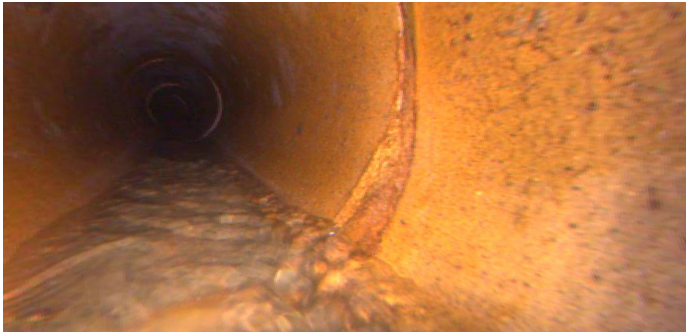
Code: **DAE**  
Description: **Deposits Attached Encrustation**

Distance (ft): **10.7**  
Structural Grade: **0**  
O&M Grade: **2**  
Clock Start/From: **3**  
Clock To: **5**  
1st Value:  
2nd Value:  
Value Percent: **5.000**  
Continuous Index:  
Within 8" of Joint: **YES**  
Remarks:

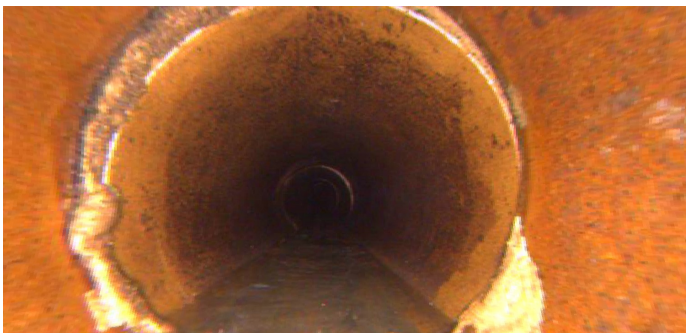
Code: **DAZ**  
Description: **Deposits Attached Other**

Distance (ft): **16.4**  
Structural Grade: **0**  
O&M Grade: **2**  
Clock Start/From: **7**  
Clock To: **5**  
1st Value:  
2nd Value:  
Value Percent: **5.000**  
Continuous Index: **S01**  
Within 8" of Joint: **YES**  
Remarks:

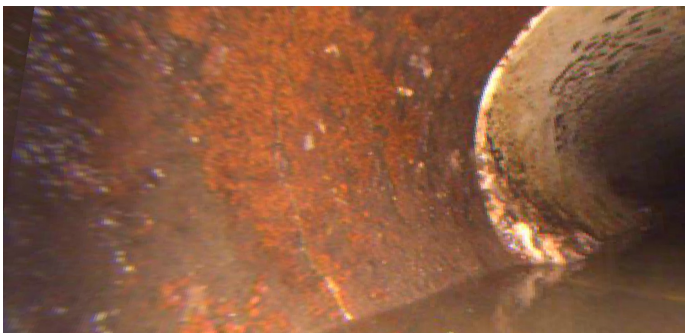
Code: **CC**  
Description: **Crack Circumferential**

Distance (ft): **33.5**  
Structural Grade: **1**  
O&M Grade: **0**  
Clock Start/From: **7**  
Clock To: **5**  
1st Value:  
2nd Value:  
Value Percent:  
Continuous Index:  
Within 8" of Joint:  
Remarks:

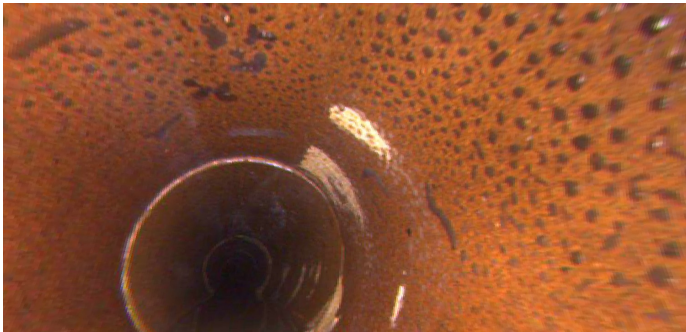
Code: **DAZ**  
Description: **Deposits Attached Other**

Distance (ft): **89.3**  
Structural Grade: **0**  
O&M Grade: **2**  
Clock Start/From: **2**  
Clock To:  
1st Value:  
2nd Value:  
Value Percent: **5.000**  
Continuous Index: **S02**  
Within 8" of Joint: **NO**  
Remarks: **wandering in barrel**

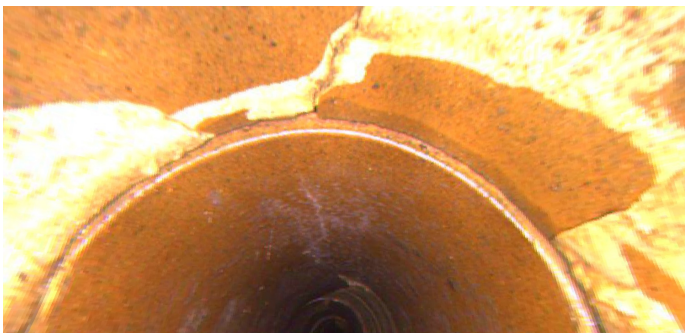
Code: **CM**  
Description: **Crack Multiple**

Distance (ft): **166.8**  
Structural Grade: **3**  
O&M Grade: **0**  
Clock Start/From: **7**  
Clock To: **5**  
1st Value:  
2nd Value:  
Value Percent:  
Continuous Index: **S03**  
Within 8" of Joint: **YES**  
Remarks: **wandering**

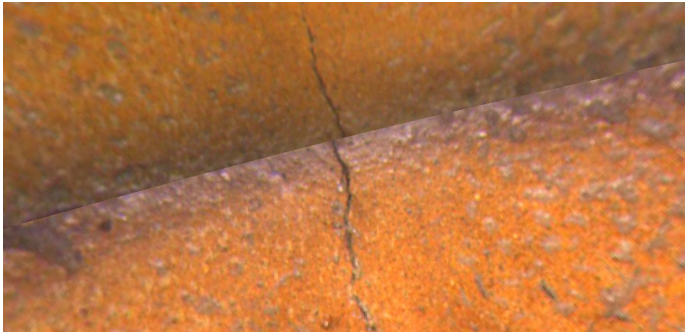
Code: **CL**  
Description: **Crack Longitudinal**

Distance (ft): **172.3**  
Structural Grade: **2**  
O&M Grade: **0**  
Clock Start/From: **12**  
Clock To:  
1st Value:  
2nd Value:  
Value Percent:  
Continuous Index:  
Within 8" of Joint: **YES**  
Remarks:

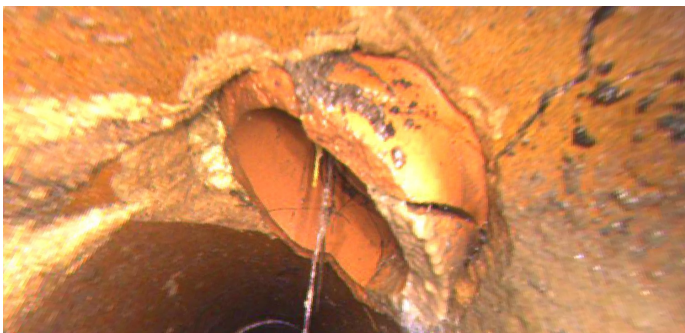
Code: **TBI**  
Description: **Tap Break-in Intruding**

Distance (ft): **173.5**  
Structural Grade: **0**  
O&M Grade: **2**  
Clock Start/From: **1**  
Clock To:  
1st Value: **4.000**  
2nd Value: **1.500**  
Value Percent:  
Continuous Index:  
Within 8" of Joint:  
Remarks:

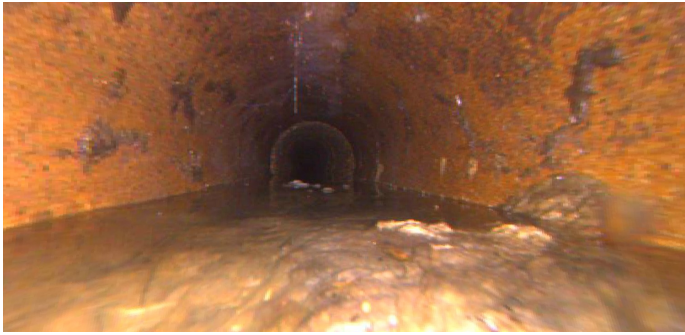
Code: **DSC**  
Description: **Deposits Settled Compacted**

Distance (ft): **176.2**  
Structural Grade: **0**  
O&M Grade: **4**  
Clock Start/From: **6**  
Clock To:  
1st Value:  
2nd Value:  
Value Percent: **25.000**  
Continuous Index:  
Within 8" of Joint: **NO**  
Remarks:

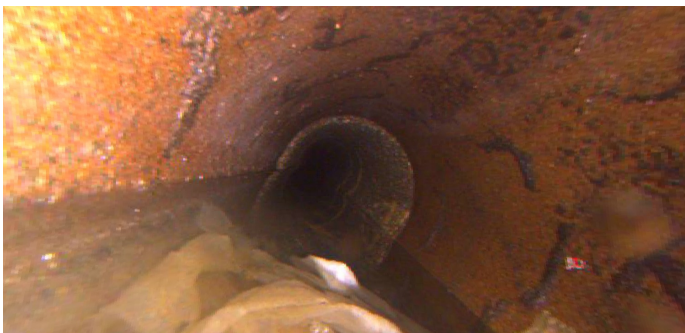
Code: **MSA**  
Description: **Abandoned Survey**

Distance (ft): **177.7**  
Structural Grade: **0**  
O&M Grade: **0**  
Clock Start/From:  
Clock To:  
1st Value:  
2nd Value:  
Value Percent:  
Continuous Index:  
Within 8" of Joint: **NO**  
Remarks: **camera flipped**

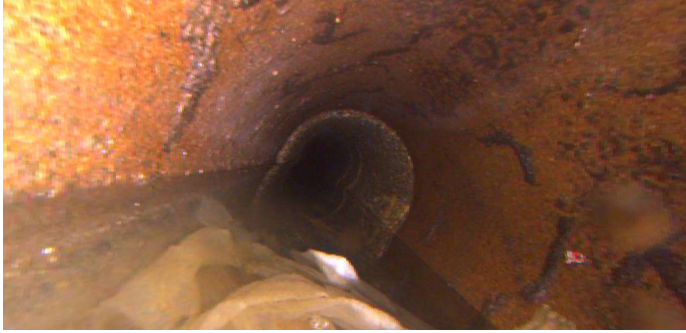
Code: **CM**  
Description: **Crack Multiple**

Distance (ft): **177.7**  
Structural Grade: **3**  
O&M Grade: **0**  
Clock Start/From: **7**  
Clock To: **5**  
1st Value:  
2nd Value:  
Value Percent:  
Continuous Index: **F03**  
Within 8" of Joint: **YES**  
Remarks: **wandering**

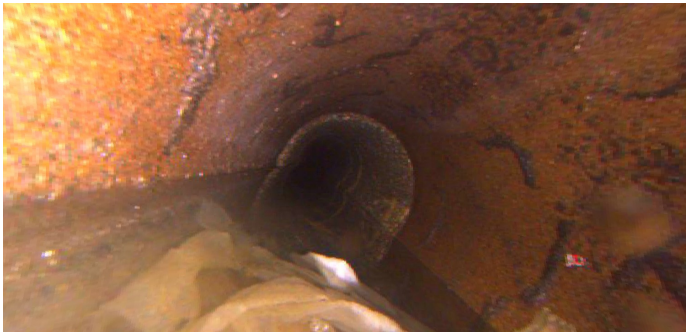
Code: **DAZ**  
Description: **Deposits Attached Other**

Distance (ft): **177.7**  
Structural Grade: **0**  
O&M Grade: **2**  
Clock Start/From: **2**  
Clock To:  
1st Value:  
2nd Value:  
Value Percent: **5.000**  
Continuous Index: **F02**  
Within 8" of Joint: **NO**  
Remarks: **wandering in barrel**

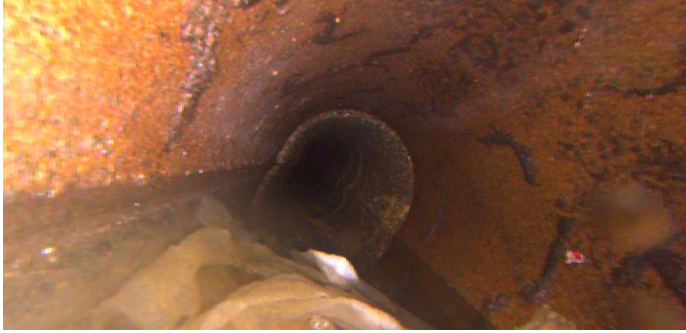
Code:	<b>DAZ</b>
Description:	<b>Deposits Attached Other</b>
Distance (ft):	<b>177.7</b>
Structural Grade:	<b>0</b>
O&M Grade:	<b>2</b>
Clock Start/From:	<b>7</b>
Clock To:	<b>5</b>
1st Value:	
2nd Value:	
Value Percent:	<b>5.000</b>
Continuous Index:	<b>F01</b>
Within 8" of Joint:	<b>YES</b>
Remarks:
