Profile/Photo Observation Report

Date:	04/24/2018	Weather:		Coding:	PACP 6.0
Pipe Length (ft):	205.4	Owner:	NA	Pre Clean:	No Pre-Cleaning
P.O.#:		Surveyor:	Jen Costello	PSR:	P-305-043-057
Customer:		Clean Date:	01/01/1900	Shape:	C

Street:	CRESTWOOD DR	Flow Control:	Not Controlled
City:	Hobart, IN	Year Renewed:	
Location:	Yard	Tape/Media #:	
Purpose:	Routine Assessment	Dia/Height:	8"
Use:	Sanitary	Material:	VCP
Drain Area:	NA	Lining:	
Category:	NA		
Comment:	R_M at 32 ft debris

Location Details:		Direction of Survey:	Downstream
US MH:	M-305-043	DS MH:	M-305-057
		Total Length Surveyed (ft):	33.1

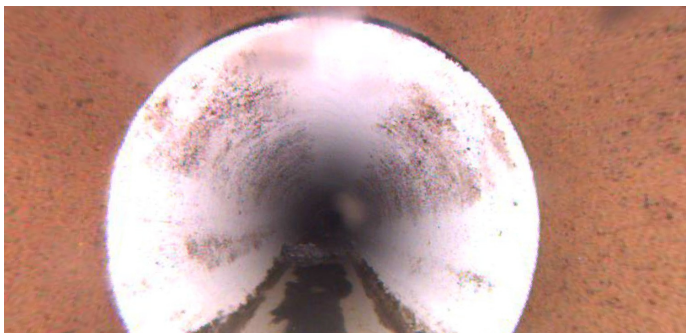
Code: **AMH**
Description: **Manhole**

Distance (ft): **.0**
Structural Grade: **0**
O&M Grade: **0**
Clock Start/From:
Clock To:
1st Value:
2nd Value:
Value Percent:
Continuous Index:
Within 8" of Joint: **NO**
Remarks: **M-305-043**

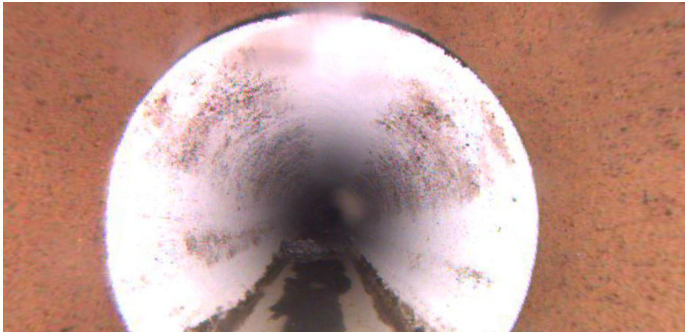
Code:	MWL
Description:	Water Level

Distance (ft):	.0
Structural Grade:	0
O&M Grade:	0
Clock Start/From:	
Clock To:	
1st Value:	
2nd Value:	
Value Percent:	5.000
Continuous Index:	
Within 8" of Joint:	NO
Remarks:

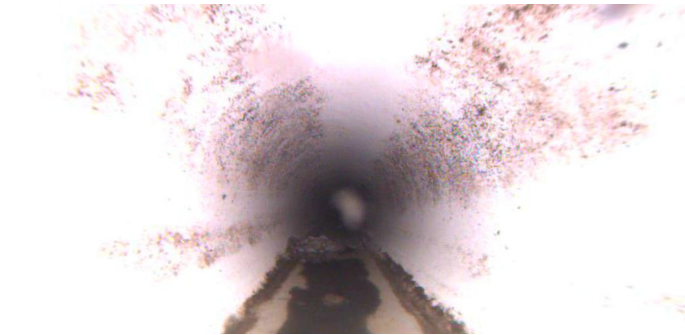
Code:	MMC
Description:	Material Change

Distance (ft):	.4
Structural Grade:	0
O&M Grade:	0
Clock Start/From:	
Clock To:	
1st Value:	
2nd Value:	
Value Percent:	
Continuous Index:	
Within 8" of Joint:	NO
Remarks:	PVC

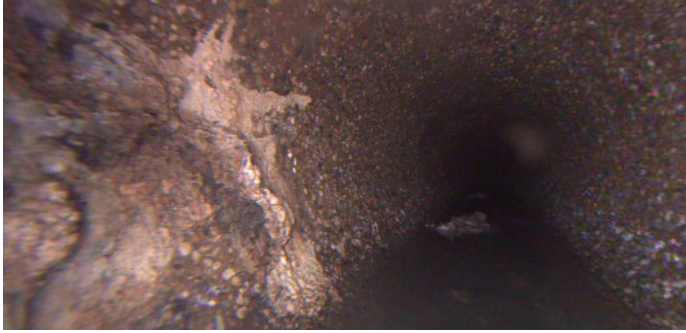
Code: **FS**
Description: **Fracture Spiral**

Distance (ft): **13.3**
Structural Grade: **3**
O&M Grade: **0**
Clock Start/From: **7**
Clock To: **9**
1st Value:
2nd Value:
Value Percent:
Continuous Index:
Within 8" of Joint: **YES**
Remarks:

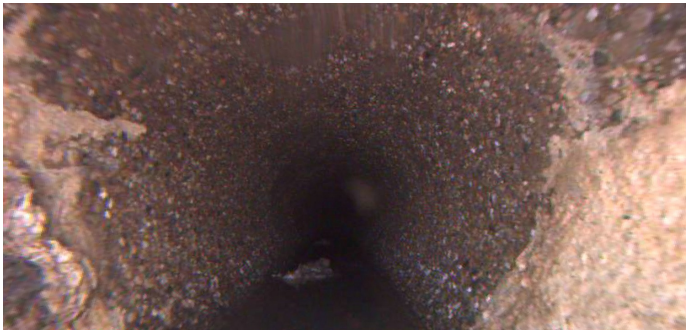
Code: **MMC**
Description: **Material Change**

Distance (ft): **13.3**
Structural Grade: **0**
O&M Grade: **0**
Clock Start/From:
Clock To:
1st Value:
2nd Value:
Value Percent:
Continuous Index:
Within 8" of Joint: **NO**
Remarks: **cp**

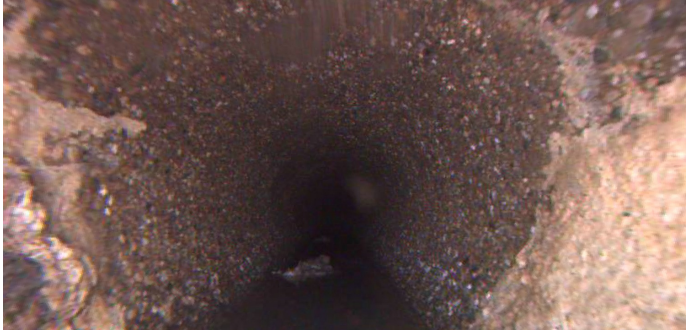
Code: **SAP**
Description: **Surface Aggregate Projecting**

Distance (ft): **13.3**
Structural Grade: **3**
O&M Grade: **0**
Clock Start/From: **7**
Clock To: **5**
1st Value:
2nd Value:
Value Percent:
Continuous Index: **S01**
Within 8" of Joint:
Remarks:

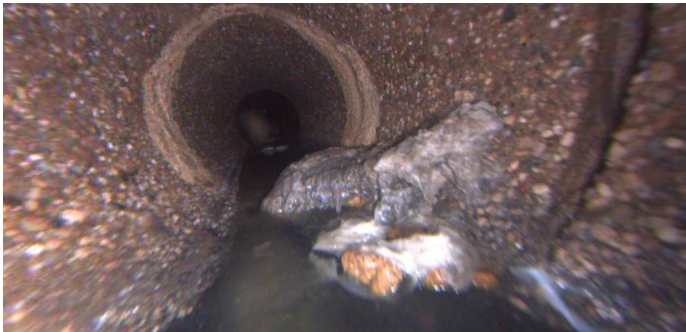
Code: **OBZ**
Description: **Obstacle Other**

Distance (ft): **31.1**
Structural Grade: **0**
O&M Grade: **2**
Clock Start/From: **3**
Clock To: **6**
1st Value:
2nd Value:
Value Percent: **10.000**
Continuous Index:
Within 8" of Joint: **NO**
Remarks: **MISC**

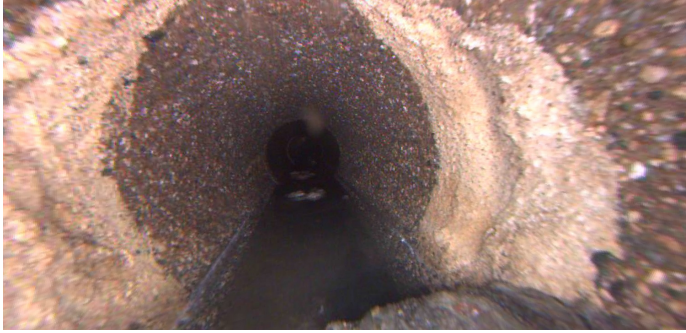
Code: **DAE**
Description: **Deposits Attached Encrustation**

Distance (ft): **31.8**
Structural Grade: **0**
O&M Grade: **2**
Clock Start/From: **8**
Clock To: **4**
1st Value:
2nd Value:
Value Percent: **5.000**
Continuous Index:
Within 8" of Joint: **YES**
Remarks:

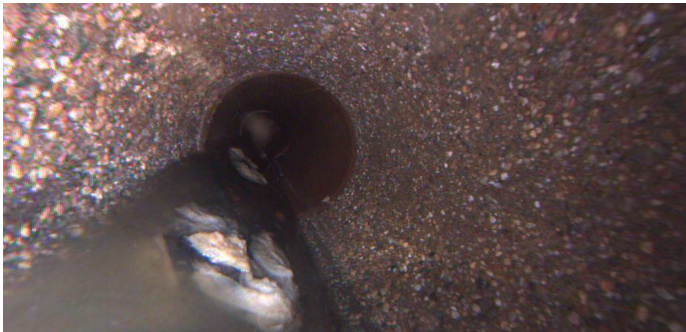
Code: **MSA**
Description: **Abandoned Survey**

Distance (ft): **33.1**
Structural Grade: **0**
O&M Grade: **0**
Clock Start/From:
Clock To:
1st Value:
2nd Value:
Value Percent:
Continuous Index:
Within 8" of Joint: **NO**
Remarks: **OVERTURNED**

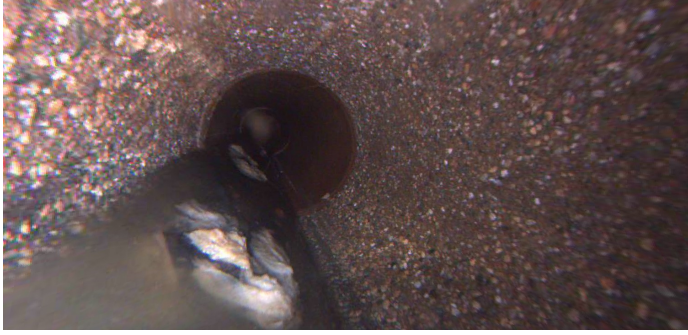
Code:	SAP
Description:	Surface Aggregate Projecting
Distance (ft):	33.1
Structural Grade:	3
O&M Grade:	0
Clock Start/From:	7
Clock To:	5
1st Value:	
2nd Value:	
Value Percent:	
Continuous Index:	F01
Within 8" of Joint:	
Remarks:
