Profile/Photo Observation Report

Date:	04/24/2018	Weather:		Coding:	PACP 6.0
Pipe Length (ft):	205.4	Owner:	NA	Pre Clean:	No Pre-Cleaning
P.O.#:		Surveyor:	Jen Costello	PSR:	P-305-043-057
Customer:		Clean Date:	01/01/1900	Shape:	C

Street:	FOXCROFT STREET	Flow Control:	Not Controlled
City:	Hobart, IN	Year Renewed:	
Location:	Yard	Tape/Media #:	
Purpose:	Routine Assessment	Dia/Height:	8"
Use:	Sanitary	Material:	VCP
Drain Area:	NA	Lining:	
Category:	NA		
Comment:	R_M at 32 ft debris

Location Details:		Direction of Survey:	Downstream
US MH:	M-305-043	DS MH:	M-305-057
		Total Length Surveyed (ft):	33.1

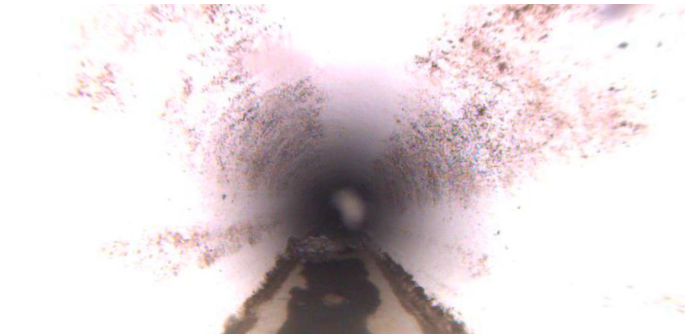
Code:	MMC
Description:	Material Change

Distance (ft):	.4
Structural Grade:	0
O&M Grade:	0
Clock Start/From:	
Clock To:	
1st Value:	
2nd Value:	
Value Percent:	
Continuous Index:	
Within 8" of Joint:	NO
Remarks:	PVC

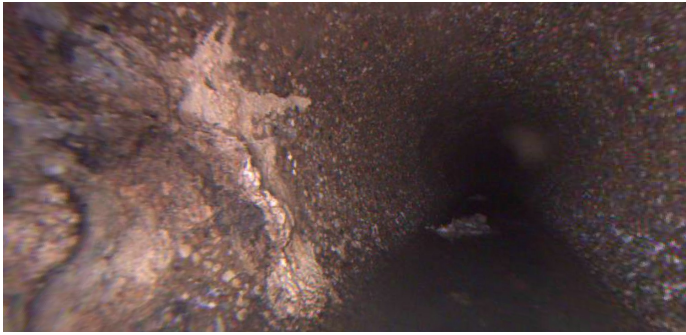
Code: **FS**
Description: **Fracture Spiral**

Distance (ft): **13.3**
Structural Grade: **3**
O&M Grade: **0**
Clock Start/From: **7**
Clock To: **9**
1st Value:
2nd Value:
Value Percent:
Continuous Index:
Within 8" of Joint: **YES**
Remarks:

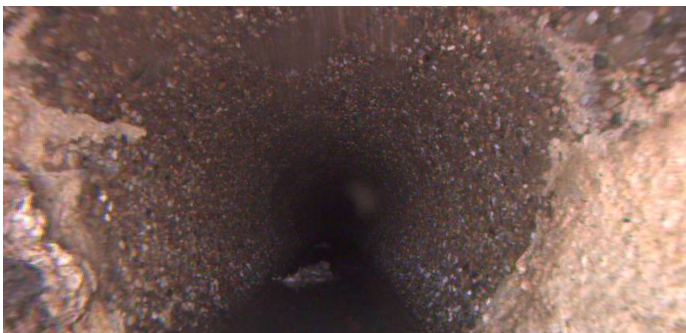
Code: **MMC**
Description: **Material Change**

Distance (ft): **13.3**
Structural Grade: **0**
O&M Grade: **0**
Clock Start/From:
Clock To:
1st Value:
2nd Value:
Value Percent:
Continuous Index:
Within 8" of Joint: **NO**
Remarks: **cp**

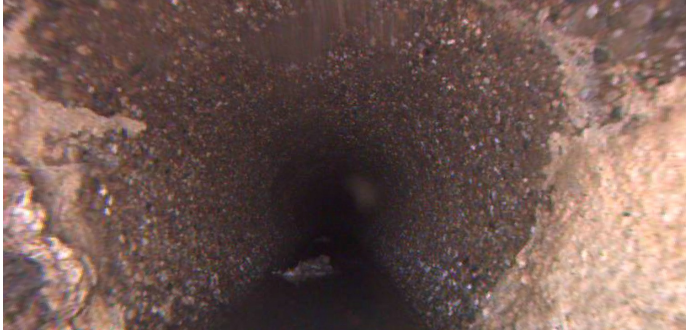
Code: **SAP**
Description: **Surface Aggregate Projecting**

Distance (ft): **13.3**
Structural Grade: **3**
O&M Grade: **0**
Clock Start/From: **7**
Clock To: **5**
1st Value:
2nd Value:
Value Percent:
Continuous Index: **S01**
Within 8" of Joint:
Remarks:

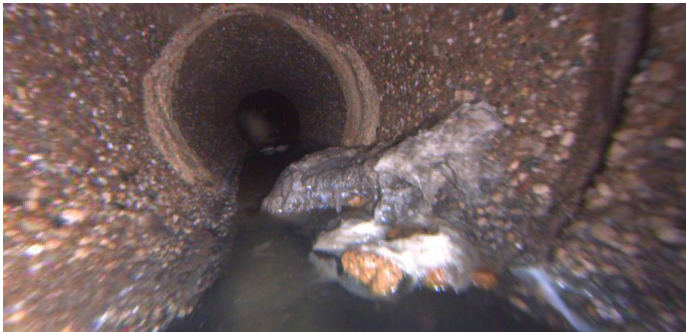
Code: **OBZ**
Description: **Obstacle Other**

Distance (ft): **31.1**
Structural Grade: **0**
O&M Grade: **2**
Clock Start/From: **3**
Clock To: **6**
1st Value:
2nd Value:
Value Percent: **10.000**
Continuous Index:
Within 8" of Joint: **NO**
Remarks: **MISC**

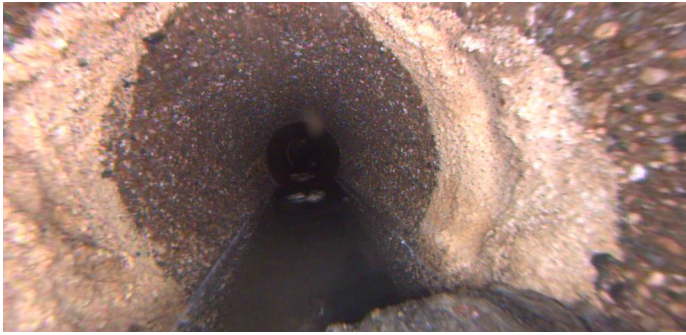
Code: **DAE**
Description: **Deposits Attached Encrustation**

Distance (ft): **31.8**
Structural Grade: **0**
O&M Grade: **2**
Clock Start/From: **8**
Clock To: **4**
1st Value:
2nd Value:
Value Percent: **5.000**
Continuous Index:
Within 8" of Joint: **YES**
Remarks:

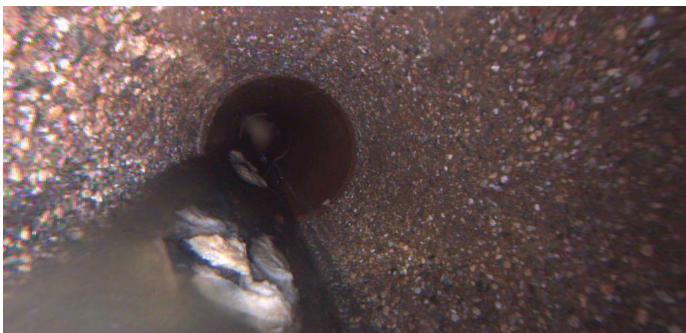
Code: **MSA**
Description: **Abandoned Survey**

Distance (ft): **33.1**
Structural Grade: **0**
O&M Grade: **0**
Clock Start/From:
Clock To:
1st Value:
2nd Value:
Value Percent:
Continuous Index:
Within 8" of Joint: **NO**
Remarks: **OVERTURNED**

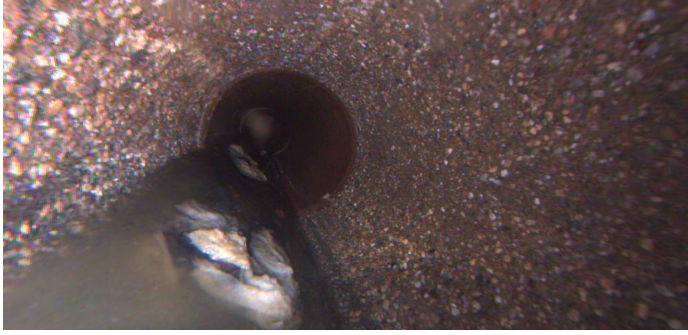
Code:	SAP
Description:	Surface Aggregate Projecting
Distance (ft):	33.1
Structural Grade:	3
O&M Grade:	0
Clock Start/From:	7
Clock To:	5
1st Value:	
2nd Value:	
Value Percent:	
Continuous Index:	F01
Within 8" of Joint:	
Remarks:
