Profile/Photo Observation Report

Date:	04/24/2018	Weather:		Coding:	PACP 6.0
Pipe Length (ft):		Owner:	City of Hobart	Pre Clean:	No Pre-Cleaning
P.O.#:	73	Surveyor:	M. Pielacha	PSR:	P-305-044-045
Customer:	City of Hobart	Clean Date:		Shape:	C

Street:	3rd Street	Flow Control:	Not Controlled
City:	Hobart, IN	Year Renewed:	
Location:	Light Highway	Tape/Media #:	DEP 73
Purpose:	Routine Assessment	Dia/Height:	15"
Use:	Sanitary	Material:	VCP
Drain Area:		Lining:	
Category:	NA		
Comment:	YES501824 Submittal 2		
Location Details:		Direction of Survey:	Downstream
US MH:	M-305-044	DS MH:	M-405-045
		Total Length Surveyed (ft):	68.4

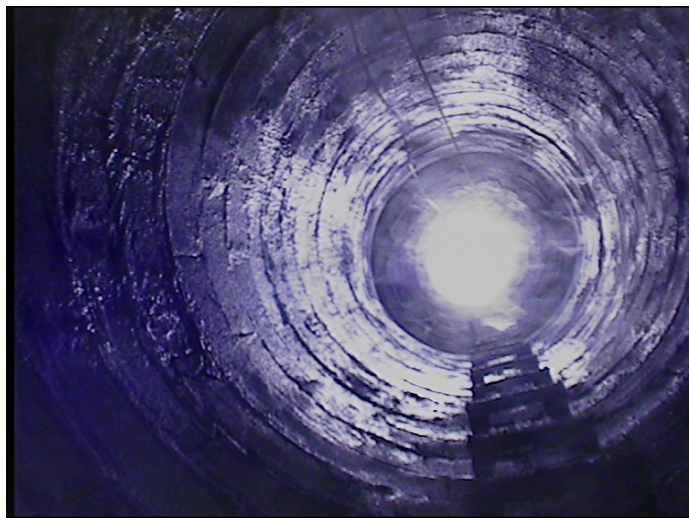
Code: **AMH**
Description: **Manhole**

Distance (ft): **.0**
Structural Grade: **0**
O&M Grade: **0**
Clock Start/From:
Clock To:
1st Value:
2nd Value:
Value Percent:
Continuous Index:
Within 8" of Joint: **NO**
Remarks: **M-305-044**

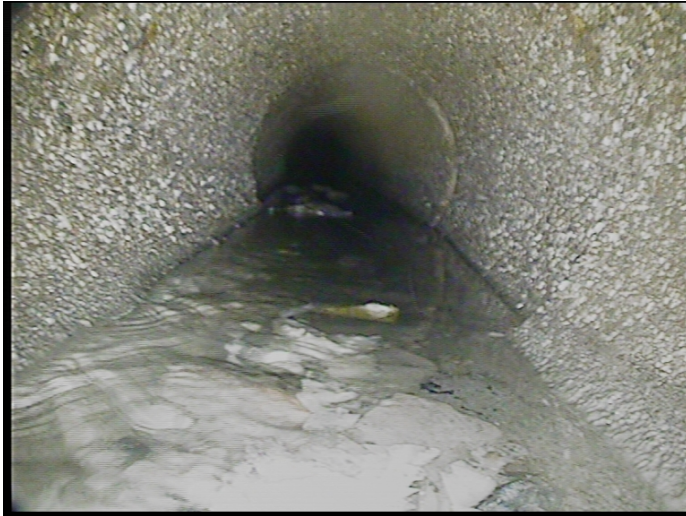
Code: **MWL**
Description: **Water Level**

Distance (ft): **.0**
Structural Grade: **0**
O&M Grade: **0**
Clock Start/From:
Clock To:
1st Value:
2nd Value:
Value Percent: **10.000**
Continuous Index:
Within 8" of Joint: **NO**
Remarks:

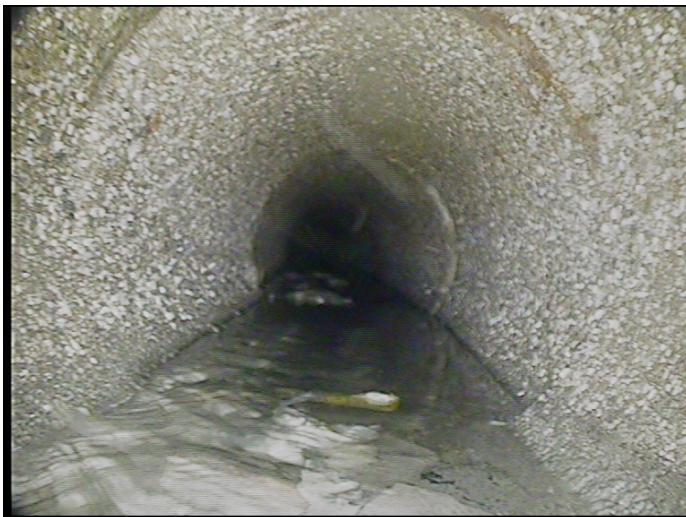
Code: **SAV**
Description: **Surface Aggregate Visible**

Distance (ft): **.0**
Structural Grade: **3**
O&M Grade: **0**
Clock Start/From: **7**
Clock To: **5**
1st Value:
2nd Value:
Value Percent:
Continuous Index: **S01**
Within 8" of Joint: **YES**
Remarks:

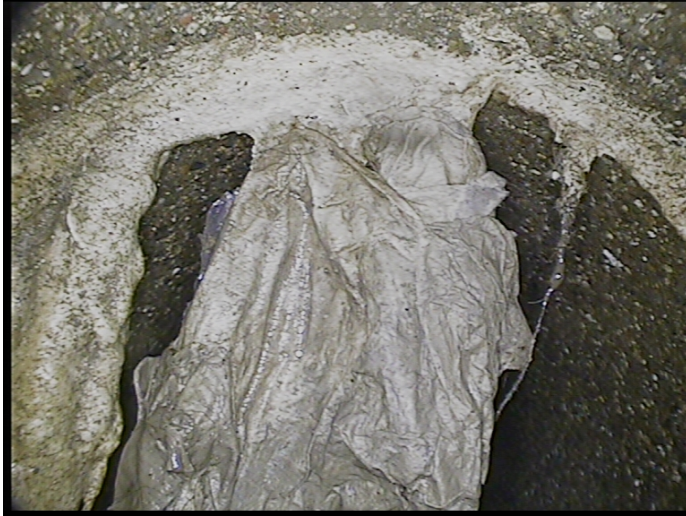
Code: **DAR**
Description: **Deposits Attached Ragging**

Distance (ft): **51.4**
Structural Grade: **0**
O&M Grade: **2**
Clock Start/From: **10**
Clock To: **2**
1st Value:
2nd Value:
Value Percent: **10.000**
Continuous Index: **S02**
Within 8" of Joint: **YES**
Remarks:

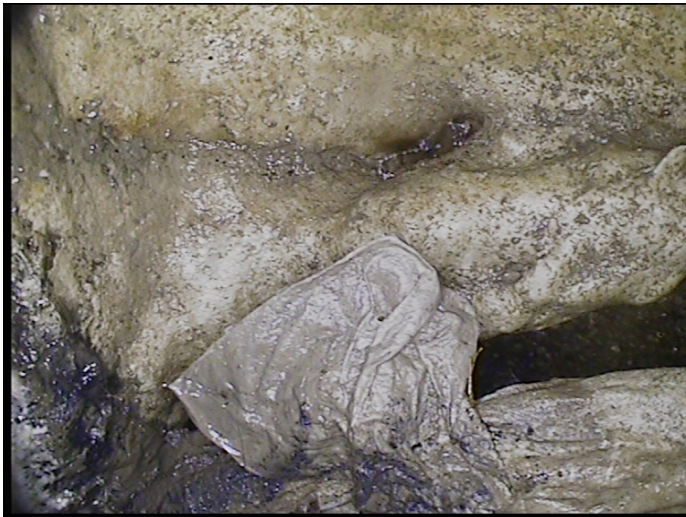
Code: **DAE**
Description: **Deposits Attached Encrustation**

Distance (ft): **52.0**
Structural Grade: **0**
O&M Grade: **2**
Clock Start/From: **7**
Clock To: **11**
1st Value:
2nd Value:
Value Percent: **10.000**
Continuous Index:
Within 8" of Joint: **NO**
Remarks:

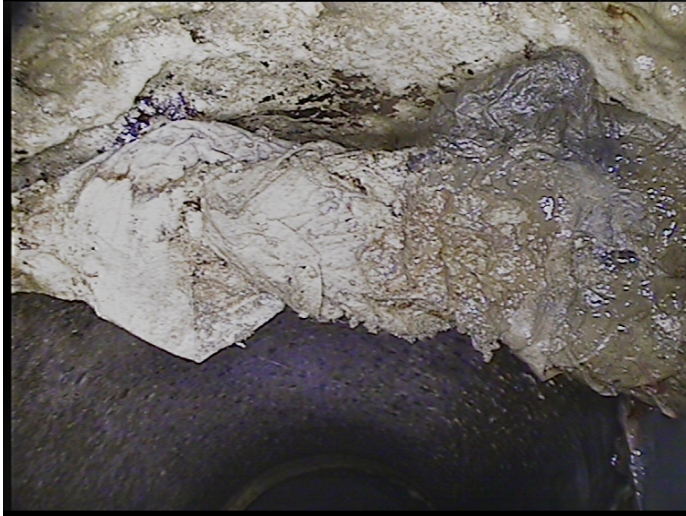
Code: **DAE**
Description: **Deposits Attached Encrustation**

Distance (ft): **67.7**
Structural Grade: **0**
O&M Grade: **2**
Clock Start/From: **1**
Clock To: **5**
1st Value:
2nd Value:
Value Percent: **10.000**
Continuous Index:
Within 8" of Joint: **YES**
Remarks:

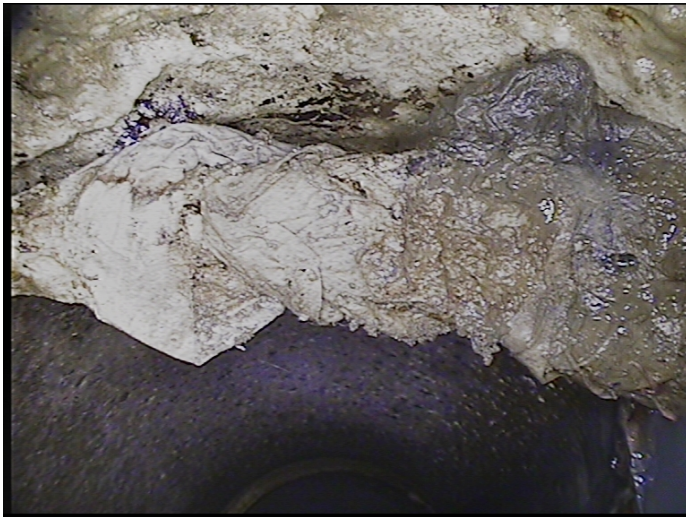
Code: **DAR**
Description: **Deposits Attached Ragging**

Distance (ft): **67.7**
Structural Grade: **0**
O&M Grade: **2**
Clock Start/From: **10**
Clock To: **2**
1st Value:
2nd Value:
Value Percent: **10.000**
Continuous Index: **F02**
Within 8" of Joint: **NO**
Remarks:

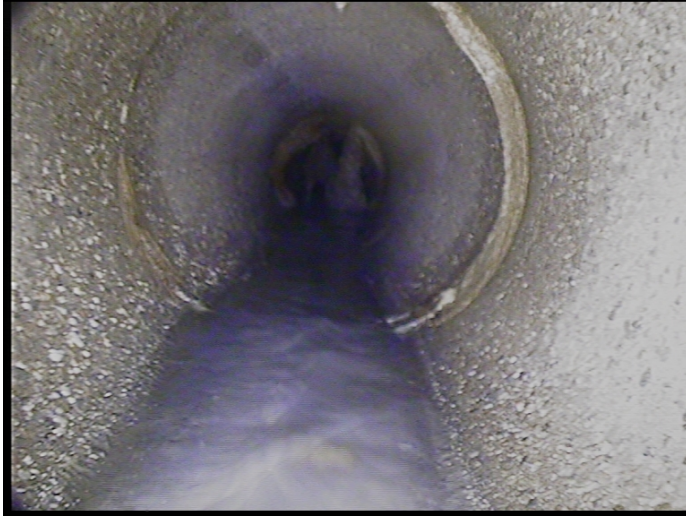
Code: **SAV**
Description: **Surface Aggregate Visible**

Distance (ft): **68.4**
Structural Grade: **3**
O&M Grade: **0**
Clock Start/From: **7**
Clock To: **5**
1st Value:
2nd Value:
Value Percent:
Continuous Index: **F01**
Within 8" of Joint: **NO**
Remarks:

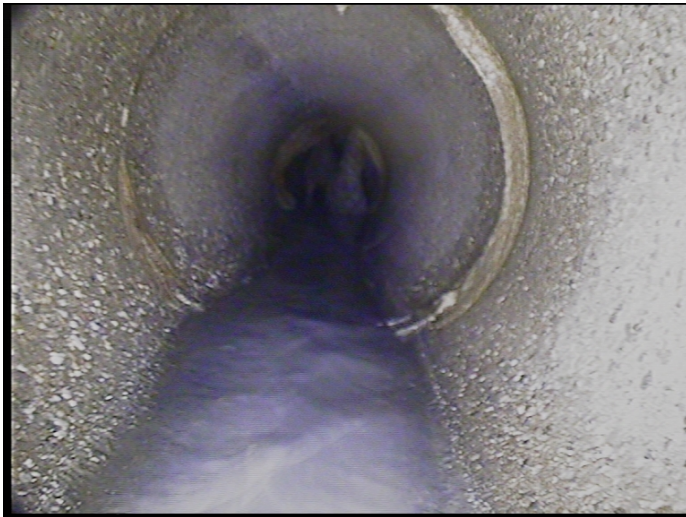
Code: **MSA**
Description: **Abandoned Survey**

Distance (ft): **68.4**
Structural Grade: **0**
O&M Grade: **0**
Clock Start/From:
Clock To:
1st Value:
2nd Value:
Value Percent:
Continuous Index:
Within 8" of Joint: **NO**
Remarks: **Encrustation**
