Profile/Photo Observation Report

Date:	09/15/2022	Weather:		Coding:	PACP 7.0
Pipe Length (ft):	252.0	Owner:	City of Hobart	Pre Clean:	Heavy Cleaning
P.O.#:	YES502259	Surveyor:	S. Bucklin	PSR:	P-305-044-045
Customer:	City of Hobart	Clean Date:	08/14/2022	Shape:	C

Street:	West 3rd Street	Flow Control:	Not Controlled
City:	Hobart, IN	Year Renewed:	
Location:	Local rural streets with light traffic, t	Tape/Media #:	
Purpose:	Routine Assessment	Dia/Height:	15"
Use:	Sanitary Sewage Pipe	Material:	RCP
Drain Area:		Lining:	None
Category:	NA		
Comment:			
Location Details:		Direction of Survey:	Upstream
US MH:	M-305-044	DS MH:	M-405-045
		Total Length Surveyed (ft):	251.1

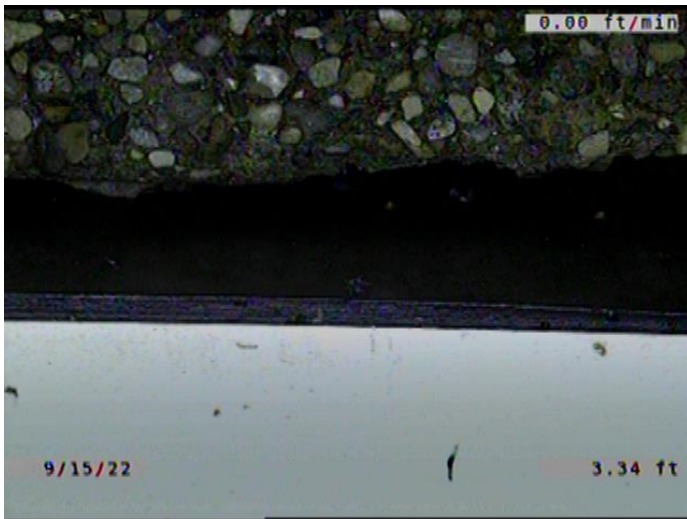
Code: **RPR**
Description: **Point Repair Replacement**

Distance (ft): **3.3**
Structural Grade: **0**
O&M Grade: **0**
Clock Start/From:
Clock To:
1st Value:
2nd Value:
Value Percent:
Continuous Index: **S01**
Within 8" of Joint: **YES**
Remarks: **REPLACED WITH PVC.**

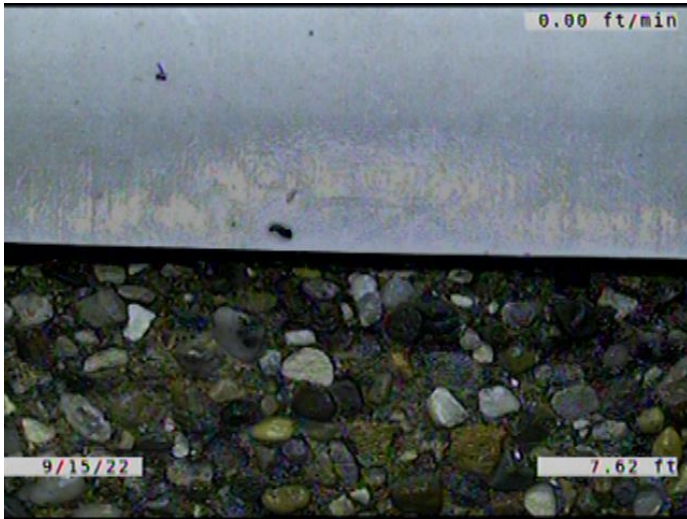
Code: **RPR**
 Description: **Point Repair Replacement**

Distance (ft): **7.6**
 Structural Grade: **0**
 O&M Grade: **0**
 Clock Start/From:
 Clock To:
 1st Value:
 2nd Value:
 Value Percent:
 Continuous Index: **F01**
 Within 8" of Joint: **YES**
 Remarks: **REPLACED WITH PVC.**

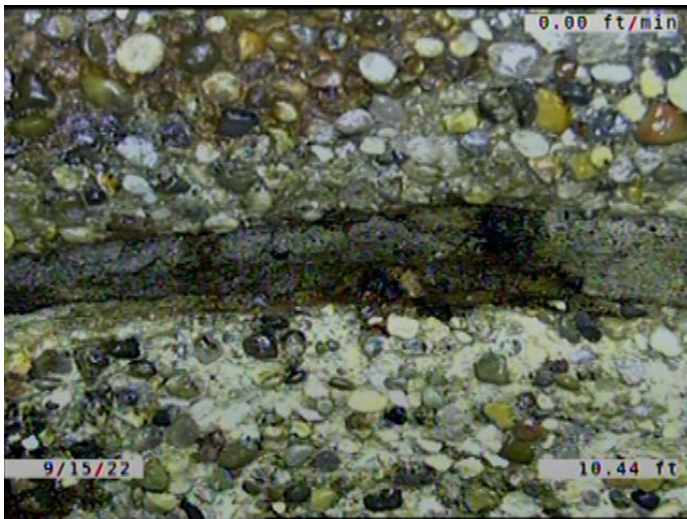
Code: **ISJ**
 Description: **Infiltration Stain Joint**

Distance (ft): **10.4**
 Structural Grade: **0**
 O&M Grade: **1**
 Clock Start/From: **8**
 Clock To: **4**
 1st Value:
 2nd Value:
 Value Percent:
 Continuous Index: **S02**
 Within 8" of Joint: **YES**
 Remarks:

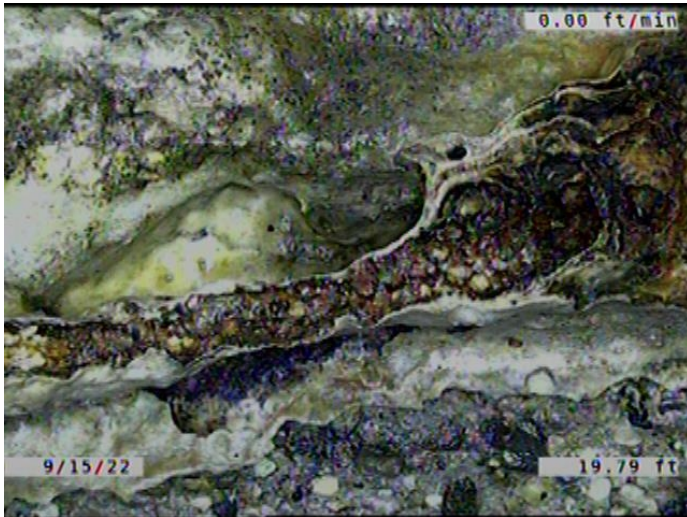
Code: **DAE**
 Description: **Deposits Attached Encrustation**

Distance (ft): **19.8**
 Structural Grade: **0**
 O&M Grade: **2**
 Clock Start/From: **8**
 Clock To: **4**
 1st Value:
 2nd Value:
 Value Percent: **5.000**
 Continuous Index: **S03**
 Within 8" of Joint: **YES**
 Remarks:

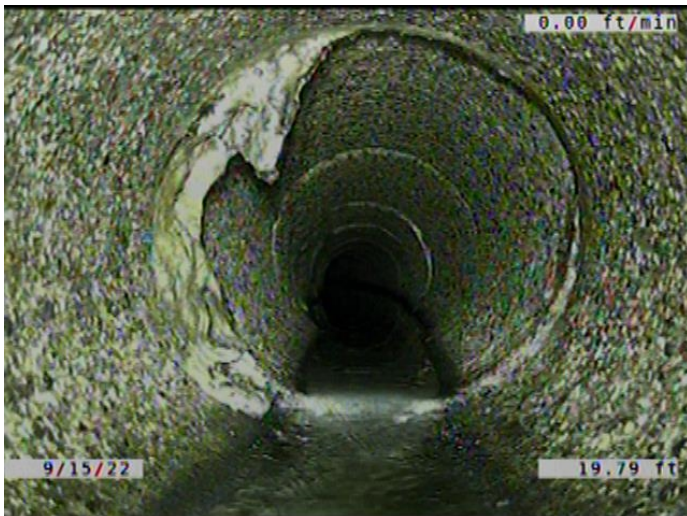
Code: **ISJ**
 Description: **Infiltration Stain Joint**

Distance (ft): **19.8**
 Structural Grade: **0**
 O&M Grade: **1**
 Clock Start/From: **8**
 Clock To: **4**
 1st Value:
 2nd Value:
 Value Percent:
 Continuous Index: **F02**
 Within 8" of Joint: **YES**
 Remarks:

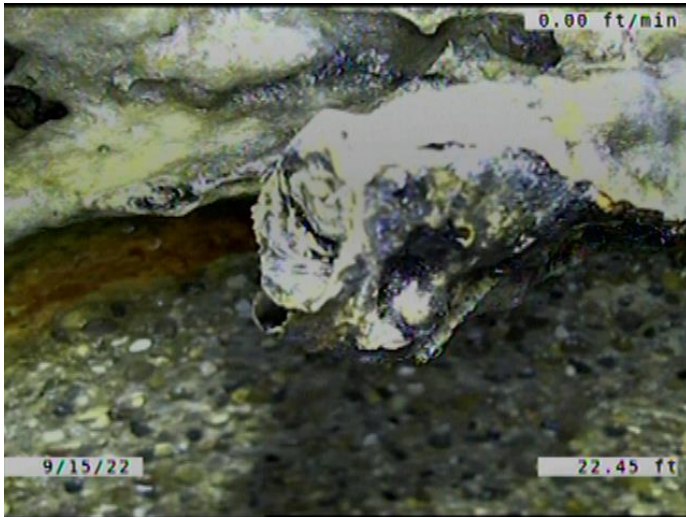
Code: **IWJ**
 Description: **Infiltration Weeper Joint**

Distance (ft): **22.4**
 Structural Grade: **0**
 O&M Grade: **2**
 Clock Start/From: **11**
 Clock To:
 1st Value:
 2nd Value:
 Value Percent:
 Continuous Index:
 Within 8" of Joint: **YES**
 Remarks:

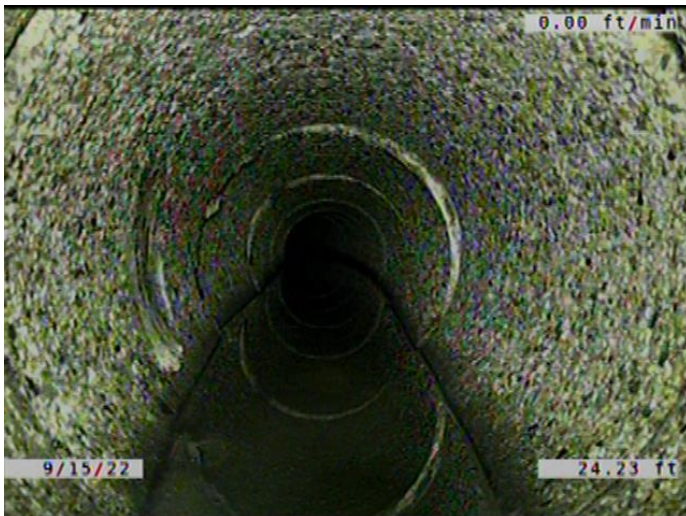
Code: **MWLS**
 Description: **Miscellaneous Water Level Sag**

Distance (ft): **24.2**
 Structural Grade: **2**
 O&M Grade: **0**
 Clock Start/From:
 Clock To:
 1st Value:
 2nd Value:
 Value Percent: **20.000**
 Continuous Index: **S04**
 Within 8" of Joint: **NO**
 Remarks:

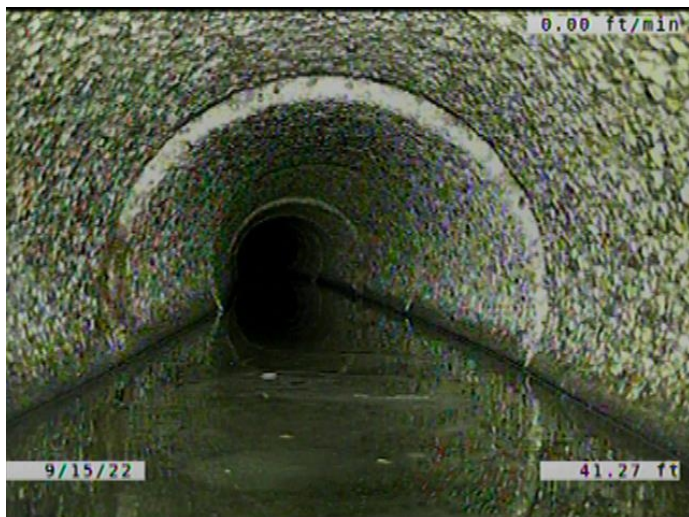
Code: **LL**
 Description: **Line Left**

Distance (ft): **41.3**
 Structural Grade: **0**
 O&M Grade: **2**
 Clock Start/From:
 Clock To:
 1st Value:
 2nd Value:
 Value Percent: **20.000**
 Continuous Index:
 Within 8" of Joint: **NO**
 Remarks:

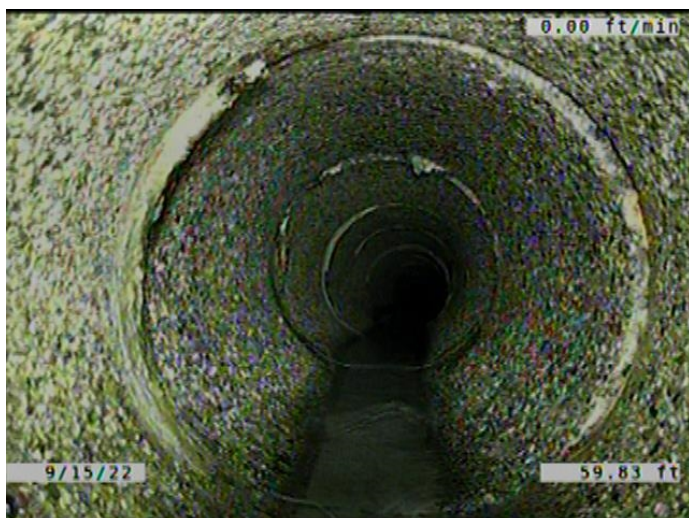
Code: **MWLS**
 Description: **Miscellaneous Water Level Sag**

Distance (ft): **59.8**
 Structural Grade: **2**
 O&M Grade: **0**
 Clock Start/From:
 Clock To:
 1st Value:
 2nd Value:
 Value Percent: **20.000**
 Continuous Index: **F04**
 Within 8" of Joint: **NO**
 Remarks:

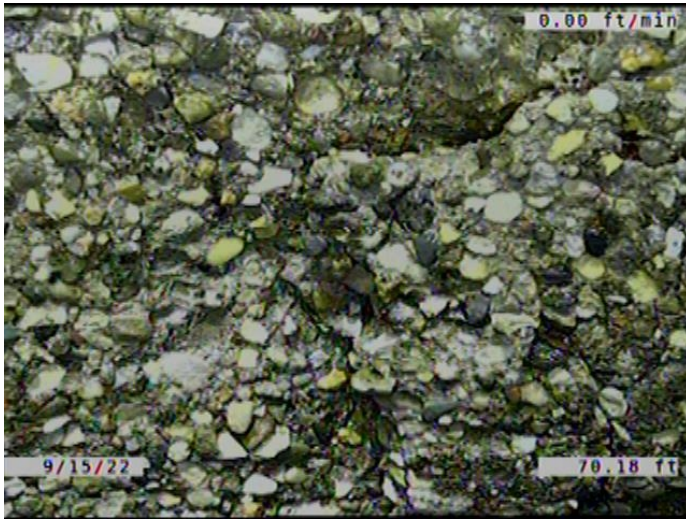
Code: **B**
Description: **Broken**

Distance (ft): **70.2**
Structural Grade: **4**
O&M Grade: **0**
Clock Start/From: **12**
Clock To: **2**
1st Value:
2nd Value:
Value Percent:
Continuous Index:
Within 8" of Joint: **NO**
Remarks:

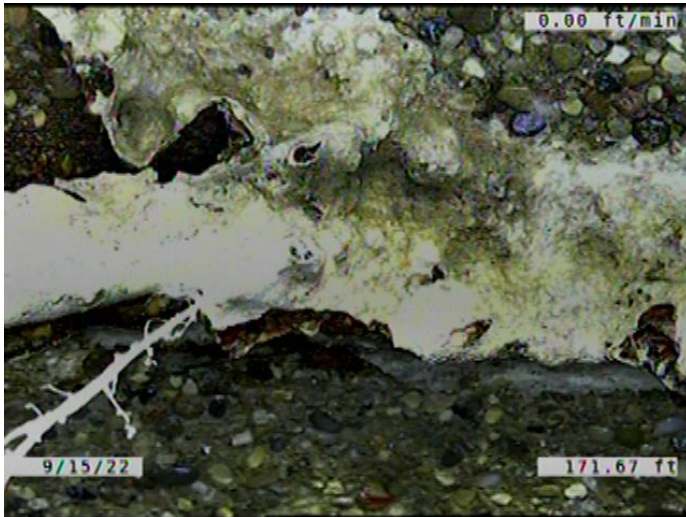
Code: **RFJ**
 Description: **Roots Fine Joint**

Distance (ft): **171.7**
 Structural Grade: **0**
 O&M Grade: **1**
 Clock Start/From: **11**
 Clock To:
 1st Value:
 2nd Value:
 Value Percent:
 Continuous Index:
 Within 8" of Joint: **YES**
 Remarks:

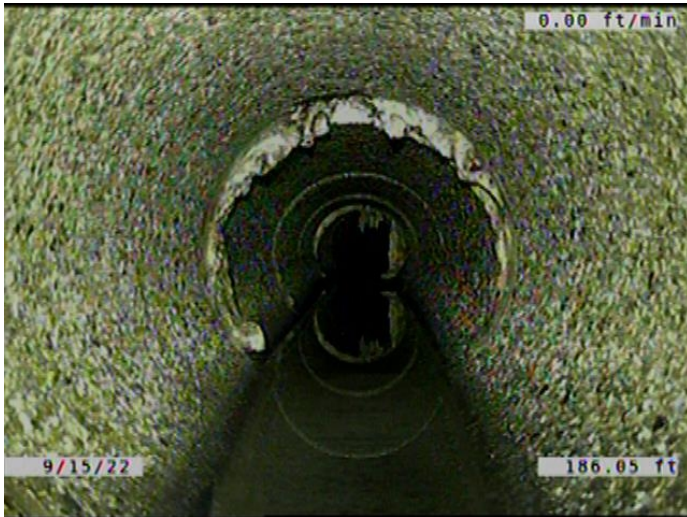
Code: **MWLS**
 Description: **Miscellaneous Water Level Sag**

Distance (ft): **186.0**
 Structural Grade: **2**
 O&M Grade: **0**
 Clock Start/From:
 Clock To:
 1st Value:
 2nd Value:
 Value Percent: **10.000**
 Continuous Index: **S05**
 Within 8" of Joint: **NO**
 Remarks:

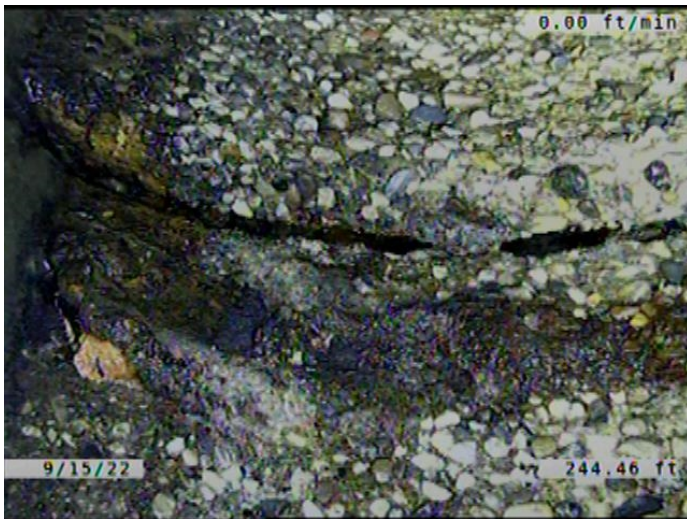
Code: **JOMD**
 Description: **Joint Offset Medium Defective**

Distance (ft): **244.5**
 Structural Grade: **3**
 O&M Grade: **0**
 Clock Start/From:
 Clock To:
 1st Value:
 2nd Value:
 Value Percent:
 Continuous Index:
 Within 8" of Joint: **NO**
 Remarks:

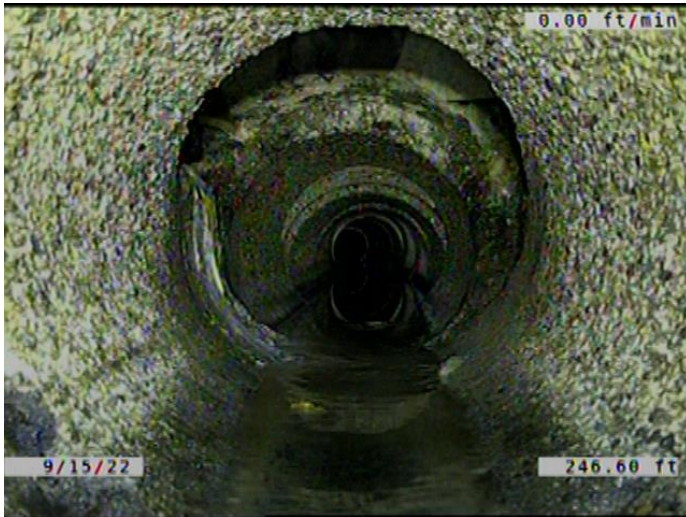
Code: **MWLS**
Description: **Miscellaneous Water Level Sag**

Distance (ft): **246.6**
Structural Grade: **2**
O&M Grade: **0**
Clock Start/From:
Clock To:
1st Value:
2nd Value:
Value Percent: **10.000**
Continuous Index: **F05**
Within 8" of Joint: **NO**
Remarks:

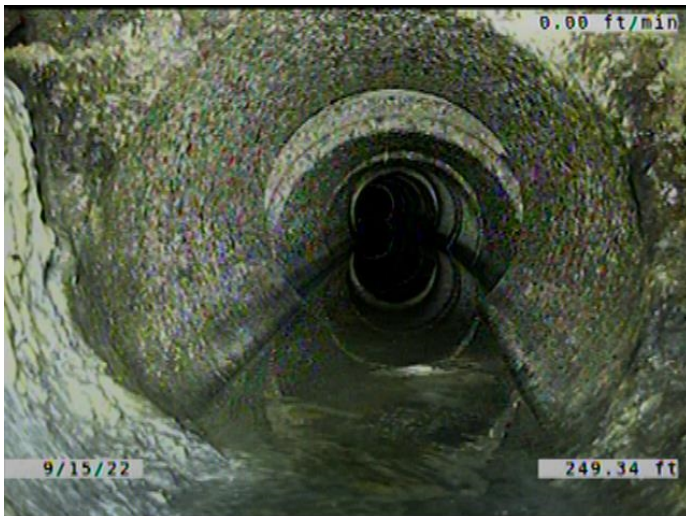
Code: **DAE**
Description: **Deposits Attached Encrustation**

Distance (ft): **249.3**
Structural Grade: **0**
O&M Grade: **2**
Clock Start/From: **8**
Clock To: **4**
1st Value:
2nd Value:
Value Percent: **5.000**
Continuous Index: **F03**
Within 8" of Joint: **YES**
Remarks:
