Profile/Photo Observation Report

Street:	FOXCROFT STREET	Flow Control:	Not Controlled
City:	Hobart, IN	Year Renewed:	
Location:	Yard	Tape/Media #:	
Purpose:	Routine Assessment	Dia/Height:	10"
Use:	Sanitary	Material:	VCP
Drain Area:	NA	Lining:	
Category:	NA		
Comment:	P_C at 37 ft build up At the lateral		
Location Details:		Direction of Survey:	Downstream
US MH:	M-305-046	DS MH:	M-305-044
		Total Length Surveyed (ft):	38.9

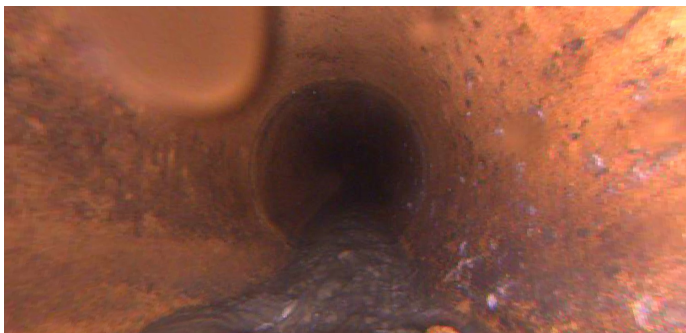
Code: **AMH**
Description: **Manhole**

Distance (ft): **.0**
Structural Grade: **0**
O&M Grade: **0**
Clock Start/From:
Clock To:
1st Value:
2nd Value:
Value Percent:
Continuous Index:
Within 8" of Joint: **NO**
Remarks: **M-305-046**

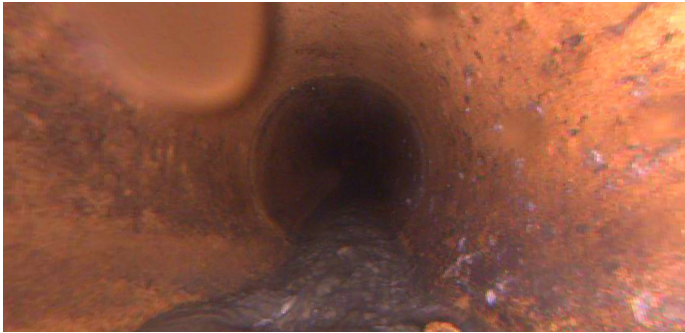
Code:	MWL
Description:	Water Level

Distance (ft):	.0
Structural Grade:	0
O&M Grade:	0
Clock Start/From:	
Clock To:	
1st Value:	
2nd Value:	
Value Percent:	5.000
Continuous Index:	
Within 8" of Joint:	NO
Remarks:

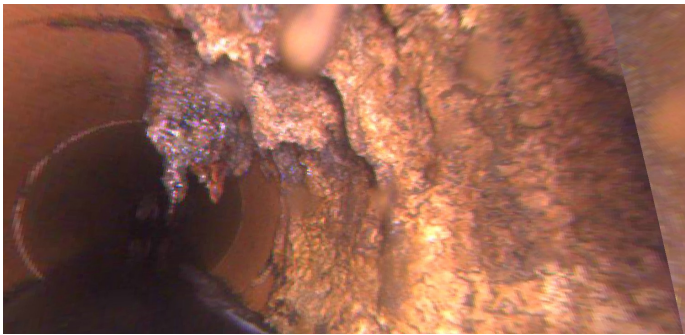
Code:	DAE
Description:	Deposits Attached Encrustation

Distance (ft):	30.6
Structural Grade:	0
O&M Grade:	2
Clock Start/From:	12
Clock To:	5
1st Value:	
2nd Value:	
Value Percent:	10.000
Continuous Index:	
Within 8" of Joint:	NO
Remarks:

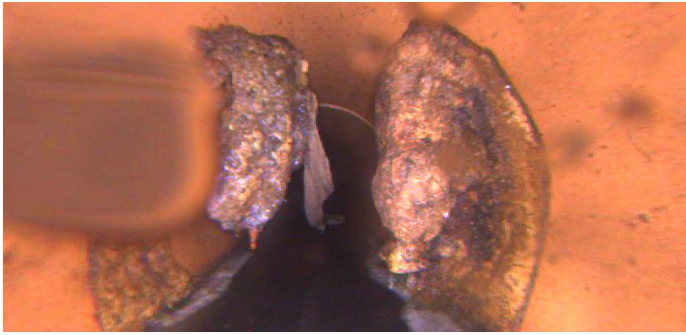
Code: **DAE**
Description: **Deposits Attached Encrustation**

Distance (ft): **36.9**
Structural Grade: **0**
O&M Grade: **4**
Clock Start/From: **7**
Clock To: **5**
1st Value:
2nd Value:
Value Percent: **25.000**
Continuous Index:
Within 8" of Joint: **NO**
Remarks:

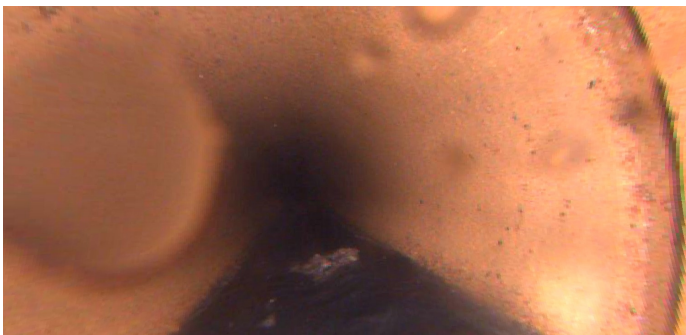
Code: **MSA**
Description: **Abandoned Survey**

Distance (ft): **38.9**
Structural Grade: **0**
O&M Grade: **0**
Clock Start/From:
Clock To:
1st Value:
2nd Value:
Value Percent:
Continuous Index:
Within 8" of Joint: **NO**
Remarks: **dae**
