## Profile/Photo Observation Report

Date:	<b>09/14/2022</b>	Weather:		Coding:	<b>PACP 7.0</b>
Pipe Length (ft):	<b>194.0</b>	Owner:	<b>City of Hobart</b>	Pre Clean:	<b>Heavy Cleaning</b>
P.O.#:	<b>YES502259</b>	Surveyor:	<b>S. Bucklin</b>	PSR:	<b>P-305-046-044</b>
Customer:	<b>City of Hobart</b>	Clean Date:	<b>08/13/2022</b>	Shape:	<b>C</b>

Street:	<b>West 3rd Street</b>	Flow Control:	<b>Not Controlled</b>
City:	<b>Hobart, IN</b>	Year Renewed:	
Location:	<b>Sidewalk</b>	Tape/Media #:	
Purpose:	<b>Routine Assessment</b>	Dia/Height:	<b>12"</b>
Use:	<b>Sanitary Sewage Pipe</b>	Material:	<b>VCP</b>
Drain Area:		Lining:	<b>None</b>
Category:	<b>NA</b>

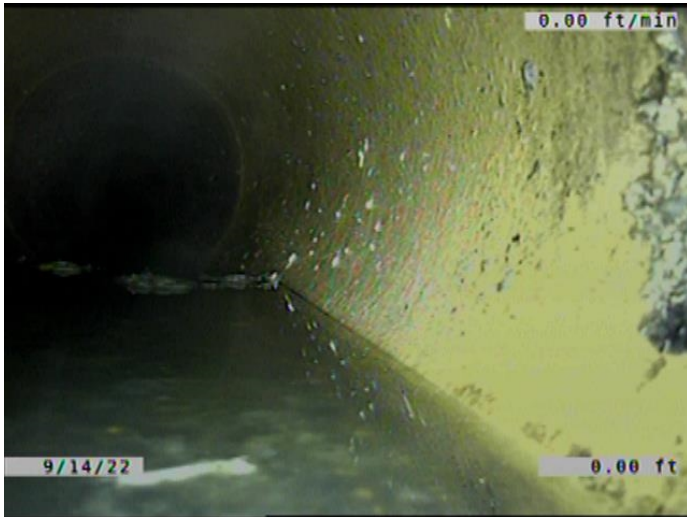
Code: **DSF**  
 Description: **Deposits Settled Fine**

Distance (ft): **.0**  
 Structural Grade: **0**  
 O&M Grade: **2**  
 Clock Start/From: **5**  
 Clock To: **7**  
 1st Value:  
 2nd Value:  
 Value Percent: **5.000**  
 Continuous Index: **S01**  
 Within 8" of Joint: **YES**  
 Remarks:

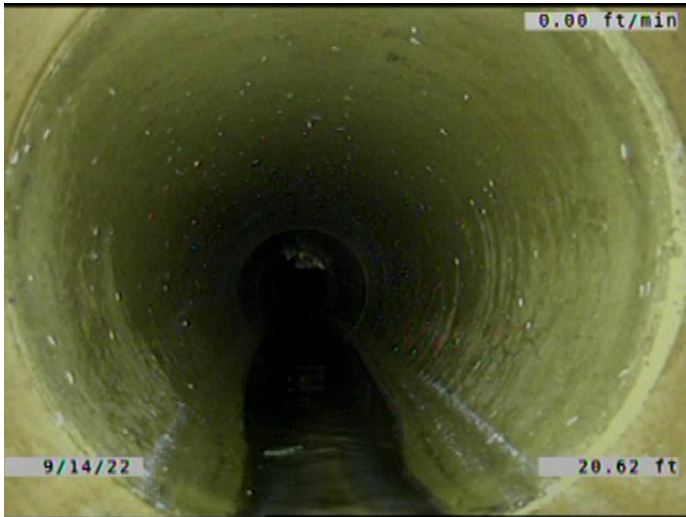
Code: **LL**  
 Description: **Line Left**

Distance (ft): **20.6**  
 Structural Grade: **0**  
 O&M Grade: **1**  
 Clock Start/From:  
 Clock To:  
 1st Value:  
 2nd Value:  
 Value Percent: **5.000**  
 Continuous Index:  
 Within 8" of Joint: **NO**  
 Remarks:

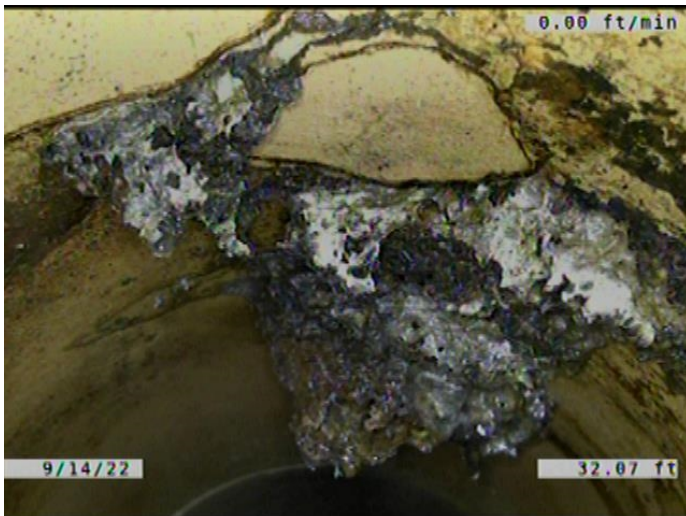
Code: **DAE**  
 Description: **Deposits Attached Encrustation**

Distance (ft): **32.1**  
 Structural Grade: **0**  
 O&M Grade: **2**  
 Clock Start/From: **8**  
 Clock To: **4**  
 1st Value:  
 2nd Value:  
 Value Percent: **5.000**  
 Continuous Index:  
 Within 8" of Joint: **YES**  
 Remarks:

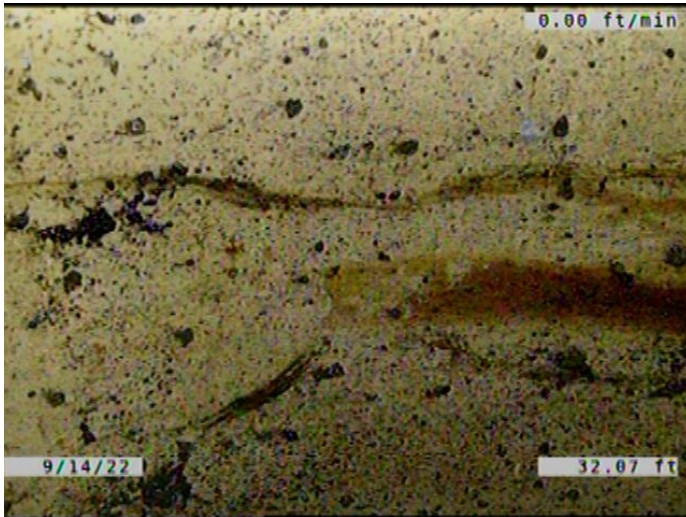
Code: **CM**  
Description: **Crack Multiple**

Distance (ft): **32.1**  
Structural Grade: **3**  
O&M Grade: **0**  
Clock Start/From: **8**  
Clock To: **4**  
1st Value:  
2nd Value:  
Value Percent:  
Continuous Index:  
Within 8" of Joint: **YES**  
Remarks:

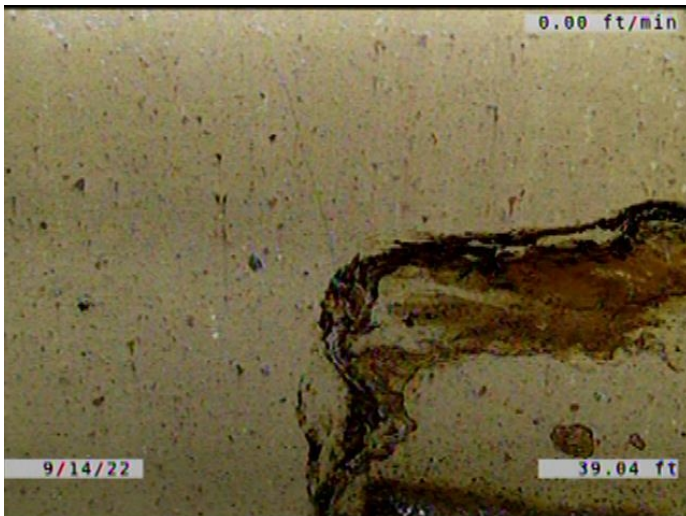
Code: **CM**  
Description: **Crack Multiple**

Distance (ft): **39.0**  
Structural Grade: **3**  
O&M Grade: **0**  
Clock Start/From: **7**  
Clock To: **5**  
1st Value:  
2nd Value:  
Value Percent:  
Continuous Index:  
Within 8" of Joint: **YES**  
Remarks:

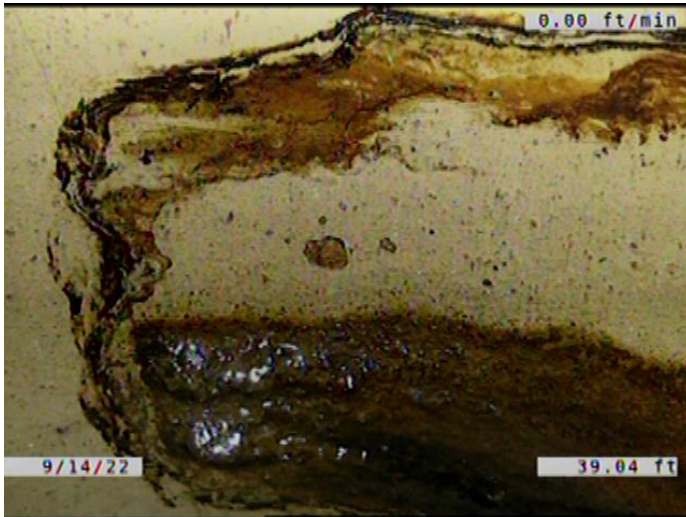
Code: **DAE**  
 Description: **Deposits Attached Encrustation**

Distance (ft): **39.0**  
 Structural Grade: **0**  
 O&M Grade: **2**  
 Clock Start/From: **1**  
 Clock To: **5**  
 1st Value:  
 2nd Value:  
 Value Percent: **5.000**  
 Continuous Index:  
 Within 8" of Joint: **NO**  
 Remarks:

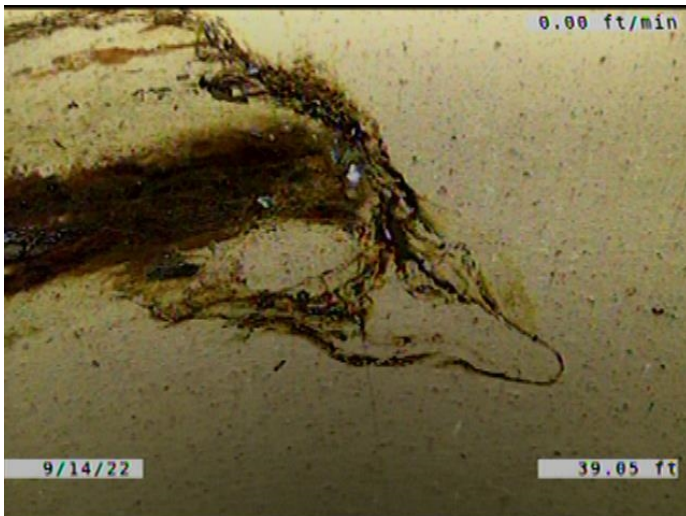
Code: **DAE**  
 Description: **Deposits Attached Encrustation**

Distance (ft): **39.0**  
 Structural Grade: **0**  
 O&M Grade: **2**  
 Clock Start/From: **7**  
 Clock To: **11**  
 1st Value:  
 2nd Value:  
 Value Percent: **5.000**  
 Continuous Index:  
 Within 8" of Joint: **NO**  
 Remarks:

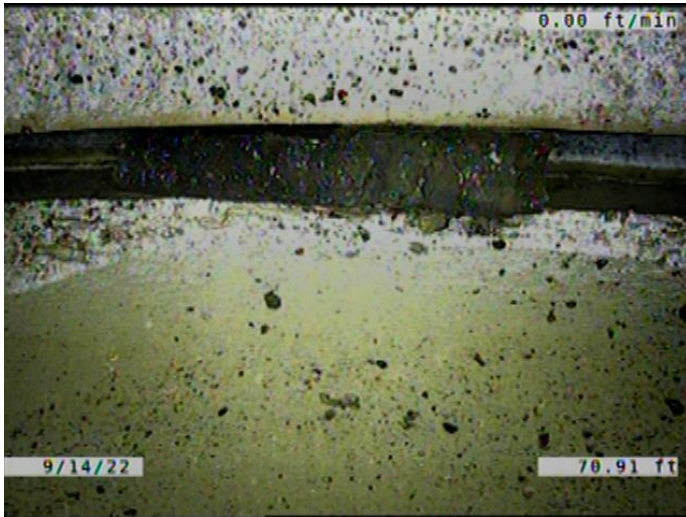
Code: **ISSRH**  
Description: **Intruding Sealing Material Sealing Ring Hanging**

Distance (ft): **70.9**  
Structural Grade: **0**  
O&M Grade: **2**  
Clock Start/From: **11**  
Clock To: **12**  
1st Value:  
2nd Value:  
Value Percent: **5.000**  
Continuous Index:  
Within 8" of Joint: **NO**  
Remarks:

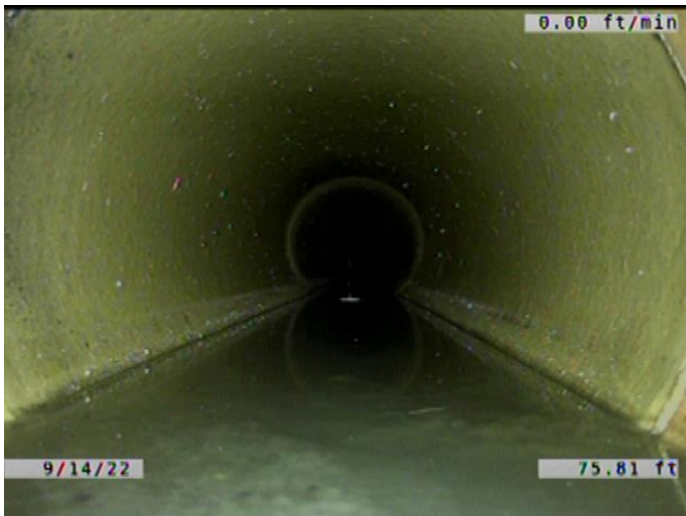
Code: **MWLS**  
Description: **Miscellaneous Water Level Sag**

Distance (ft): **75.8**  
Structural Grade: **2**  
O&M Grade: **0**  
Clock Start/From:  
Clock To:  
1st Value:  
2nd Value:  
Value Percent: **15.000**  
Continuous Index:  
Within 8" of Joint: **NO**  
Remarks:

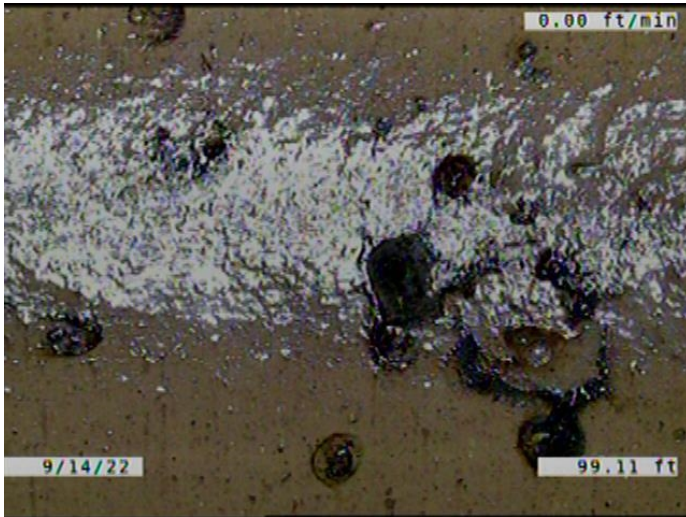
Code: **ISB**  
 Description: **Infiltration Stain Barrel**

Distance (ft): **99.1**  
 Structural Grade: **0**  
 O&M Grade: **1**  
 Clock Start/From: **11**  
 Clock To: **1**  
 1st Value:  
 2nd Value:  
 Value Percent:  
 Continuous Index:  
 Within 8" of Joint: **NO**  
 Remarks:

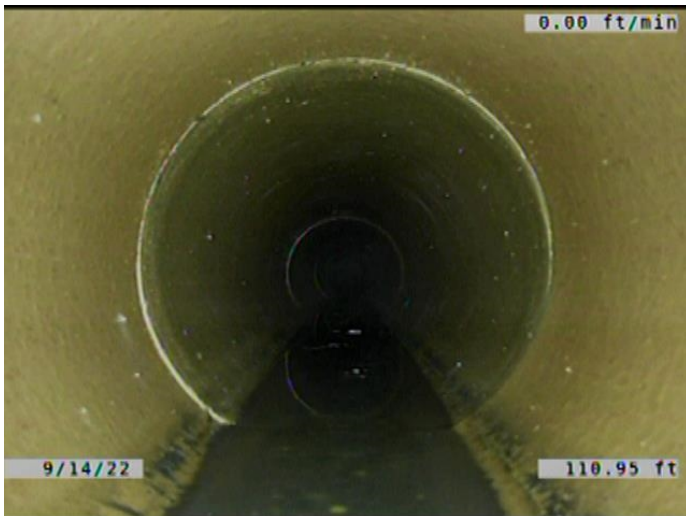
Code: **MWLS**  
 Description: **Miscellaneous Water Level Sag**

Distance (ft): **110.9**  
 Structural Grade: **2**  
 O&M Grade: **0**  
 Clock Start/From:  
 Clock To:  
 1st Value:  
 2nd Value:  
 Value Percent: **5.000**  
 Continuous Index: **S02**  
 Within 8" of Joint: **NO**  
 Remarks:

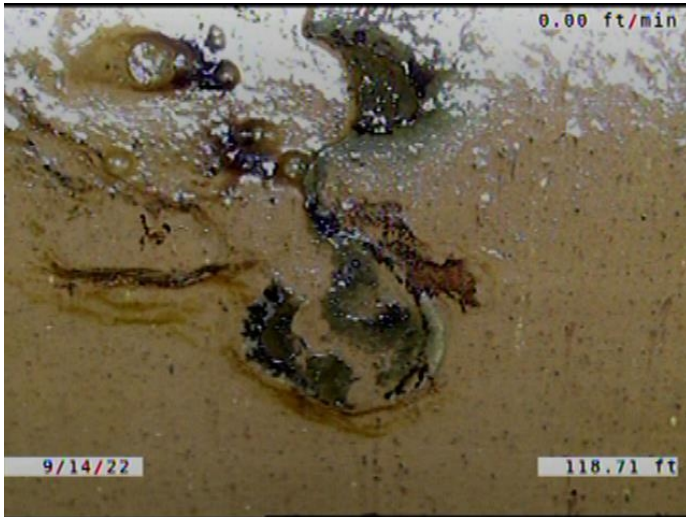
Code: **ISB**  
 Description: **Infiltration Stain Barrel**

Distance (ft): **118.7**  
 Structural Grade: **0**  
 O&M Grade: **1**  
 Clock Start/From: **11**  
 Clock To: **12**  
 1st Value:  
 2nd Value:  
 Value Percent:  
 Continuous Index:  
 Within 8" of Joint: **YES**  
 Remarks:

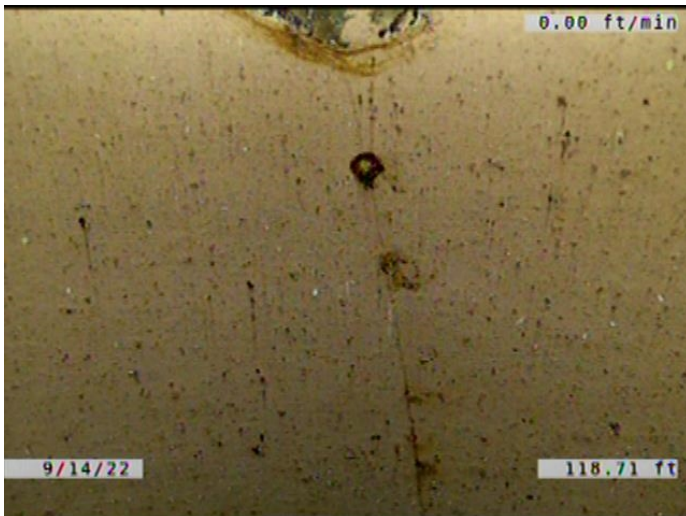
Code: **CS**  
 Description: **Crack Spiral**

Distance (ft): **118.7**  
 Structural Grade: **2**  
 O&M Grade: **0**  
 Clock Start/From: **11**  
 Clock To: **12**  
 1st Value:  
 2nd Value:  
 Value Percent:  
 Continuous Index:  
 Within 8" of Joint: **YES**  
 Remarks:

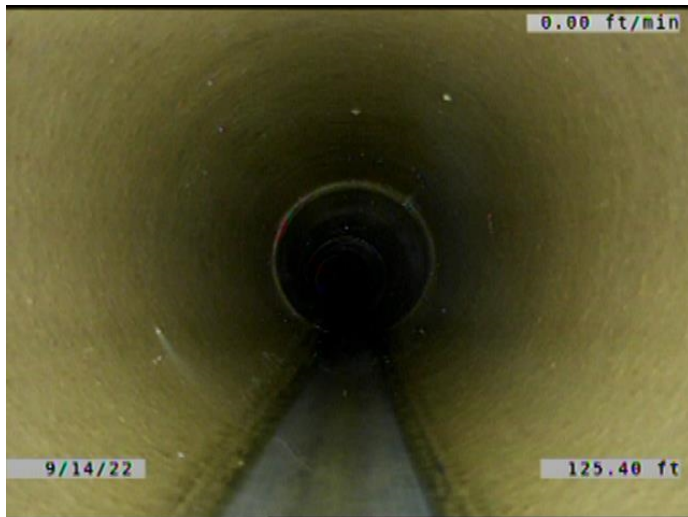
Code: **MWLS**  
Description: **Miscellaneous Water Level Sag**

Distance (ft): **125.4**  
Structural Grade: **2**  
O&M Grade: **0**  
Clock Start/From:  
Clock To:  
1st Value:  
2nd Value:  
Value Percent: **5.000**  
Continuous Index: **F02**  
Within 8" of Joint: **NO**  
Remarks:

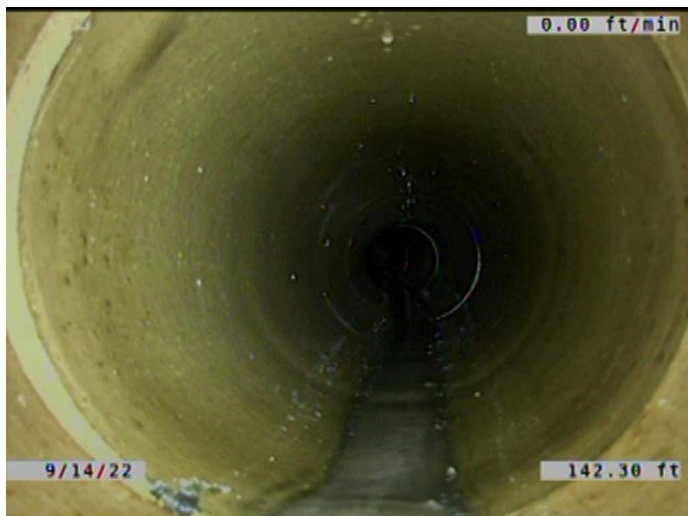
Code: **LR**  
Description: **Line Right**

Distance (ft): **142.3**  
Structural Grade: **0**  
O&M Grade: **1**  
Clock Start/From:  
Clock To:  
1st Value:  
2nd Value:  
Value Percent: **5.000**  
Continuous Index:  
Within 8" of Joint: **NO**  
Remarks:

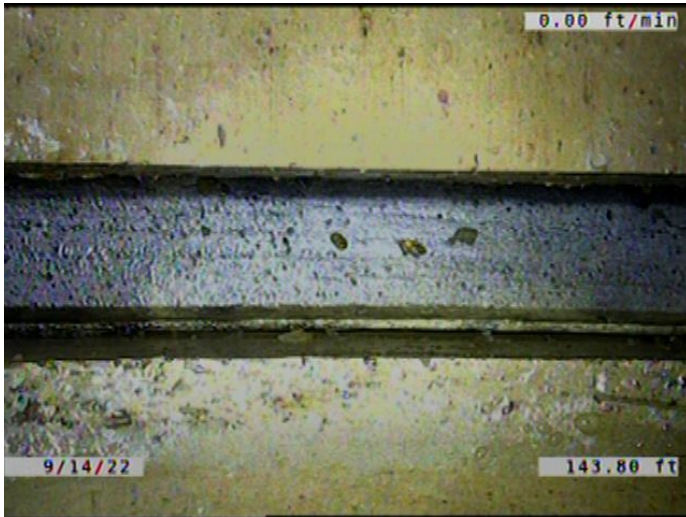
Code: **JAM**  
Description: **Joint Angular Medium**

Distance (ft): **143.8**  
Structural Grade: **3**  
O&M Grade: **0**  
Clock Start/From:  
Clock To:  
1st Value:  
2nd Value:  
Value Percent:  
Continuous Index:  
Within 8" of Joint: **NO**  
Remarks:

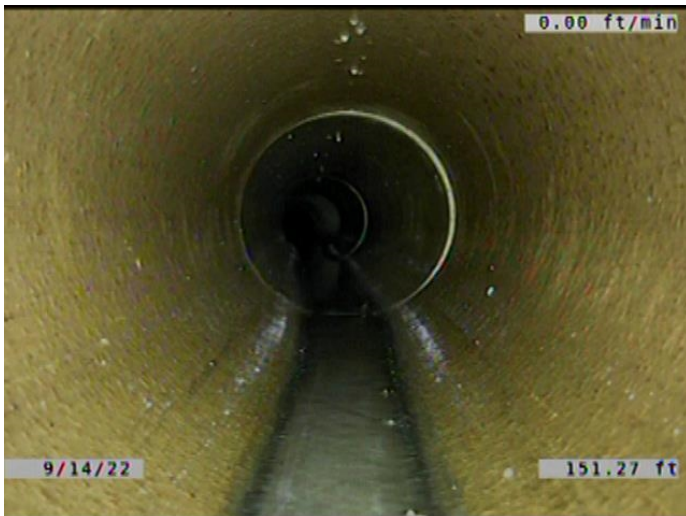
Code: **LL**  
Description: **Line Left**

Distance (ft): **151.3**  
Structural Grade: **0**  
O&M Grade: **1**  
Clock Start/From:  
Clock To:  
1st Value:  
2nd Value:  
Value Percent: **5.000**  
Continuous Index:  
Within 8" of Joint: **NO**  
Remarks:

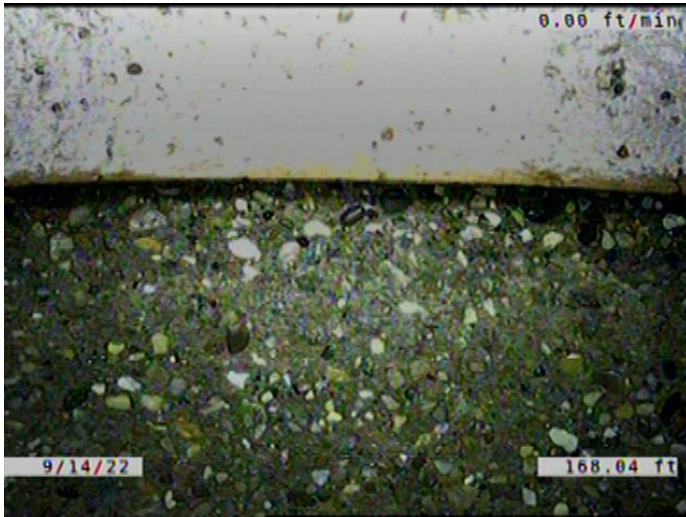
Code: **MMC**  
Description: **Miscellaneous Material Change**

Distance (ft): **168.0**  
Structural Grade: **0**  
O&M Grade: **0**  
Clock Start/From:  
Clock To:  
1st Value:  
2nd Value:  
Value Percent:  
Continuous Index:  
Within 8" of Joint: **NO**  
Remarks: **VCP TO RCP**

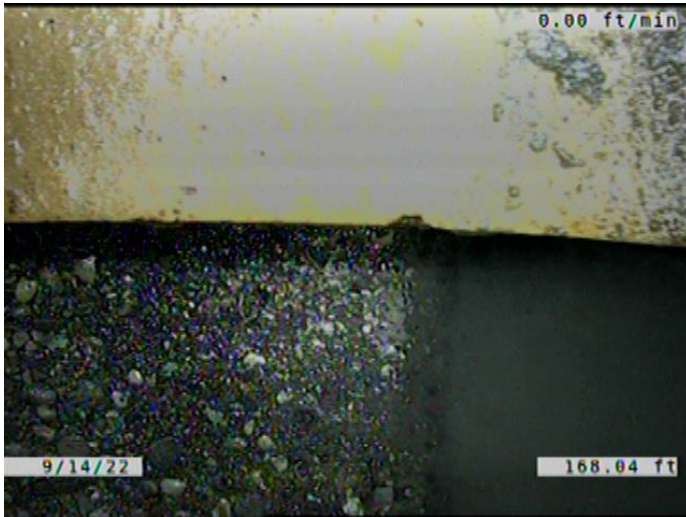
Code: **MGO**  
 Description: **Miscellaneous General Observation**

Distance (ft): **168.0**  
 Structural Grade: **0**  
 O&M Grade: **0**  
 Clock Start/From:  
 Clock To:  
 1st Value:  
 2nd Value:  
 Value Percent:  
 Continuous Index:  
 Within 8" of Joint: **NO**  
 Remarks: **12" VCP TO 15" RCP**

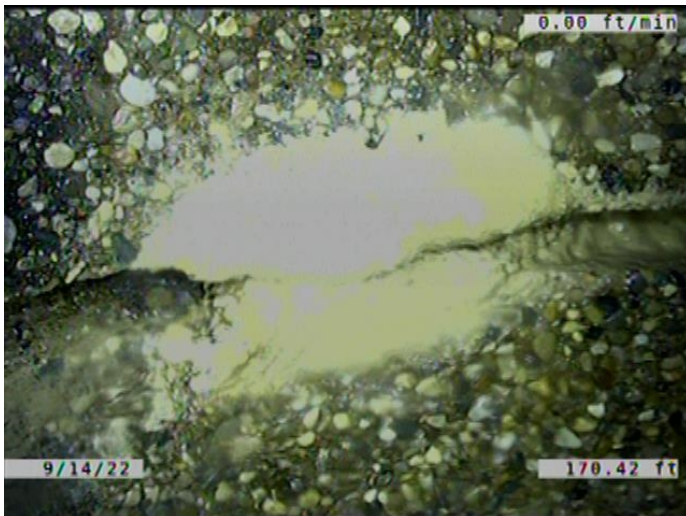
Code: **DAE**  
 Description: **Deposits Attached Encrustation**

Distance (ft): **170.4**  
 Structural Grade: **0**  
 O&M Grade: **2**  
 Clock Start/From: **8**  
 Clock To: **4**  
 1st Value:  
 2nd Value:  
 Value Percent: **5.000**  
 Continuous Index: **S03**  
 Within 8" of Joint: **YES**  
 Remarks:

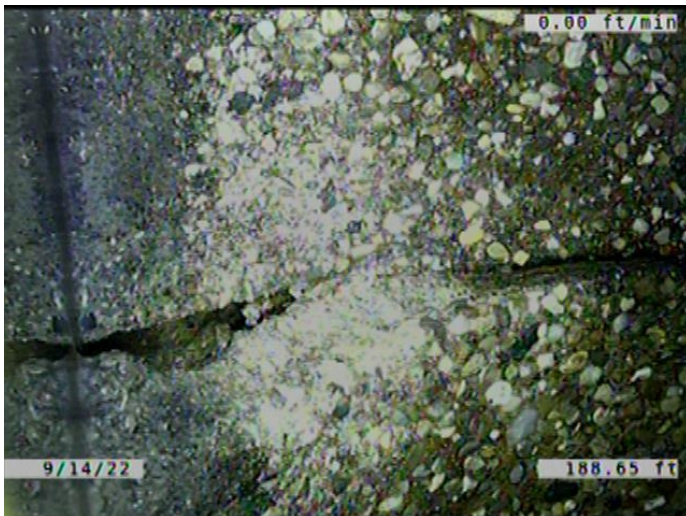
Code: **JOMD**  
 Description: **Joint Offset Medium Defective**

Distance (ft): **188.7**  
 Structural Grade: **3**  
 O&M Grade: **0**  
 Clock Start/From:  
 Clock To:  
 1st Value:  
 2nd Value:  
 Value Percent:  
 Continuous Index:  
 Within 8" of Joint: **NO**  
 Remarks: **SOIL VISIBLE.**

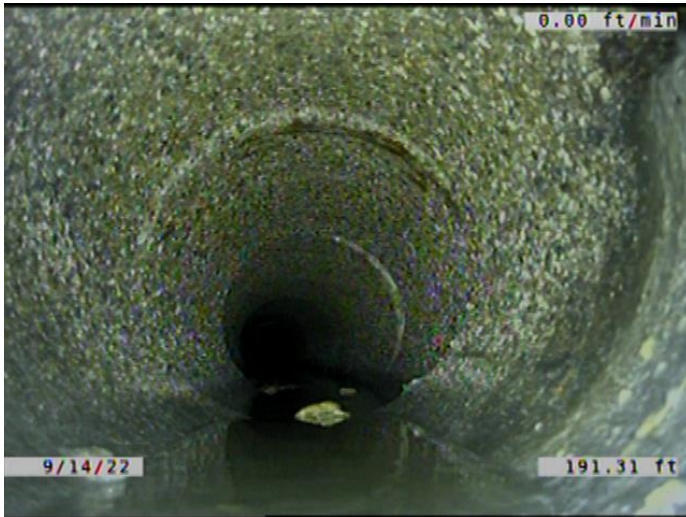
Code: **DAE**  
Description: **Deposits Attached Encrustation**

Distance (ft): **191.3**  
Structural Grade: **0**  
O&M Grade: **2**  
Clock Start/From: **8**  
Clock To: **4**  
1st Value:  
2nd Value:  
Value Percent: **5.000**  
Continuous Index: **F03**  
Within 8" of Joint: **YES**  
Remarks:

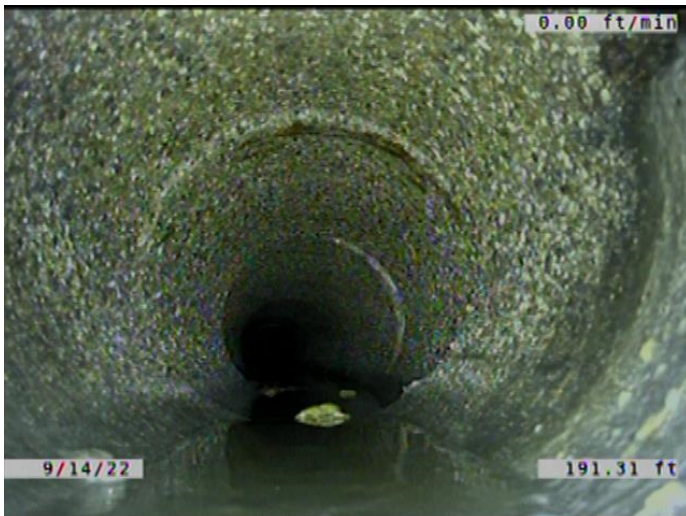
Code: **DSF**  
Description: **Deposits Settled Fine**

Distance (ft): **191.3**  
Structural Grade: **0**  
O&M Grade: **2**  
Clock Start/From: **5**  
Clock To: **7**  
1st Value:  
2nd Value:  
Value Percent: **5.000**  
Continuous Index: **F01**  
Within 8" of Joint: **YES**  
Remarks:
