## Profile/Photo Observation Report

Date:	<b>04/20/2018</b>	Weather:		Coding:	<b>PACP 6.0</b>
Pipe Length (ft):	<b>111.1</b>	Owner:	<b>NA</b>	Pre Clean:	<b>No Pre-Cleaning</b>
P.O.#:		Surveyor:	<b>Byrd Fitzgerald</b>	PSR:	<b>P-305-047-046</b>
Customer:		Clean Date:	<b>01/01/1900</b>	Shape:	<b>C</b>

Street:	<b>FOXCROFT STREET</b>	Flow Control:	<b>Not Controlled</b>
City:	<b>Hobart, IN</b>	Year Renewed:	
Location:	<b>Sidewalk</b>	Tape/Media #:	
Purpose:	<b>Routine Assessment</b>	Dia/Height:	<b>12"</b>
Use:	<b>Sanitary</b>	Material:	<b>VCP</b>
Drain Area:	<b>NA</b>	Lining:	
Category:	<b>NA</b>		
Comment:	<b>P_C at 25 ft build up at the joint</b>		
Location Details:		Direction of Survey:	<b>Upstream</b>
US MH:	<b>M-305-046</b>	DS MH:	<b>M-305-047</b>
		Total Length Surveyed (ft):	<b>27.0</b>

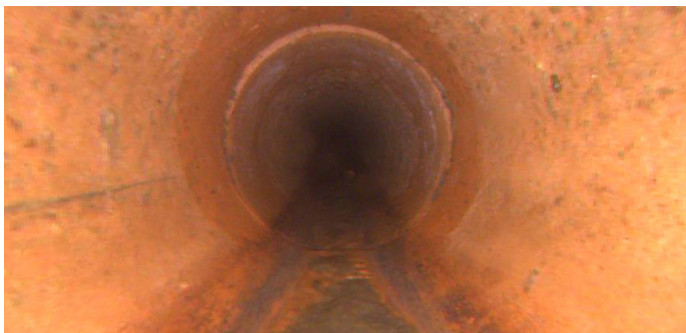
Code: **AMH**  
Description: **Manhole**

Distance (ft): **.0**  
Structural Grade: **0**  
O&M Grade: **0**  
Clock Start/From:  
Clock To:  
1st Value:  
2nd Value:  
Value Percent:  
Continuous Index:  
Within 8" of Joint: **NO**  
Remarks: **M-305-047**

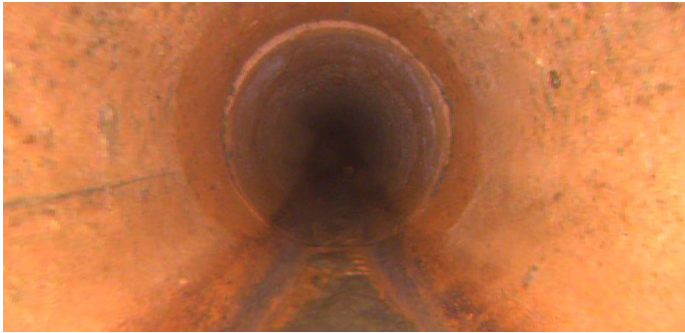
Code:	<b>MWL</b>
Description:	<b>Water Level</b>

Distance (ft):	<b>.0</b>
Structural Grade:	<b>0</b>
O&M Grade:	<b>0</b>
Clock Start/From:	
Clock To:	
1st Value:	
2nd Value:	
Value Percent:	<b>5.000</b>
Continuous Index:	
Within 8" of Joint:	<b>NO</b>
Remarks:

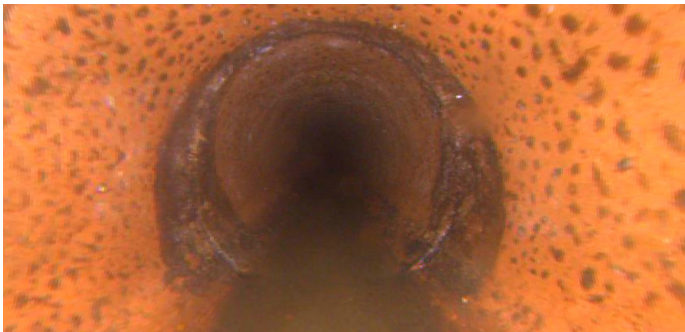
Code:	<b>DAE</b>
Description:	<b>Deposits Attached Encrustation</b>

Distance (ft):	<b>11.1</b>
Structural Grade:	<b>0</b>
O&M Grade:	<b>2</b>
Clock Start/From:	<b>7</b>
Clock To:	<b>5</b>
1st Value:	
2nd Value:	
Value Percent:	<b>5.000</b>
Continuous Index:	<b>S01</b>
Within 8" of Joint:	<b>YES</b>
Remarks:	<b>wandering</b>

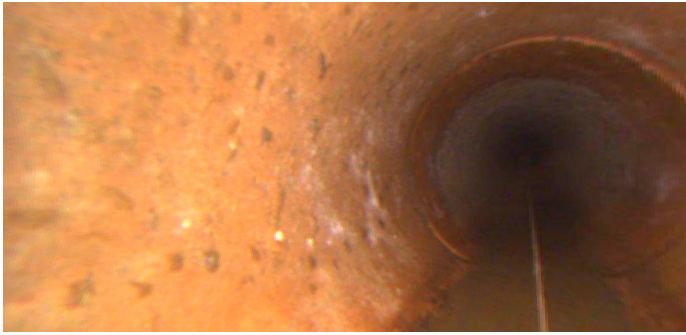
Code: **DAE**  
Description: **Deposits Attached Encrustation**

Distance (ft): **22.5**  
Structural Grade: **0**  
O&M Grade: **2**  
Clock Start/From: **7**  
Clock To: **5**  
1st Value:  
2nd Value:  
Value Percent: **5.000**  
Continuous Index: **F01**  
Within 8" of Joint: **YES**  
Remarks: **wandering**

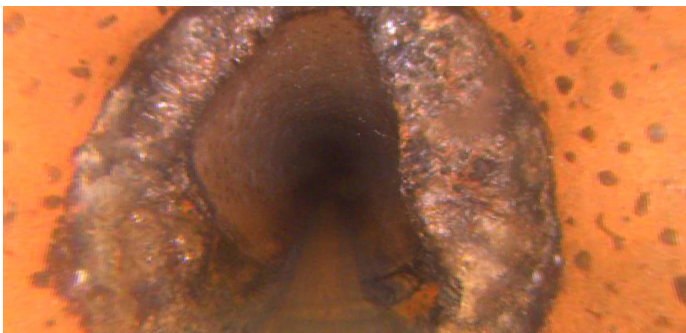
Code: **DAE**  
Description: **Deposits Attached Encrustation**

Distance (ft): **26.0**  
Structural Grade: **0**  
O&M Grade: **4**  
Clock Start/From: **7**  
Clock To: **5**  
1st Value:  
2nd Value:  
Value Percent: **25.000**  
Continuous Index:  
Within 8" of Joint: **YES**  
Remarks:

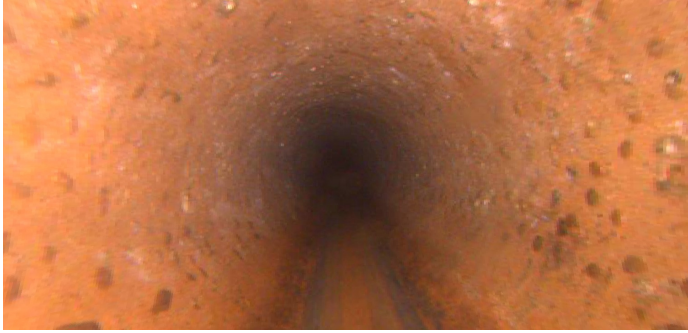
Code:	<b>MSA</b>
Description:	<b>Abandoned Survey</b>
Distance (ft):	<b>27.0</b>
Structural Grade:	<b>0</b>
O&M Grade:	<b>0</b>
Clock Start/From:	
Clock To:	
1st Value:	
2nd Value:	
Value Percent:	
Continuous Index:	
Within 8" of Joint:	<b>NO</b>
Remarks:	<b>dae</b>
