## Profile/Photo Observation Report

Street:	<b>W 3RD ST</b>	Flow Control:	<b>Not Controlled</b>
City:	<b>Hobart, IN</b>	Year Renewed:	
Location:	<b>Yard</b>	Tape/Media #:	
Purpose:	<b>Routine Assessment</b>	Dia/Height:	<b>12"</b>
Use:	<b>Sanitary</b>	Material:	<b>VCP</b>
Drain Area:	<b>NA</b>	Lining:	
Category:	<b>NA</b>		
Comment:

Location Details:		Direction of Survey:	<b>Upstream</b>
US MH:	<b>M-305-048</b>	DS MH:	<b>M-305-046</b>
		Total Length Surveyed (ft):	<b>13.1</b>

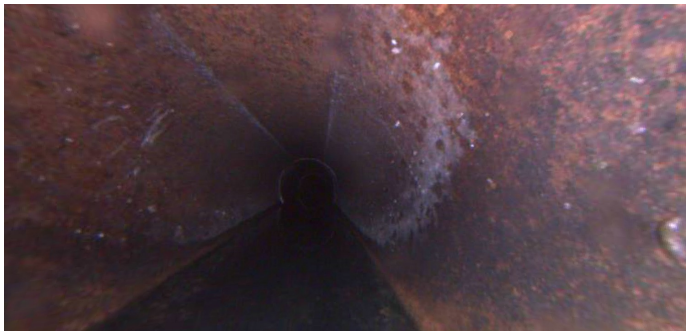
Code: **AMH**  
Description: **Manhole**

Distance (ft): **.0**  
Structural Grade: **0**  
O&M Grade: **0**  
Clock Start/From:  
Clock To:  
1st Value:  
2nd Value:  
Value Percent:  
Continuous Index:  
Within 8" of Joint: **NO**  
Remarks: **M-305-046**

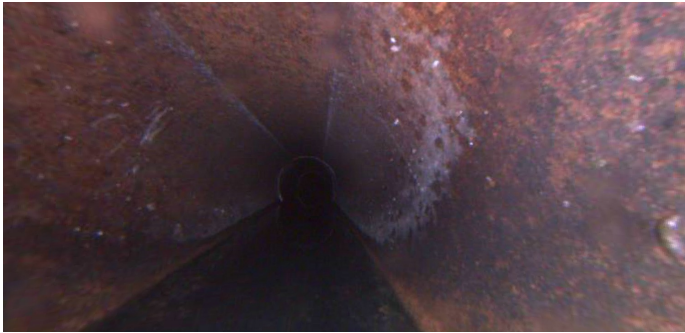
Code:	<b>MWL</b>
Description:	<b>Water Level</b>

Distance (ft):	<b>.0</b>
Structural Grade:	<b>0</b>
O&M Grade:	<b>0</b>
Clock Start/From:	
Clock To:	
1st Value:	
2nd Value:	
Value Percent:	<b>10.000</b>
Continuous Index:	
Within 8" of Joint:	<b>NO</b>
Remarks:

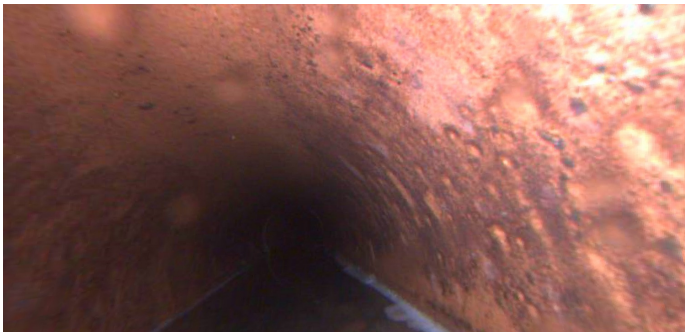
Code:	<b>MSA</b>
Description:	<b>Abandoned Survey</b>

Distance (ft):	<b>13.1</b>
Structural Grade:	<b>0</b>
O&M Grade:	<b>0</b>
Clock Start/From:	
Clock To:	
1st Value:	
2nd Value:	
Value Percent:	
Continuous Index:	
Within 8" of Joint:	<b>NO</b>
Remarks:	<b>unknown</b>
