Profile/Photo Observation Report

Street:	West 3rd Street	Flow Control:	Not Controlled
City:	Hobart, IN	Year Renewed:	
Location:	Sidewalk	Tape/Media #:	
Purpose:	Routine Assessment	Dia/Height:	12"
Use:	Sanitary Sewage Pipe	Material:	VCP
Drain Area:		Lining:	None
Category:	NA		
Comment:

Location Details:		Direction of Survey:	Upstream
US MH:	M-305-048	DS MH:	M-305-046
		Total Length Surveyed (ft):	99.3

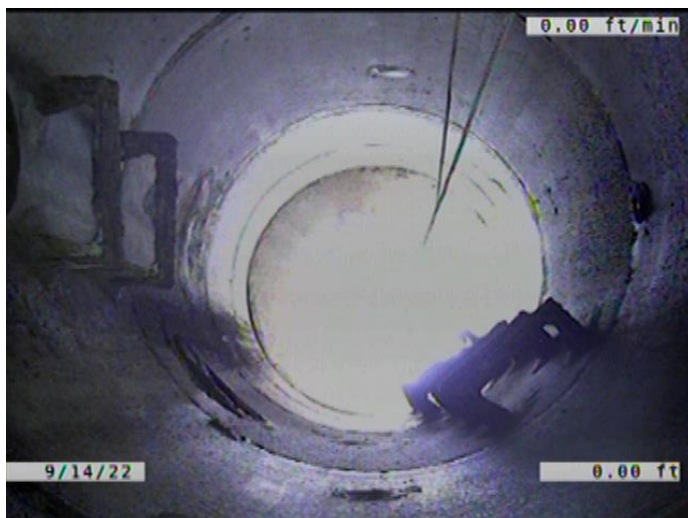
Code: **AMH**
 Description: **Manhole**

Distance (ft): **.0**
 Structural Grade: **0**
 O&M Grade: **0**
 Clock Start/From:
 Clock To:
 1st Value:
 2nd Value:
 Value Percent:
 Continuous Index:
 Within 8" of Joint: **NO**
 Remarks: **M-305-046**

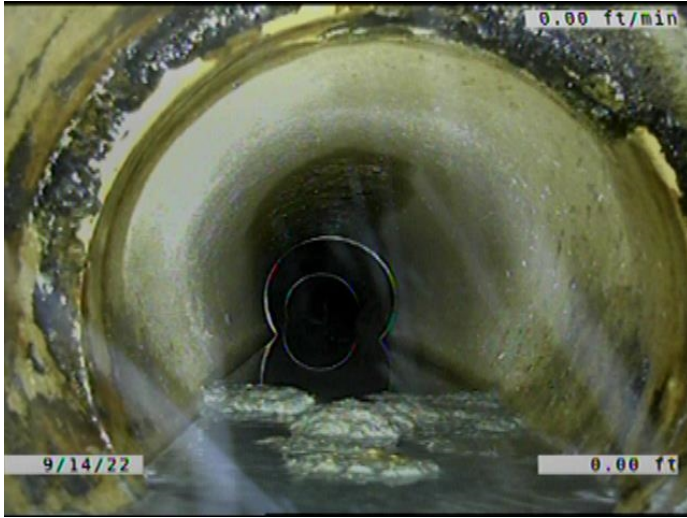
Code:	MWL
Description:	Miscellaneous Water Level
Distance (ft):	.0
Structural Grade:	0
O&M Grade:	0
Clock Start/From:	
Clock To:	
1st Value:	
2nd Value:	
Value Percent:	10.000
Continuous Index:	
Within 8" of Joint:	NO
Remarks:

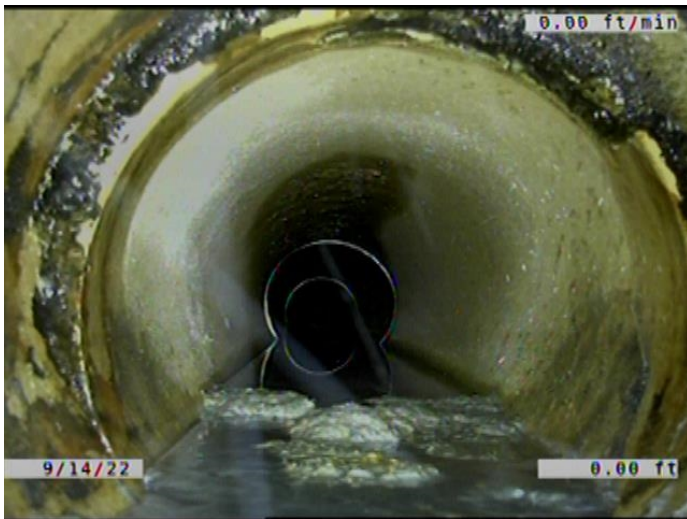
Code:	DSF
Description:	Deposits Settled Fine
Distance (ft):	.0
Structural Grade:	0
O&M Grade:	2
Clock Start/From:	5
Clock To:	7
1st Value:	
2nd Value:	
Value Percent:	5.000
Continuous Index:	S01
Within 8" of Joint:	YES
Remarks:

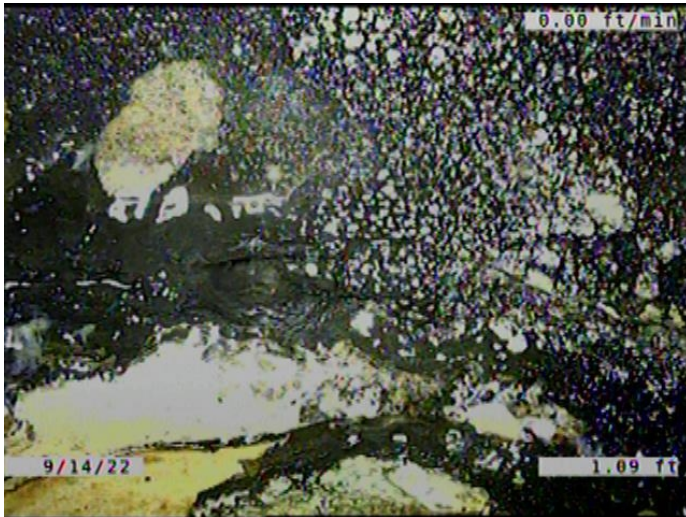
Code: **IRJ**
 Description: **Infiltration Runner Joint**

Distance (ft): **1.1**
 Structural Grade: **0**
 O&M Grade: **4**
 Clock Start/From: **9**
 Clock To: **12**
 1st Value:
 2nd Value:
 Value Percent:
 Continuous Index:
 Within 8" of Joint: **YES**
 Remarks:

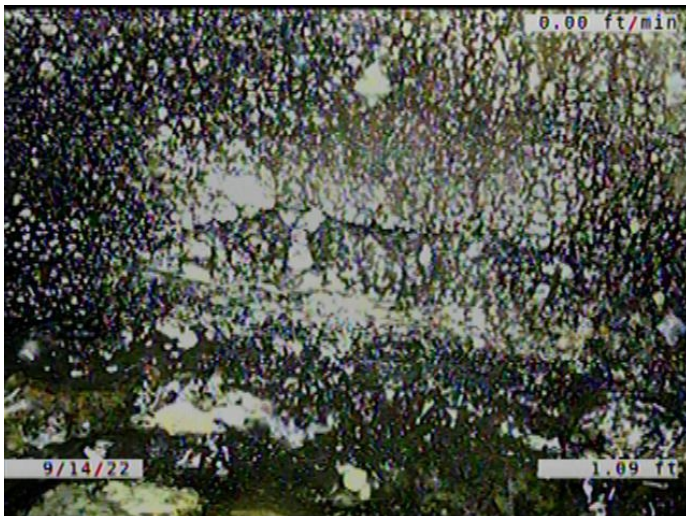
Code: **DAE**
 Description: **Deposits Attached Encrustation**

Distance (ft): **1.1**
 Structural Grade: **0**
 O&M Grade: **2**
 Clock Start/From: **7**
 Clock To: **5**
 1st Value:
 2nd Value:
 Value Percent: **5.000**
 Continuous Index:
 Within 8" of Joint: **YES**
 Remarks:

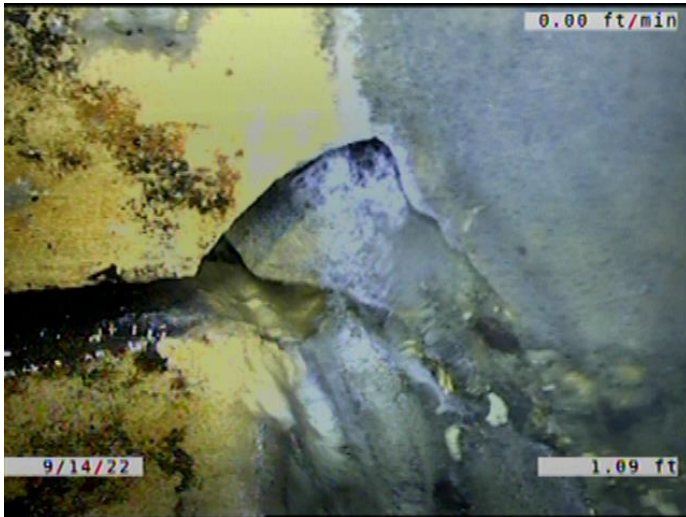
Code: **B**
 Description: **Broken**

Distance (ft): **1.1**
 Structural Grade: **4**
 O&M Grade: **0**
 Clock Start/From: **8**
 Clock To: **5**
 1st Value:
 2nd Value:
 Value Percent:
 Continuous Index:
 Within 8" of Joint: **YES**
 Remarks:

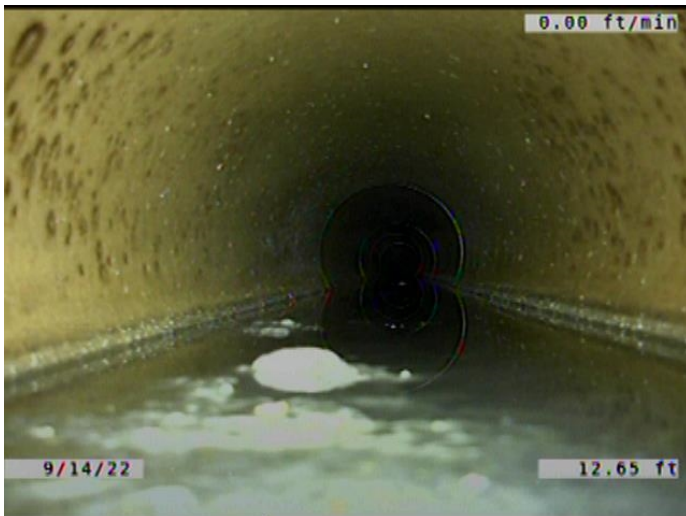
Code: **MWL**
 Description: **Miscellaneous Water Level**

Distance (ft): **12.6**
 Structural Grade: **0**
 O&M Grade: **0**
 Clock Start/From:
 Clock To:
 1st Value:
 2nd Value:
 Value Percent: **15.000**
 Continuous Index:
 Within 8" of Joint: **NO**
 Remarks:

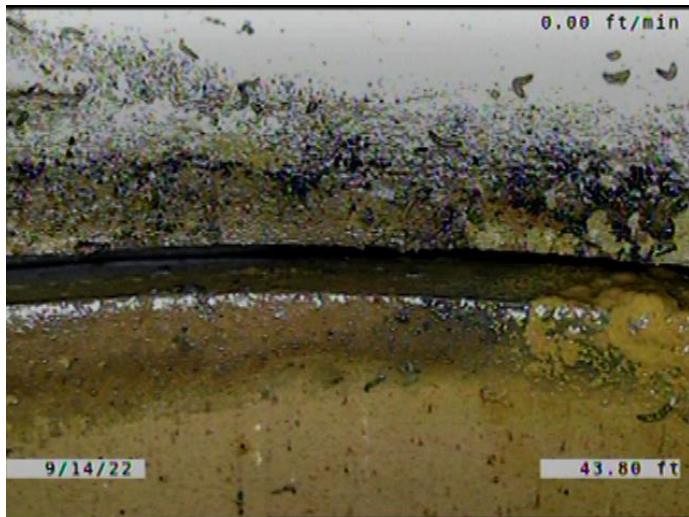
Code: **DAE**
 Description: **Deposits Attached Encrustation**

Distance (ft): **43.8**
 Structural Grade: **0**
 O&M Grade: **2**
 Clock Start/From: **8**
 Clock To: **4**
 1st Value:
 2nd Value:
 Value Percent: **5.000**
 Continuous Index: **S02**
 Within 8" of Joint: **YES**
 Remarks:

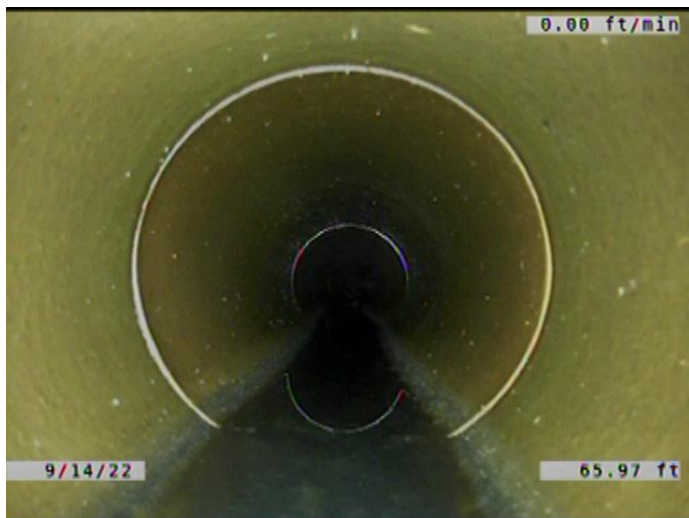
Code: **DAE**
 Description: **Deposits Attached Encrustation**

Distance (ft): **66.0**
 Structural Grade: **0**
 O&M Grade: **2**
 Clock Start/From: **8**
 Clock To: **4**
 1st Value:
 2nd Value:
 Value Percent: **5.000**
 Continuous Index: **F02**
 Within 8" of Joint: **YES**
 Remarks:

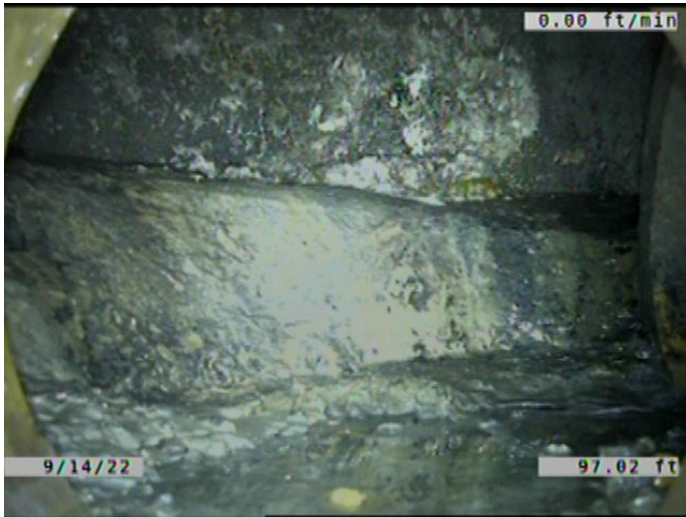
Code: **DSF**
 Description: **Deposits Settled Fine**

Distance (ft): **97.0**
 Structural Grade: **0**
 O&M Grade: **2**
 Clock Start/From: **5**
 Clock To: **7**
 1st Value:
 2nd Value:
 Value Percent: **5.000**
 Continuous Index: **F01**
 Within 8" of Joint: **YES**
 Remarks:

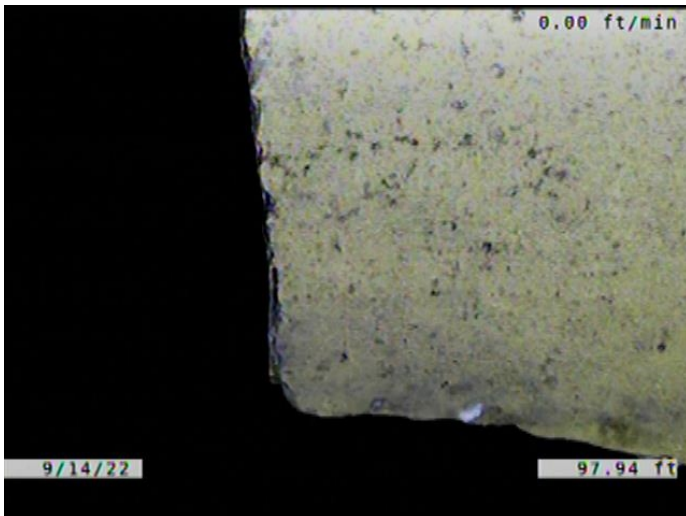
Code: **SMW**
 Description: **Surface Damage Missing Wall**

Distance (ft): **97.9**
 Structural Grade: **5**
 O&M Grade: **0**
 Clock Start/From: **11**
 Clock To: **1**
 1st Value:
 2nd Value:
 Value Percent:
 Continuous Index:
 Within 8" of Joint: **NO**
 Remarks:

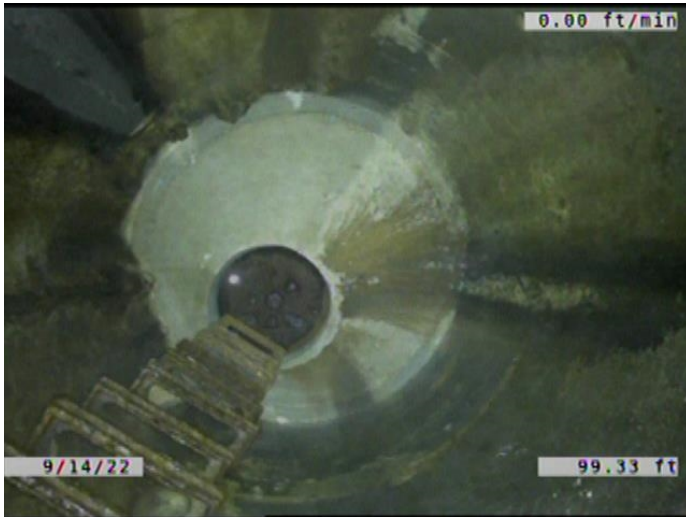
Code:	AMH
Description:	Manhole
Distance (ft):	99.3
Structural Grade:	0
O&M Grade:	0
Clock Start/From:	
Clock To:	
1st Value:	
2nd Value:	
Value Percent:	
Continuous Index:	
Within 8" of Joint:	NO
Remarks:	M-305-048
