Profile/Photo Observation Report

Date:	04/24/2018	Weather:		Coding:	PACP 6.0
Pipe Length (ft):	208.2	Owner:	NA	Pre Clean:	No Pre-Cleaning
P.O.#:		Surveyor:	Erik Redinger	PSR:	P-305-056-055
Customer:		Clean Date:	01/01/1900	Shape:	C

Street:	ALLEY BETWEEN WOODLAND LN &	Flow Control:	Not Controlled
City:	Hobart, IN	Year Renewed:	
Location:	Yard	Tape/Media #:	
Purpose:	Routine Assessment	Dia/Height:	10"
Use:	Sanitary	Material:	PVC
Drain Area:	NA	Lining:	
Category:	NA		
Comment:	Flow direction wrong . purple images start at 55 ft to 184 ft front camera only		
Location Details:		Direction of Survey:	Downstream
US MH:	M-305-055	DS MH:	M-305-056
		Total Length Surveyed (ft):	185.2

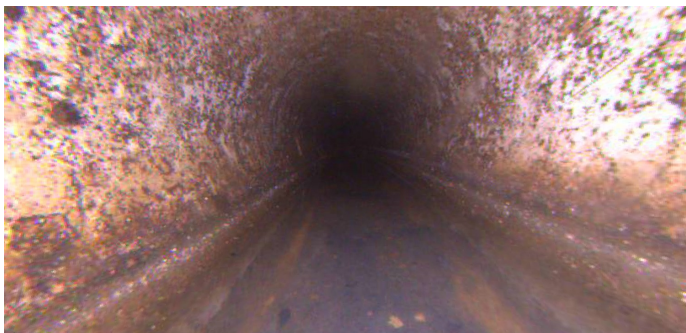
Code: **AMH**
Description: **Manhole**

Distance (ft): **.0**
Structural Grade: **0**
O&M Grade: **0**
Clock Start/From:
Clock To:
1st Value:
2nd Value:
Value Percent:
Continuous Index:
Within 8" of Joint: **NO**
Remarks: **M-305-055**

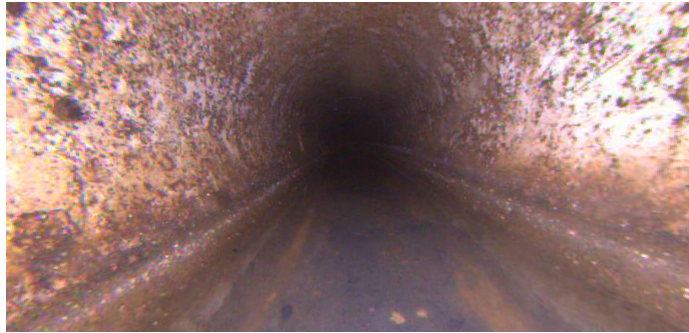
Code: **MWL**
Description: **Water Level**

Distance (ft): **.0**
Structural Grade: **0**
O&M Grade: **0**
Clock Start/From:
Clock To:
1st Value:
2nd Value:
Value Percent: **10.000**
Continuous Index:
Within 8" of Joint: **NO**
Remarks:

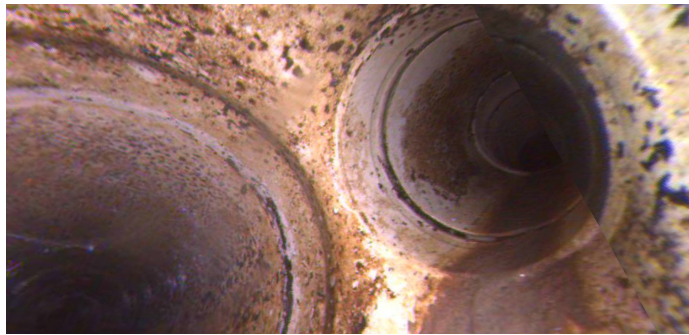
Code: **TF**
Description: **Tap Factory**

Distance (ft): **10.6**
Structural Grade: **0**
O&M Grade: **0**
Clock Start/From: **2**
Clock To:
1st Value: **4.000**
2nd Value:
Value Percent:
Continuous Index:
Within 8" of Joint:
Remarks:

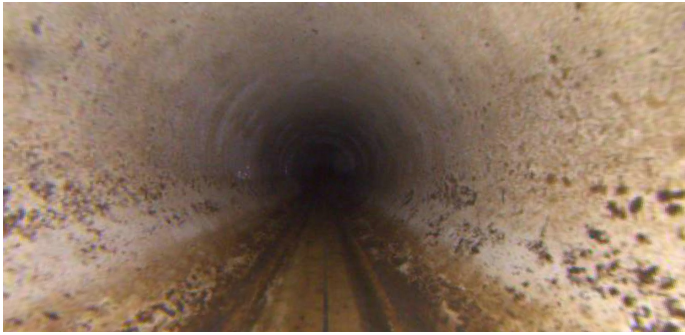
Code: **MGO**
Description: **General Observation**

Distance (ft): **55.7**
Structural Grade: **0**
O&M Grade: **0**
Clock Start/From:
Clock To:
1st Value:
2nd Value:
Value Percent:
Continuous Index:
Within 8" of Joint: **NO**
Remarks: **rear camera**

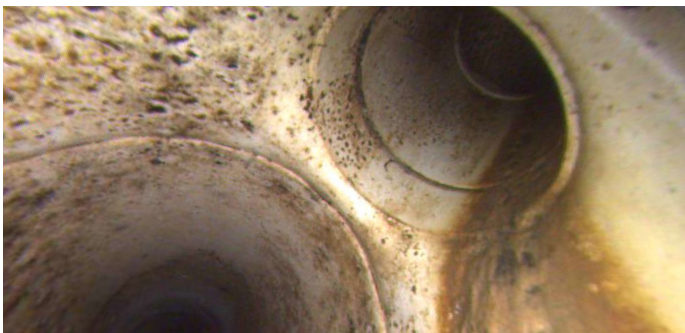
Code: **TF**
Description: **Tap Factory**

Distance (ft): **59.1**
Structural Grade: **0**
O&M Grade: **0**
Clock Start/From: **10**
Clock To:
1st Value: **4.000**
2nd Value:
Value Percent:
Continuous Index:
Within 8" of Joint:
Remarks:

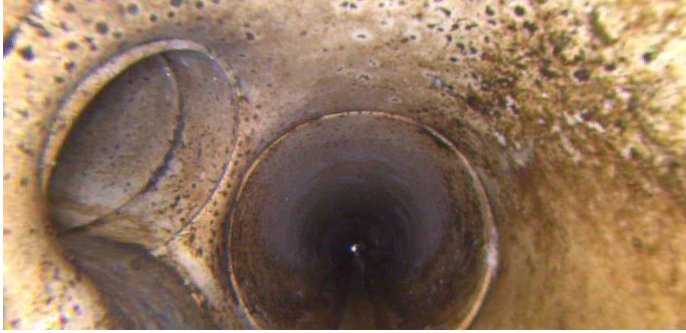
Code: **TFA**
Description: **Tap Factory Active**

Distance (ft): **74.4**
Structural Grade: **0**
O&M Grade: **0**
Clock Start/From: **3**
Clock To:
1st Value: **4.000**
2nd Value:
Value Percent:
Continuous Index:
Within 8" of Joint:
Remarks:

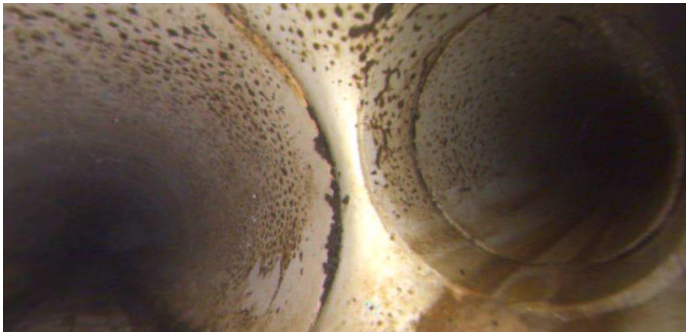
Code: **TFA**
Description: **Tap Factory Active**

Distance (ft): **114.7**
Structural Grade: **0**
O&M Grade: **0**
Clock Start/From: **9**
Clock To:
1st Value: **4.000**
2nd Value:
Value Percent:
Continuous Index:
Within 8" of Joint:
Remarks:

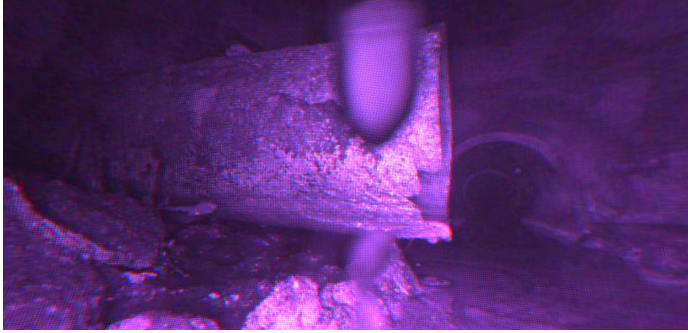
Code:	AMH
Description:	Manhole
Distance (ft):	185.2
Structural Grade:	0
O&M Grade:	0
Clock Start/From:	
Clock To:	
1st Value:	
2nd Value:	
Value Percent:	
Continuous Index:	
Within 8" of Joint:	NO
Remarks:	M-305-056
